# Lake Wyola Inventory and Evaluation Shutesbury, Massachusetts

Prepared by:  
Natural Resources Conservation Service  
August 2005

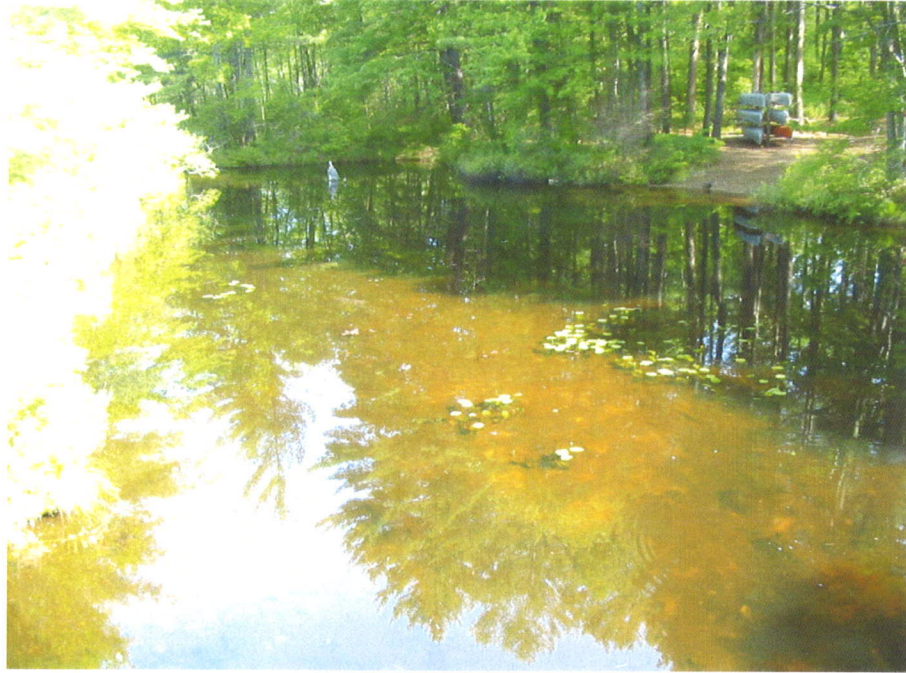
The water in the North Cove both upstream and downstream from Lakeview Road is shallow with sand bars and aquatic vegetation observed in several areas (Photo # 1). The sediment deposits and shallow water extend from approximately 200 feet above Lakeview Road to about 500 feet below the road. Part of the lake sediment problem appears to be from road sand which is used in the winter and washes into the lake (Photo # 2). We noticed that winter sand is swept from Lakeview Road, but some sand still remains along the edges of the road (Photo # 3). Debris and sediment are also accumulating under the Lakeview Road bridge. There are sediment deposits in the stream at the junction of Tyler Brook and Fiske Brook, as indicated by the sand bar in Photo # 4. Tyler Pond is located just upstream from this junction on Tyler Brook. The water level in Tyler Pond was lowered about 5 feet during the site visit. There does not appear to be much sediment deposited in the pond.

**Photo # 1 – Lakeview Road Upstream, Shallow Pond Area**

- Remove accumulated debris from the Lakeview Road bridge. Measure the depth of sediment in the bridge opening as an indicator for determining the amount of sediment which has accumulated in the North Cove area. This can provide some basic information for planning a project to remove the sediment deposits from the lake area. Additional surveys of the current lake bottom in the North Cove area and sediment samples will be needed for obtaining permits and removing the sediment.

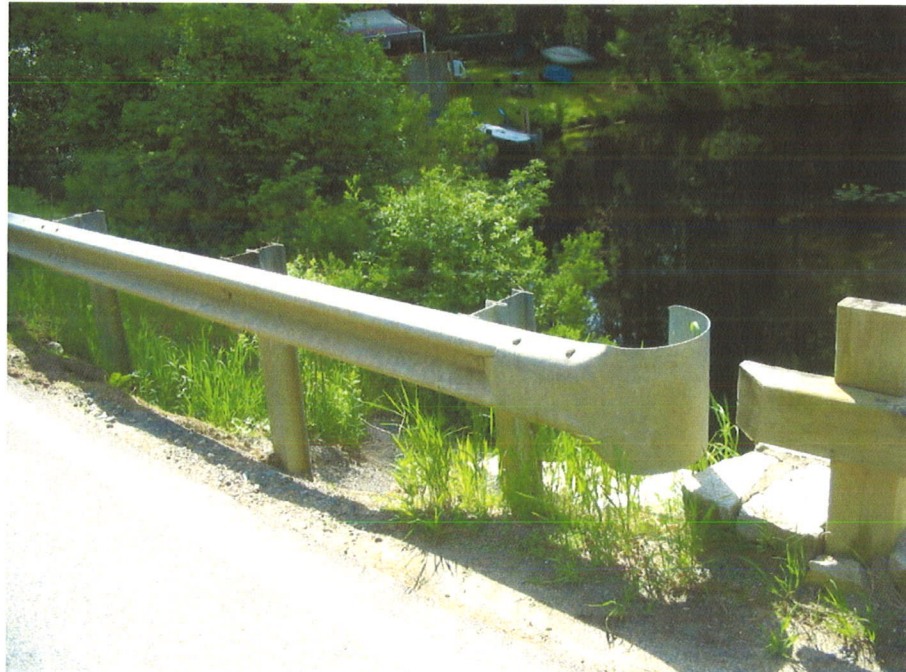
**Photo # 2 – Lakeview Road Downstream Runoff Area**

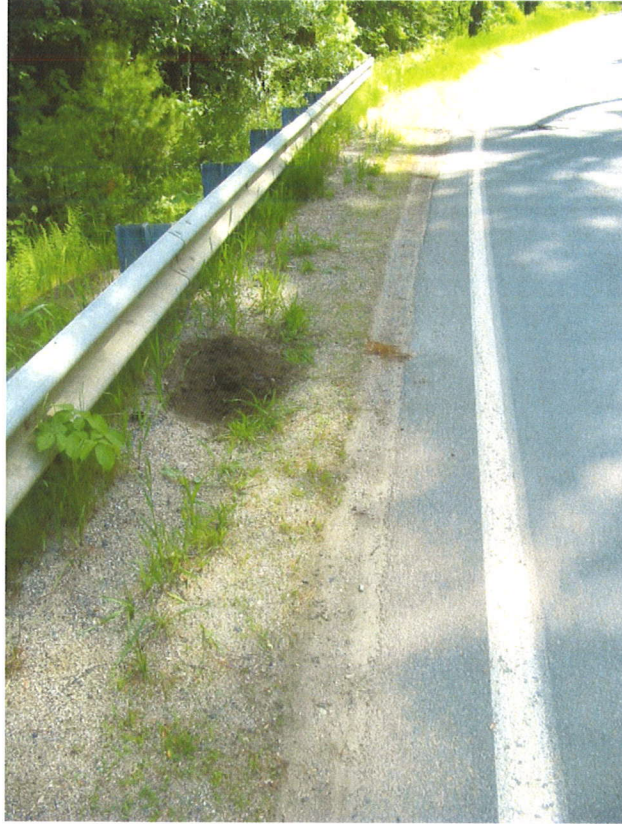
The sediment accumulation in the North Cove of Lake Wyola appears to have come from two major sources—road sand around the lake area and erosion from the banks and streambed of Fiske Brook accelerated by intermittent breaching of beaver dams or debris accumulated at the outlet spillway of Fiske Pond. A significant amount of sediment comes from winter road sand washing into the lake during storm events. Even though several of the roads are swept by the town in the spring, sand still remains on the road berms. Drainage swales carry storm runoff and sediment into the lake.

**Photo # 3 – Lakeview Road Edge, Sand Accumulation**

- Minimize the amount of sand applied to the road around Lake Wyola during the winter months
- Develop a regular road sweeping program for cleaning in the spring and during the summer and fall months, as needed
- Remove existing accumulations of sand along the shoulders of Lakeview Road
- Install curbs or berms along the edges of the roads to direct the road runoff into constructed sediment basins which can be periodically cleaned out

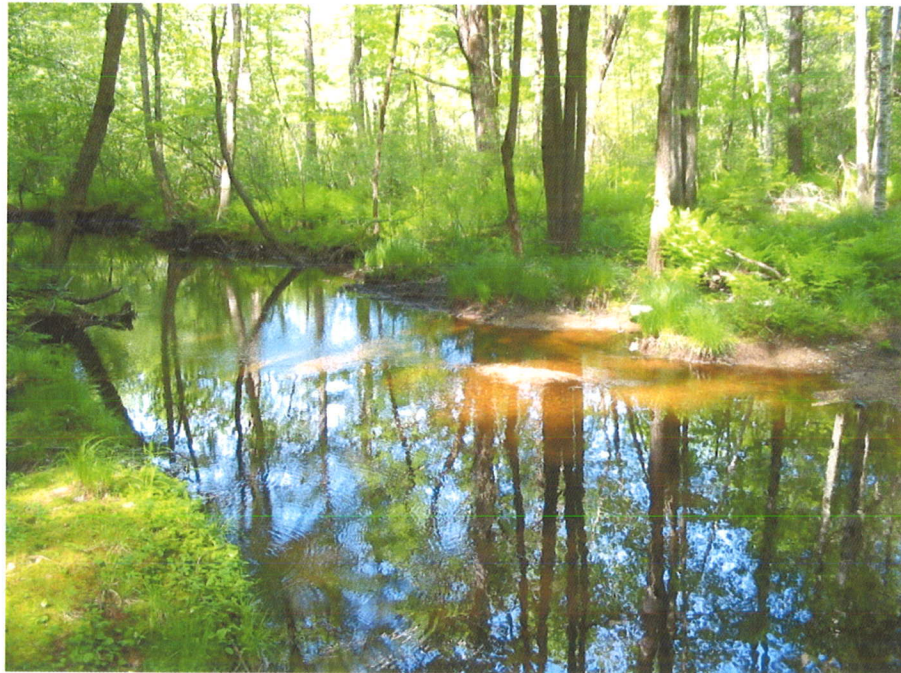
**Photo # 4 – Junction of Tyler Brook and Fiske Brook, Sand Bar**

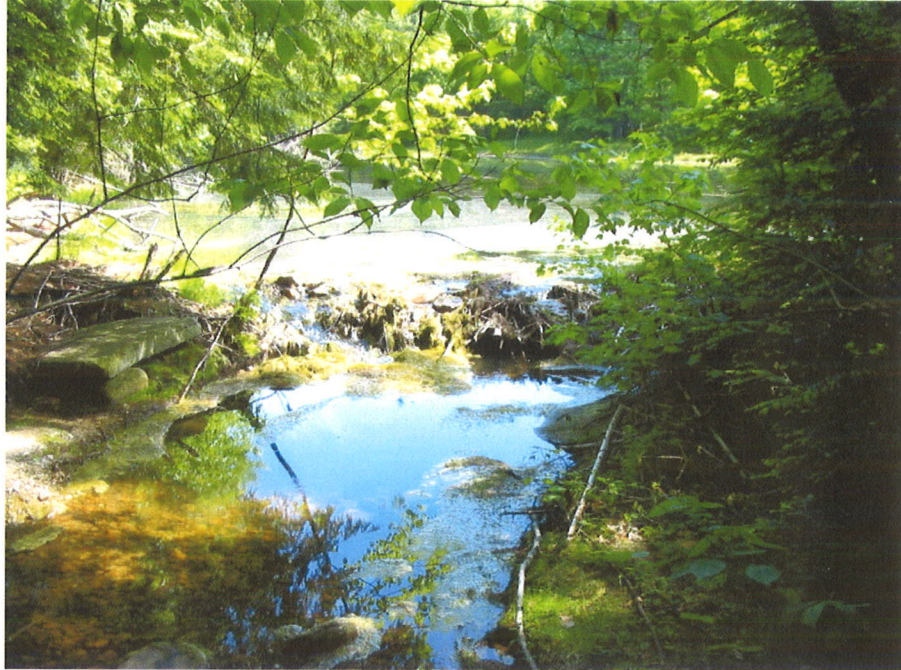
Under current conditions, the outlet structure is covered with beaver debris (the concrete weir could not be seen) and the outlet channel is eroded. We observed laid stone on a portion of the downstream face of the embankment. There is no defined channel downstream near the center of the dam, where a pipe outlet might be expected. A laid stone wall on the left side of a wetland area near the midpoint of the embankment extends 20 to 30 feet downstream perpendicular to the dam.

The second problem is beaver activity at Fiske Pond and along Fiske Brook. The Fiske Pond overflow spillway is blocked with beaver debris which holds a significant amount of water behind the debris dam. As an example, one foot of water over the 8-acre pond surface amounts to a volume of 2.6 million gallons. During major storm events it appears the debris dam breaches and high streamflows pass through and erode the outlet channel. The sediment is carried downstream during the high flows. The coarser gravels are deposited along Fiske Brook, and the finer grained sand and silt are carried all the way to Lake Wyola and deposited in North Cove. This probably occurred during the microburst, Hurricane Bertha, Hurricane Floyd, and other major rainfall events.

**Photo # 5 – Fiske Pond Overflow Spillway, Beaver Debris**

- Remove accumulated beaver debris from the spillway outlet structure and maintain the spillway free of debris. This will prevent the debris blowouts and periodic surges of water downstream in Fiske Brook which are contributing to the erosion of the outlet channel and associated sedimentation in Lake Wyola.
- Once the debris is removed the concrete spillway should be inspected to ensure water is not flowing around the ends of the spillway and endangering the integrity of the abutment.
- Install streambank and channel protection measures along the eroded outlet channel below the spillway outlet structure
- As part of future planning for the Town of Wendell, a hydraulic analysis should be conducted on Fiske Pond dam to evaluate the capacity of the spillway and the safety of the dam from overtopping.

- The Town of Wendell should develop a regular inspection and maintenance program at Fiske Pond to remove pond weeds, accumulated beaver debris, and other debris which accumulate at the spillway outlet structure.
- A log boom structure installed upstream of the spillway would help to prevent the debris dams at the spillway and allow water to pass freely over the spillway structure.
- Install beaver control measures at the active beaver areas downstream on Fiske Brook. Check with the Massachusetts Division of Fisheries and Wildlife for acceptable beaver control devices.

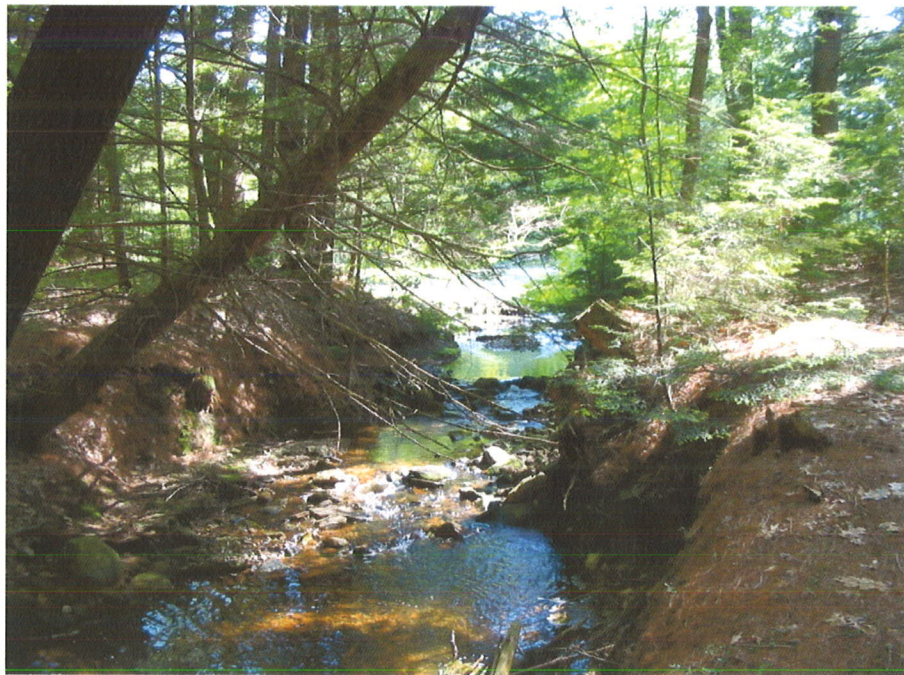
**Photo # 6 – Fiske Pond Spillway, Eroded Outlet Channel**

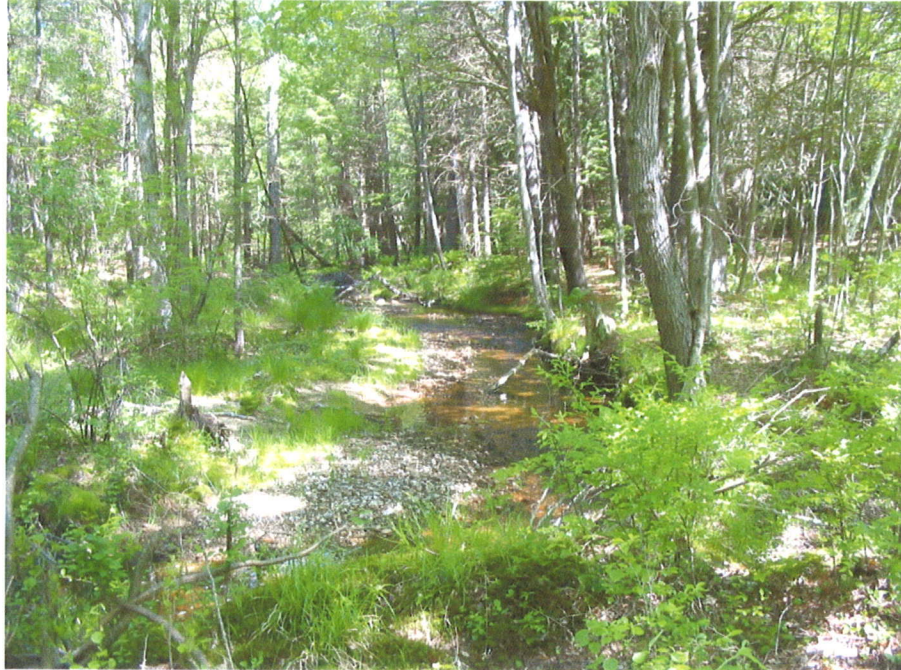
**Photo # 7 – Channel below Fiske Pond, Sediment and Debris**

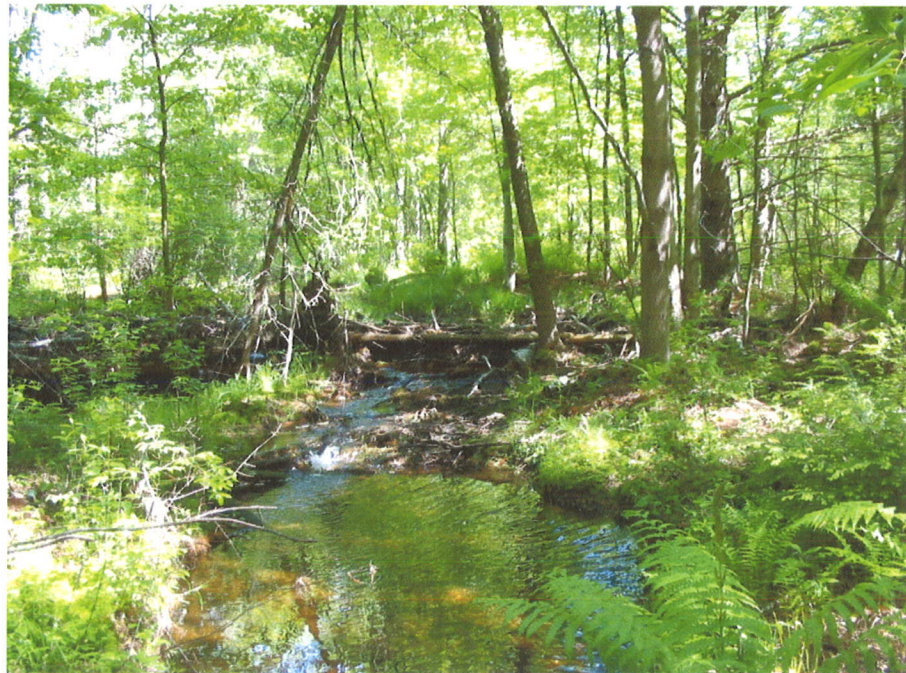
Fiske Pond is located approximately 1000 feet upstream from the junction of Tyler Brook and Fiske Brook. Fiske Pond was recently bought (obtained) by the Town of Wendell for use as a conservation area. The dam has an earthen core with a laid stone facing on the downstream side. Stone slope protection was observed on the upstream side. The main outlet is a concrete overflow spillway on the right side adjacent to the abutment. This outlet is presently blocked with beaver debris (Photo # 5). The outlet channel is eroded. We observed channel downcutting and vertical banks devoid of vegetation (Photo # 6). As we walked along the outlet channel, the upper reach was a continuation of the eroded channel and the lower reach included sediment deposits and debris (Photo # 7). The beaver debris at the Fiske Pond outlet probably breaches during major storm events causing the channel to erode and sediment to deposit in the channel downstream all the way to Lake Wyola. The sand and silt sediment finds its way into Lake Wyola. There are also several beaver dams along Fiske Brook below Fiske Pond which hold water and could breach during storm events (Photo # 8). These likely also contribute to moving the sediment downstream.

**Photo # 8 – Beaver Dam along Fiske Brook**

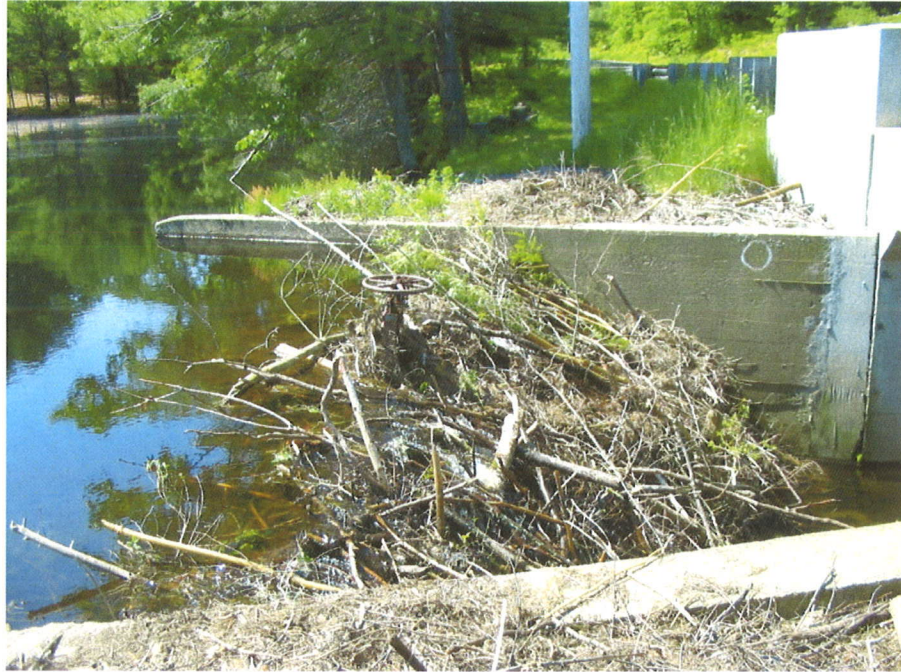
McAvoy Pond is located immediately upstream of Locks Village Road. The concrete spillway outlet structure is clogged with beaver debris (Photo # 9). A small private pond, Ethier's Pond, is located below Locks Village Road; and Tyler Pond is located further downstream.

**Photo # 9 – McAvoy Pond Outlet with Beaver Debris**

- Remove the accumulated beaver debris from the spillway outlet structure
- Periodically inspect the spillway outlet structure during the active beaver season and remove the debris
- A log boom structure installed upstream of the spillway would help to prevent the debris dams at the spillway and allow water to pass freely over the spillway structure.
