Appendix C

Post-Restoration and Mitigation Information

RE: Lot O-32 Wetland Restoration Project (MassDEP File #: 286-0298)
Wetland Restoration Initial Report

Re: DEP file # 286-298, Wetland Restoration Inspection, 66 Leverett Road

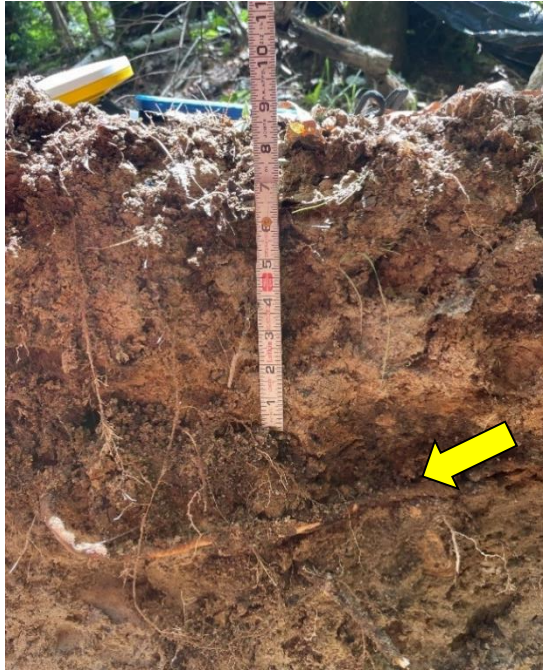
Based on the gentle slope of the buried horizon at Test Pit #1, it appears the buried horizon may have been the result of erosion and sedimentation. The shallow depth (8 inches maximum), tapering of the buried horizon, and lack of observation of buried trash in this horizon supports erosion and sedimentation as a plausible process causing the fill, rather than anthropogenic dumping. The cause of the erosion cannot be determined but may have been a result of disturbed soils eroding from previous tree clearing activities and depositing downgradient.

The soil beneath the buried horizon does not meet the criteria of a hydric soil. Redoximorphic concentrations were observed within the layer beneath the buried topsoil, indicating that the water table does fluctuate within this layer. Although the buried soils do not meet the criteria for a hydric soil, that area was excavated to remove the fill material and was conservatively included within the new BVW wetland boundary. It is anticipated that with the shrub plantings and seeding with New England Erosion Control/Restoration Mix for Detention Basins and Moist Sites, this area along the BVW boundary will give rise to hydrophytic vegetation and indicators of hydrology.

Photo 1 View south of Test Pit #1 in Trench 1. The buried topsoil visible on the south side of the trench was observed approximately 8 inches from the soil surface (6/22/23).

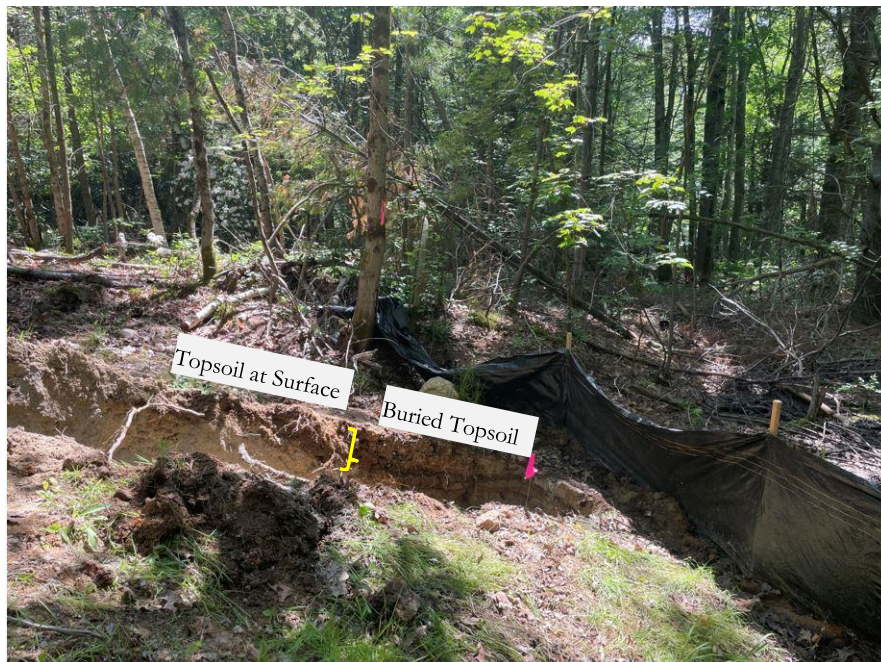
Photo 2 View south of the Trench 1 where topsoil transitions from at the ground surface to being buried (6/22/23).

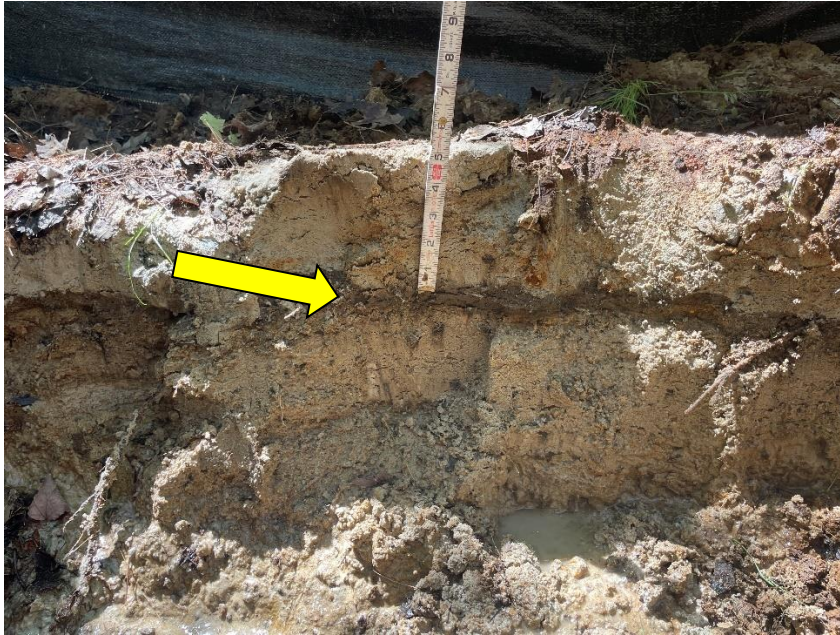
Photo 3 View of the western-most extent of Trench 1 within BVW 3, directly adjacent to the silt fence. The darker horizon was observed at a depth of 5 inches at the toe of slope. This darker horizon may indicate buried topsoil and is indicated with the yellow arrow (6/22/23).

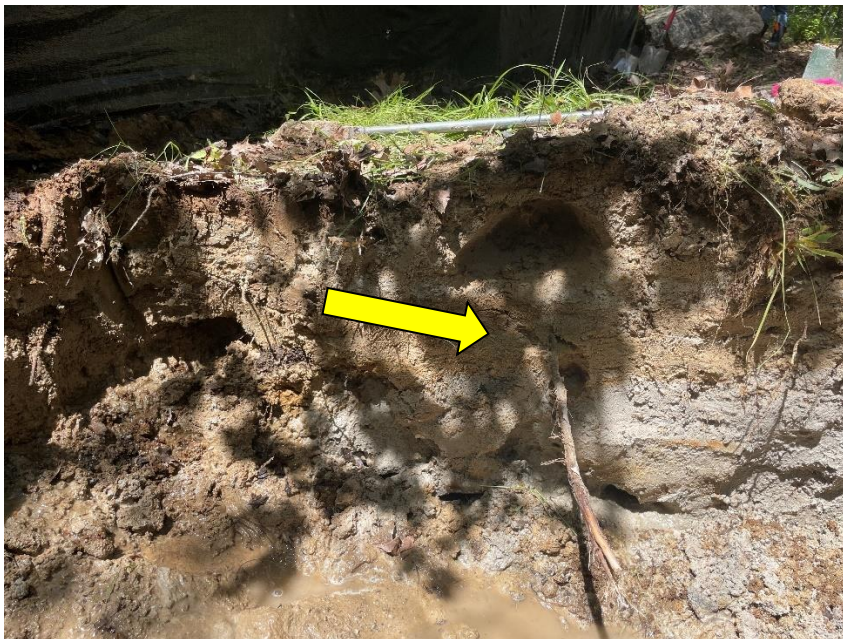
Photo 4 View north of the north side of Trench 1. The dark, buried horizon observed on the south and west side was not observed on the north side. An illuvial horizon enriched with iron and/or organic material was observed on the north side as indicated by the yellow arrow (6/22/23).

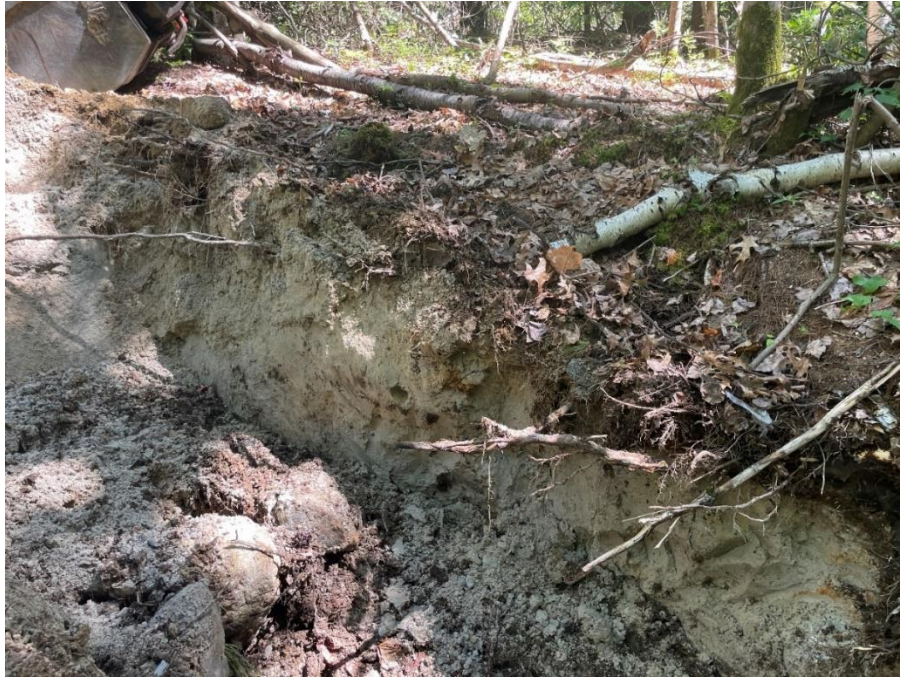
Photo 5 View south of Trench 2. No buried soils were observed at this location (6/22/23).

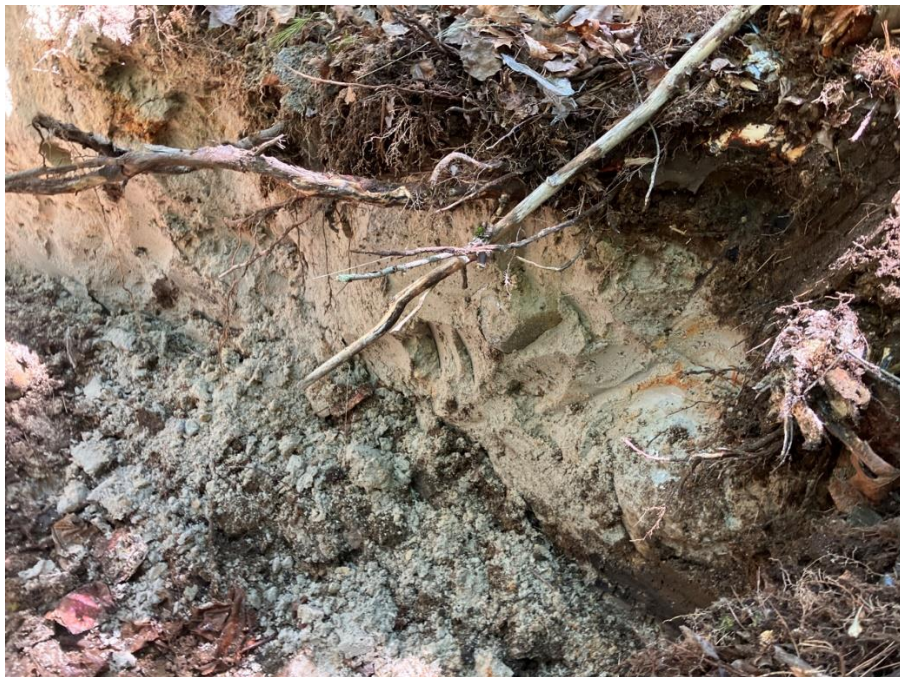
Trash observed buried in the topsoil in the vicinity of Test Pit #2 consisted of household refuse (mostly cigarette cartons) and was all contained within the darker topsoil horizon at the base of a tree. The topsoil at this location was thicker, likely due to the tree roots contributions of organic material. No buried horizon was observed at the base of the tree where the household refuse was removed. The presence of trash within the topsoil may have been the result of soil formation atop the trash.

Photo 6 Closeup view south of the Test Pit #2 location at the base of a tree adjacent to flag wf 3a-114. A thick topsoil was observed. No buried soil horizon was observed at Test Pit #2 or within Trench 2 (6/22/23).

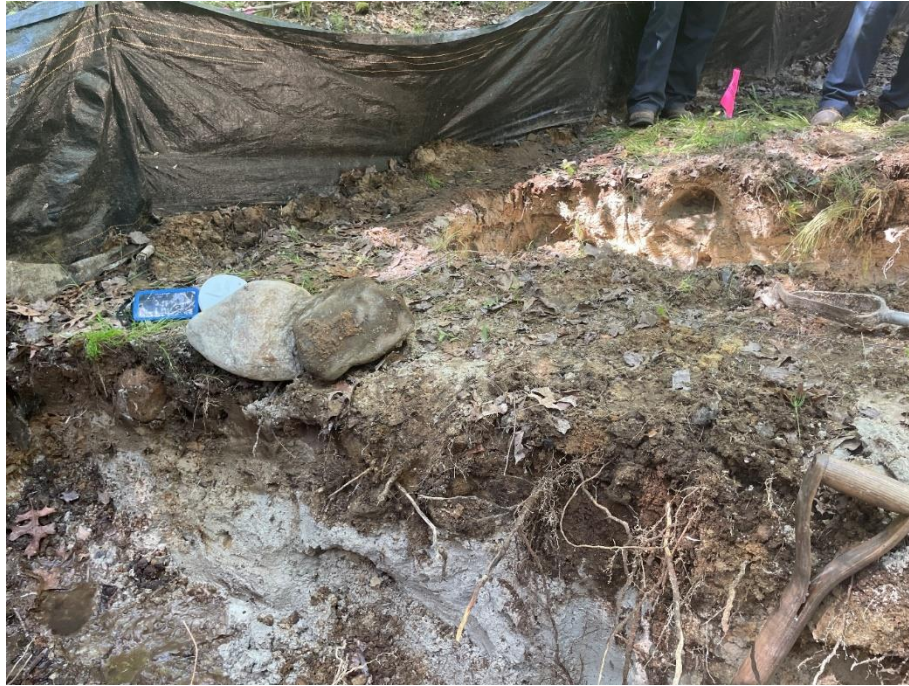
Photo 7 View north of Trench 2 in the forefront and Trench 1 in the background (6/22/23).

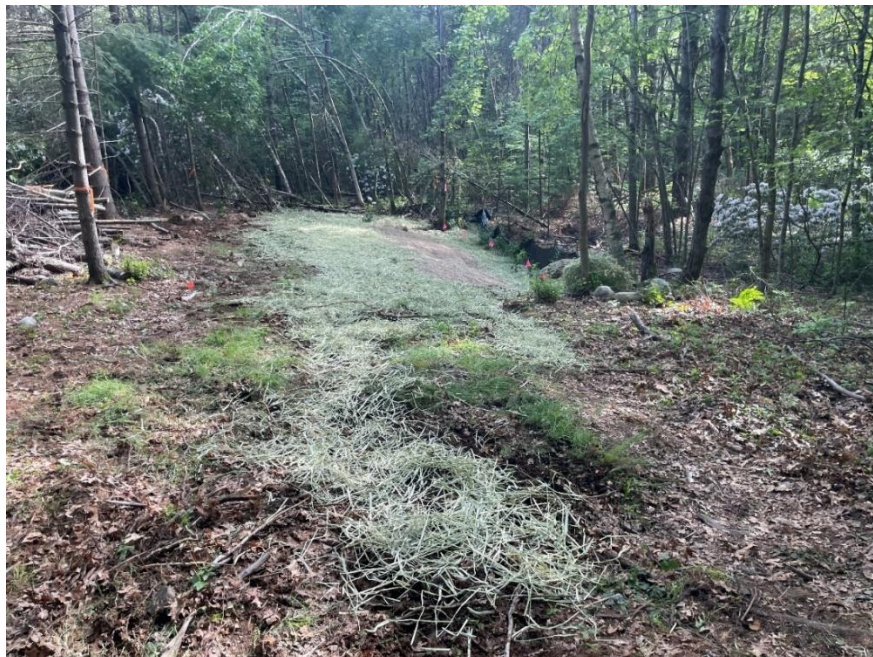
Photo 8 Overview of the BVW 3 restoration area facing south (6/22/23).

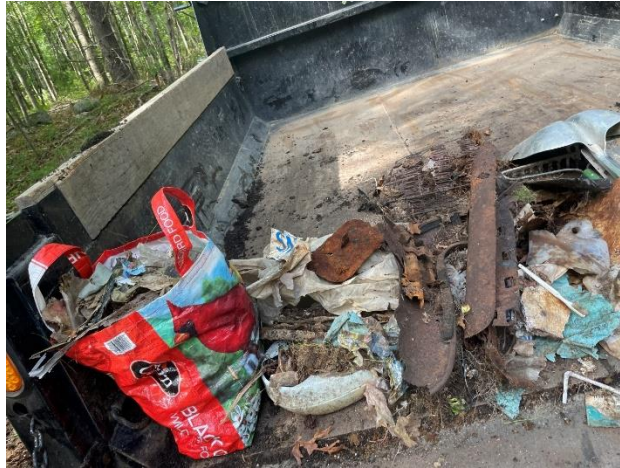
Photo 9 Trash removed from the BVW 3 and adjacent areas during restoration activities (6/22/23).

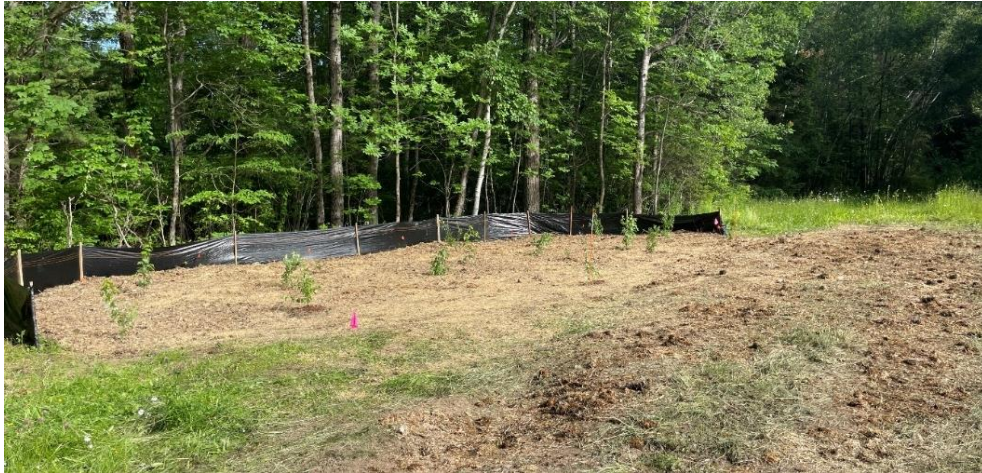
Photo 10 BVW 2 post fill removal and wetland restoration (6/22/23).

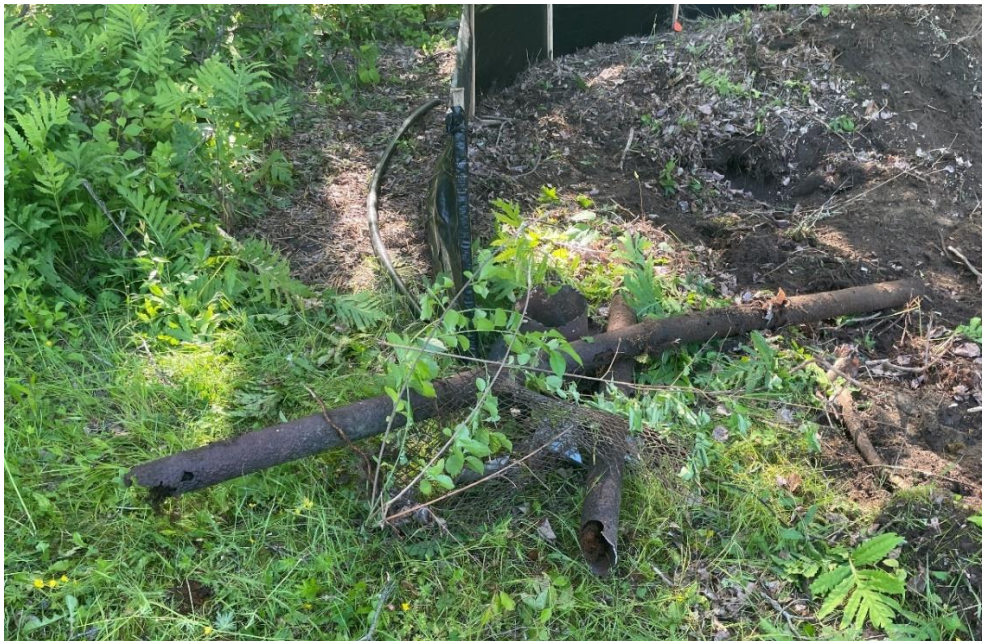
Photo 11 View of debris removed from BVW 2 during wetland restoration (6/22/23).

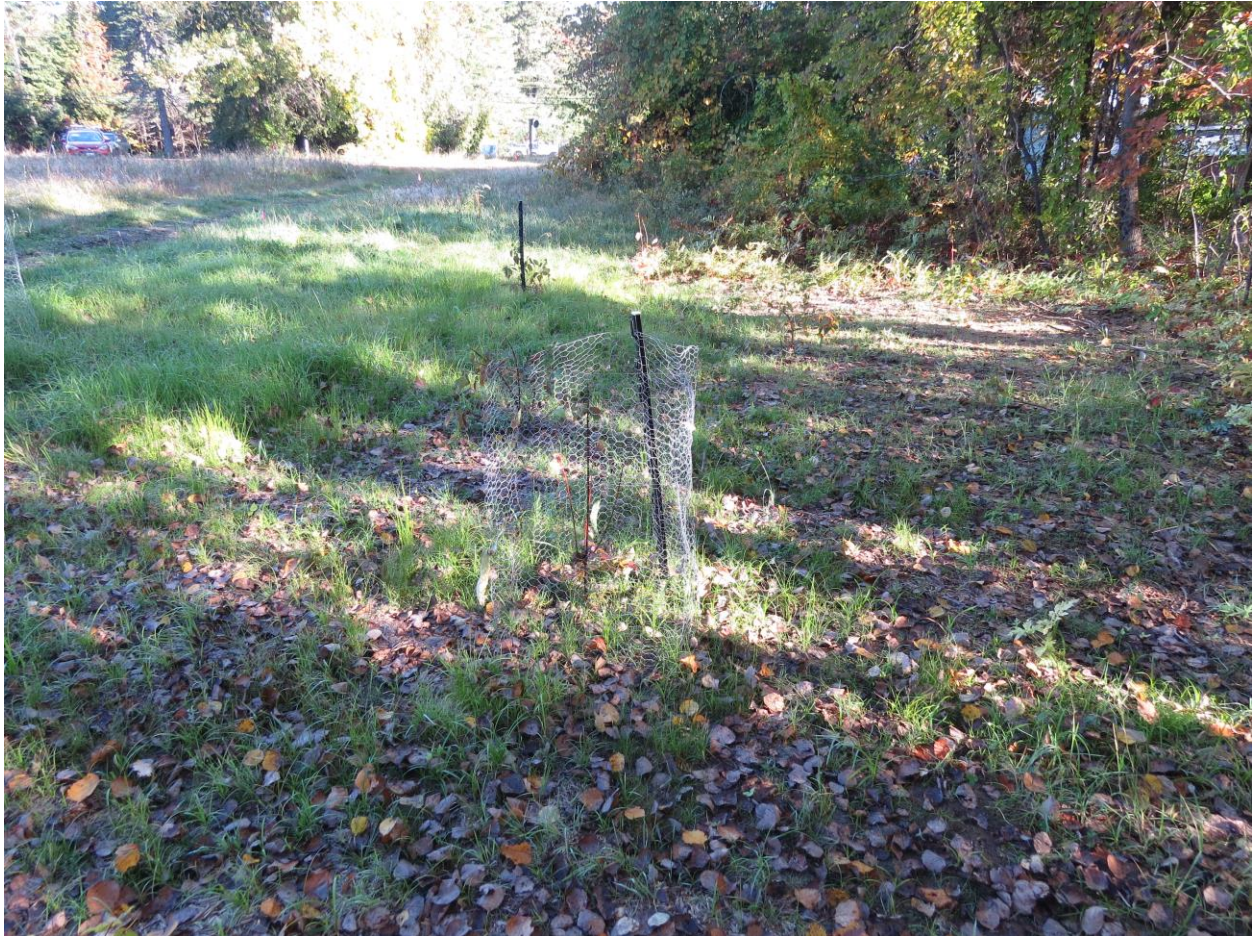
BVW 2 Restoration Area

As shown in the following photograph, the western 70% of the restoration area is well vegetated by herbaceous plants, with the eastern 30% of the area more sparsely covered. Most of the herbaceous stratum is not yet identifiable at the end of the first growing season, although many plants appear to be sedges (*Carex* spp.). However, the majority of the identifiable plants are wetland species, including: sensitive fern (*Onoclea sensibilis*); soft rush (*Juncus effusus*); dark-green bulrush (*Scirpus atrovirens*); nutsedge (*Cyperus esculentus*); and lady's thumb smartweed (*Persicaria maculosa*).

The soils in the center of the area were not saturated, despite the unusually heavy rainfall the preceding summer. There were some small locations where it was clear that water had ponded during rainfall events. However, these areas were completely dry at the time of my site visit. In addition, the excavated soil

pit did not appear to meet the criteria as outlined in the interagency document *Field Indicators for Identifying Hydric Soils in New England, Version 4 (2019)*.

Since the soils in the undisturbed wetland to the east were saturated in the B horizon, and the soils met the hydric soils criterion, I am not certain that the entire Restoration Area was a wetland prior to the unauthorized fill placement.

The eastern third of the Restoration Area should be either sown with another pound of NEE Wetmix, and/or planted with native plant plugs (also available from New England Wetland Plants).

The area will be revisited in the spring (April or early May 2024) in order to determine if wetland hydrology is present during the “wettest” part of the growing season. Additional soils pits will be excavated and the soil profiles documented at that time.

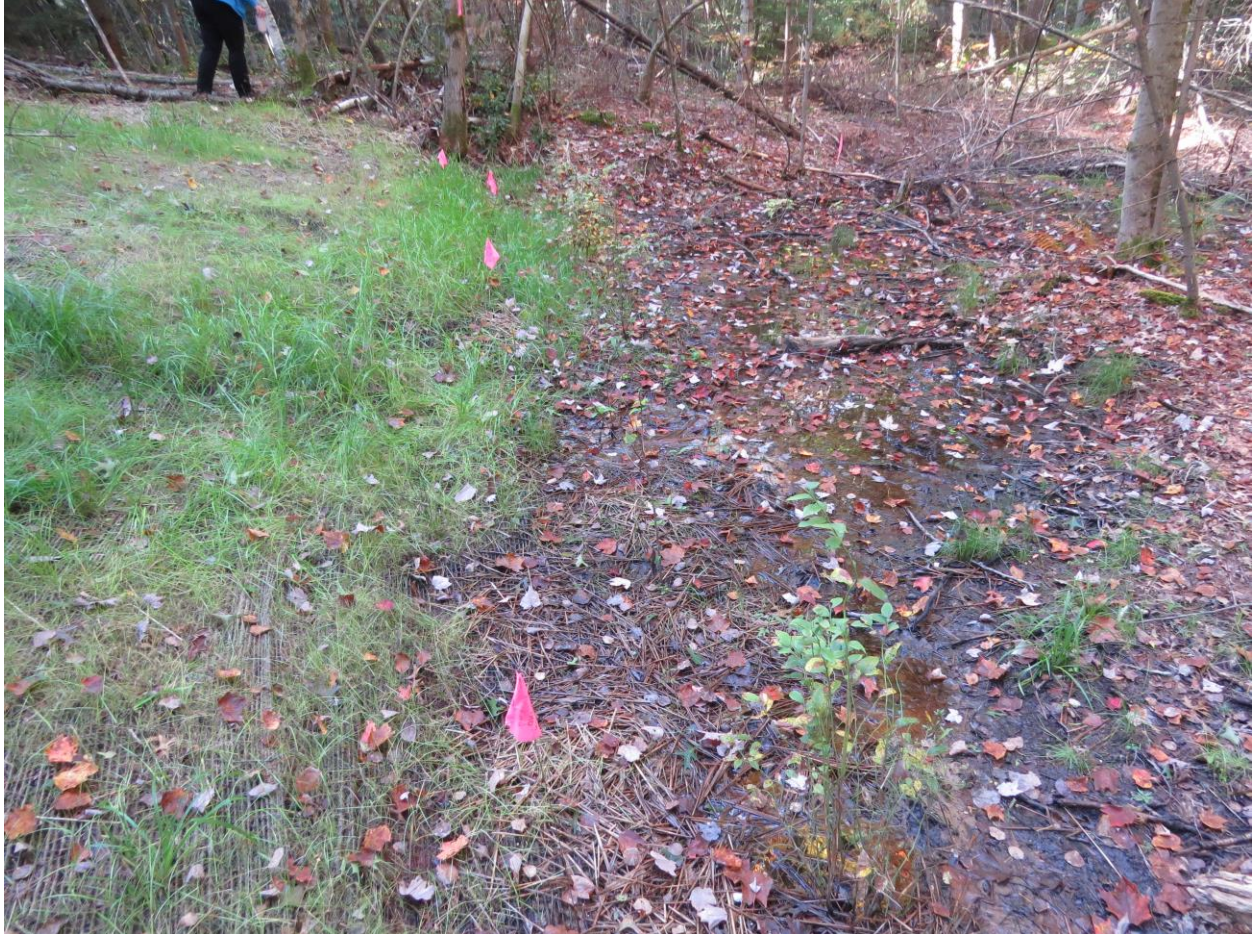
BVW 3 Restoration Area

As shown in the above photograph, it appears that most of the herbaceous plants are non-wetland grasses that were washed into the area by rainstorms after the non-wetland seed mixture was sown in the adjacent upland. However, there are scattered wetland plant species including soft rush (*Juncus effusus*); beggar's ticks (*Bidens* spp.), and sedges (*Carex* spp.).

One of the planted shrubs is dead, a spicebush (*Lindera benzoin*). This may be due to the unusually rainy Summer and the very high water table in the Restoration Area.

The area has obvious wetland hydrology. There was standing water at the edge of the Restoration Area, the water table was within two inches throughout, and the soils were saturated to the surface. Further, it appears that soil saturation exists above the wetland flags and up the adjacent slope due to capillary action.

The dead spicebush shrub should be replaced in a slightly drier (upgradient) location. Given that the area has obvious wetland hydrology, it is likely that the non-wetland species will die out over time and will be replaced with wetland species. Additional seeding will be recommended at the end of the second growing season if this does not occur naturally.
