2023 Lake Wyola Dam Water Release Observations

Sluiceway Release Observations by Conservation Commission

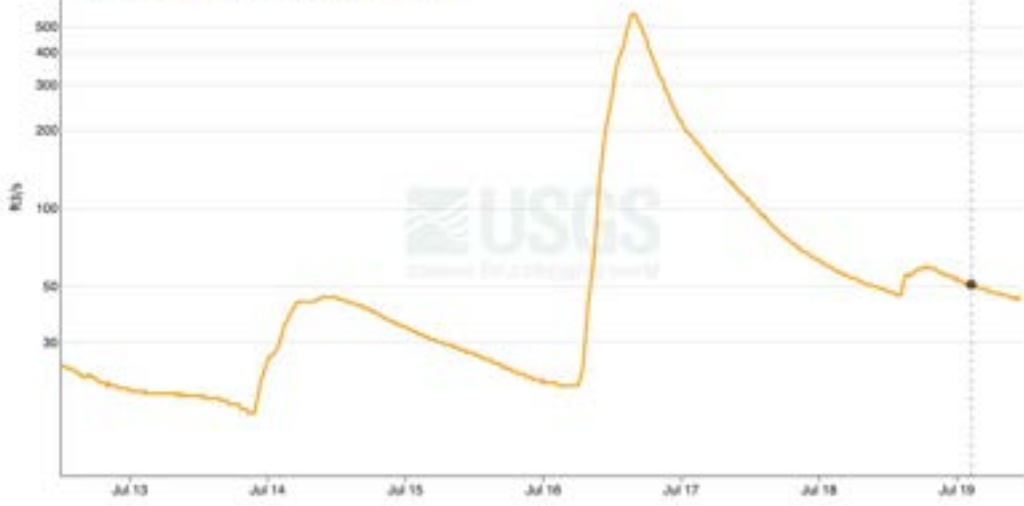
Last week

West Branch Swift River Near Shutesbury, MA - 01174565

50.8 ft³/s - Jul 19, 2023 01:30:00 AM EDT

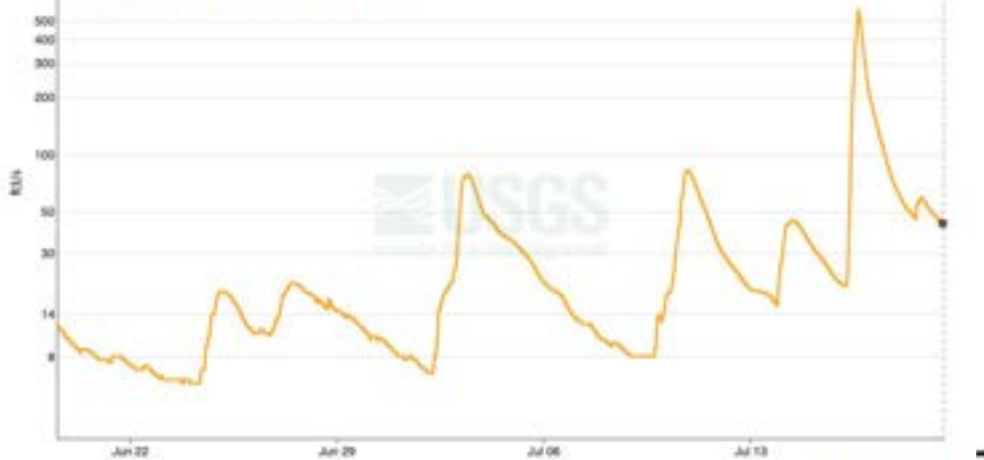
Last 30 days

West Branch Swift River Near Shutesbury, MA - 01174565

43.5 ft³/s - Jul 19, 2023 12:00:00 PM EDT

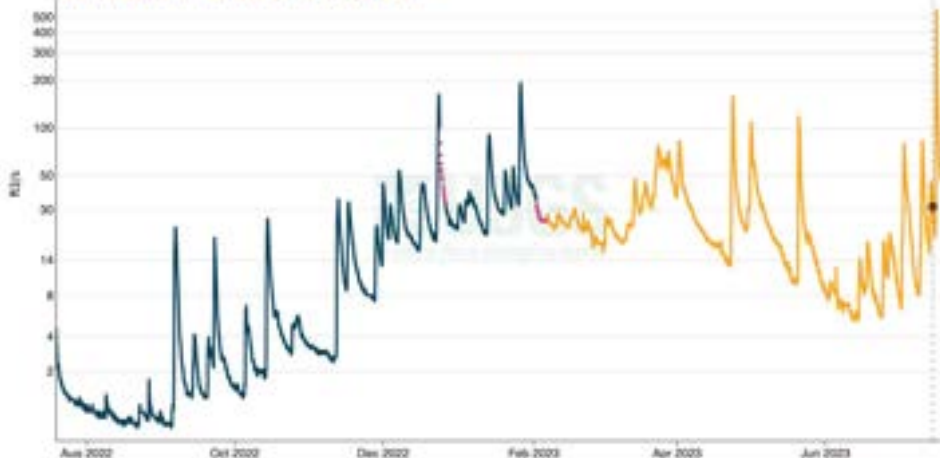
Last year

01174565

31.6 ft³/s - Jul 15, 2023 03:45:00 AM EDT

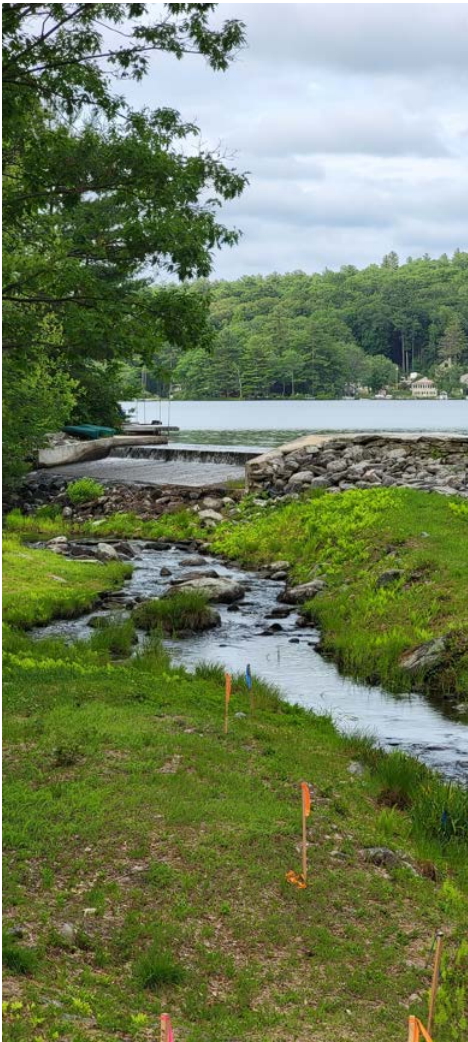
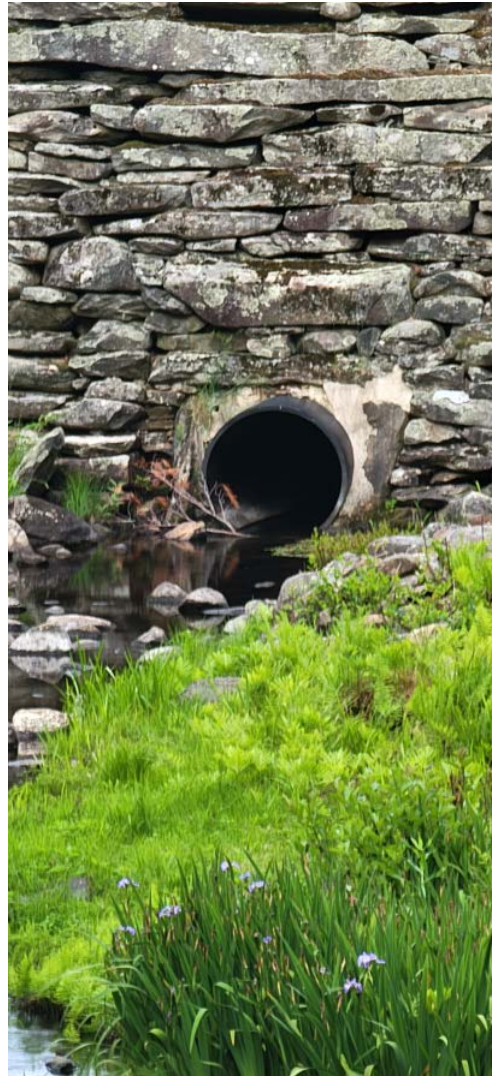
6/23/23

6/23/23: sluice way appears less than .5 cfs; very small amount of water in sluice way

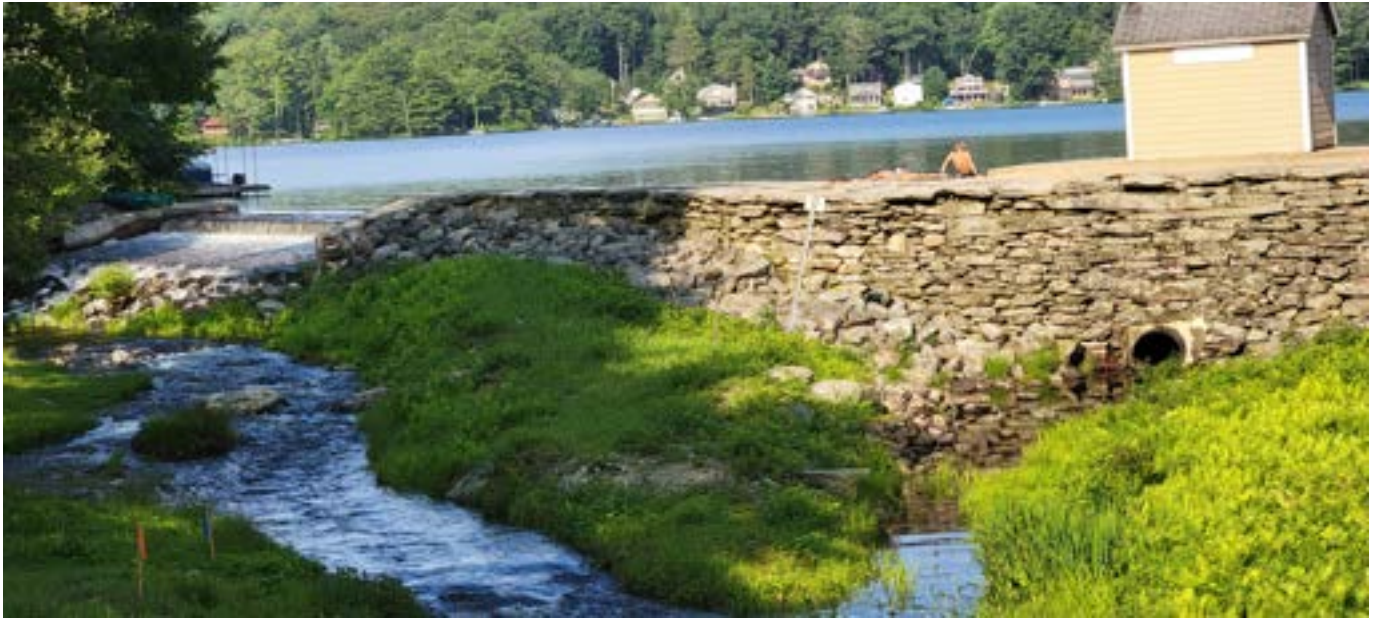
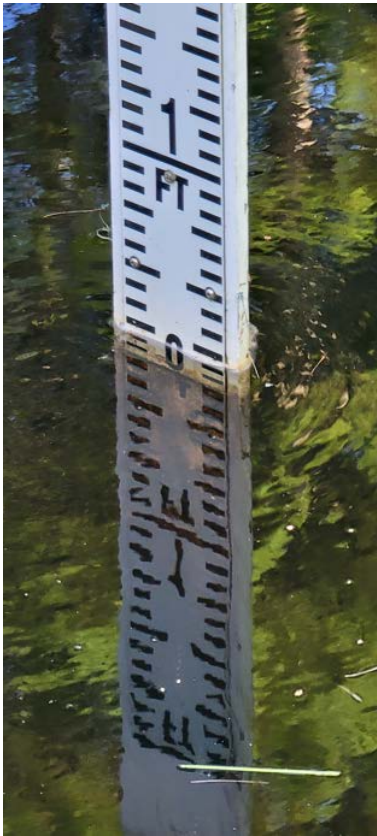
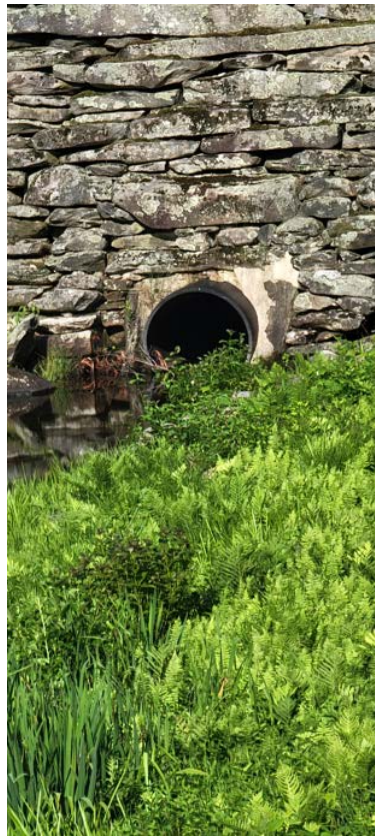
Wednesday, July 5, 2023

7/5/23: sluice way appears less than .5 cfs, gauge was +1 above neutral, very small amount of water in sluice way

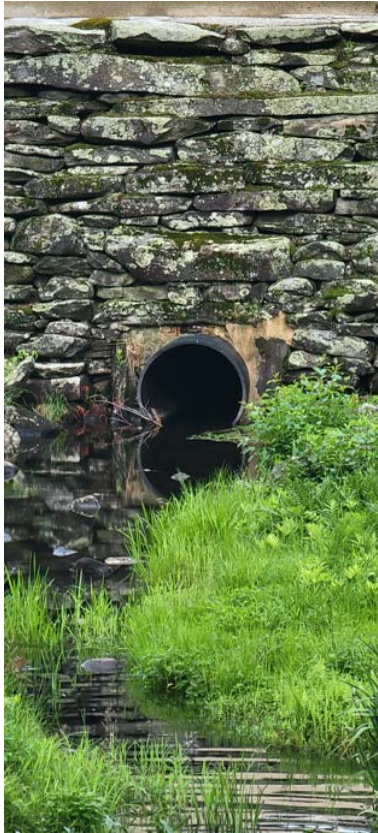
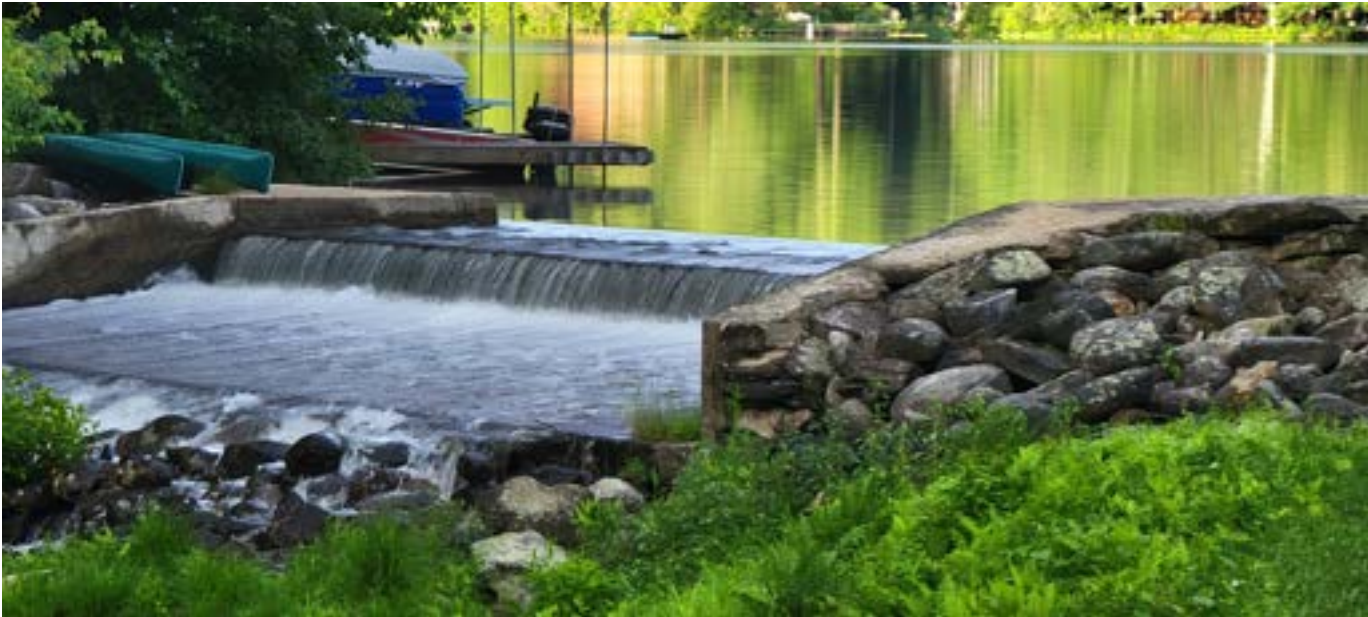
Monday, July 10, 2023

7/10/23: sluice way appears less than .5 cfs

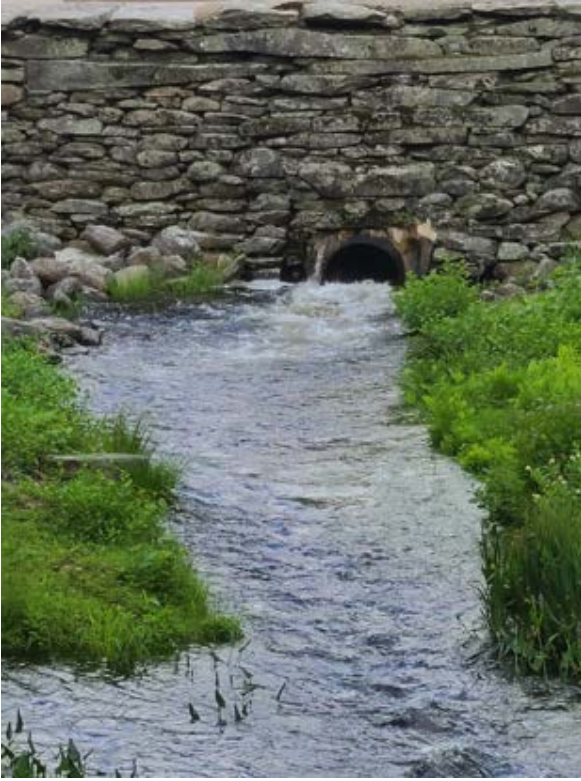
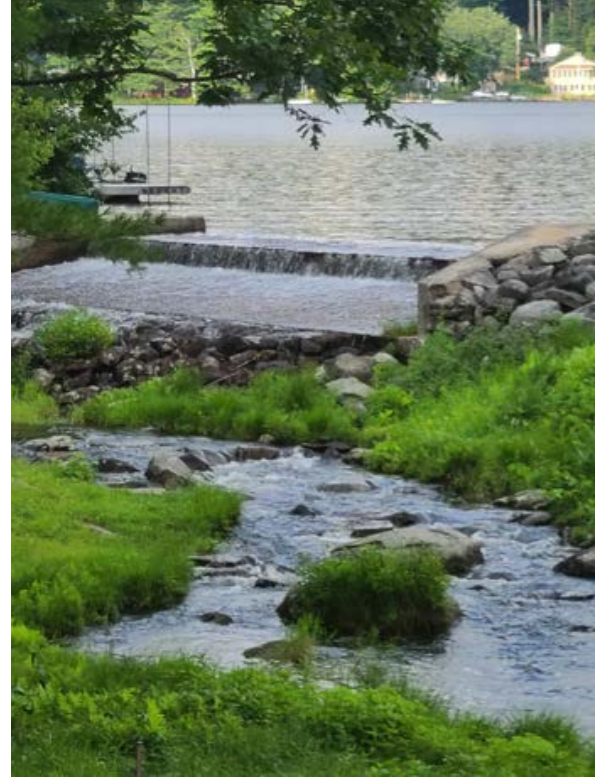
7/13/23

7/13/23: sluice way appears more than .5 cfs, Dam Keeper reported gate was partially open

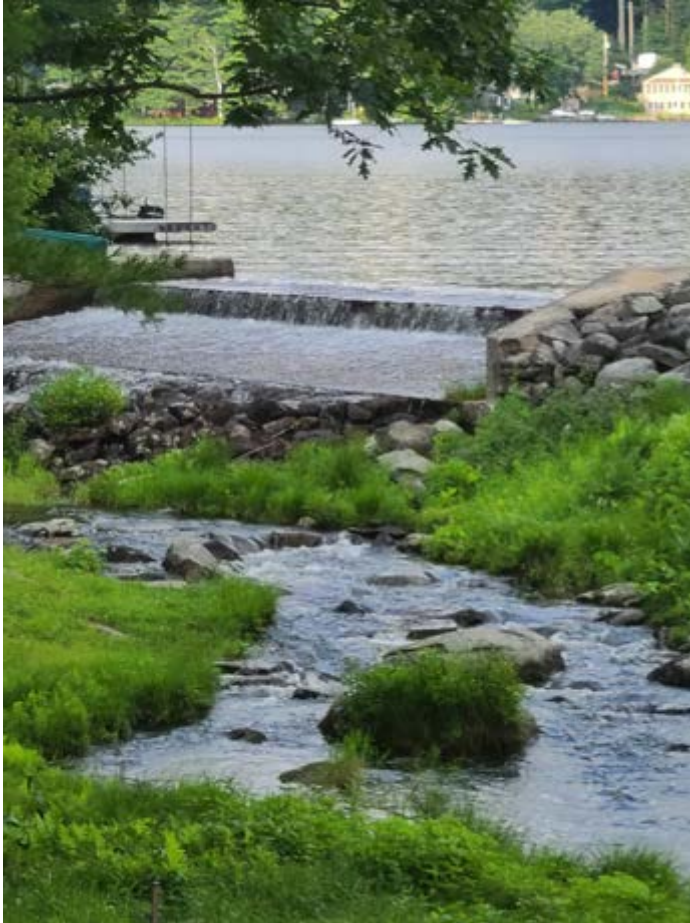
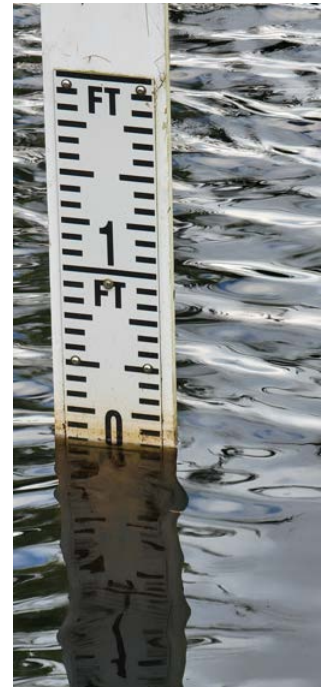
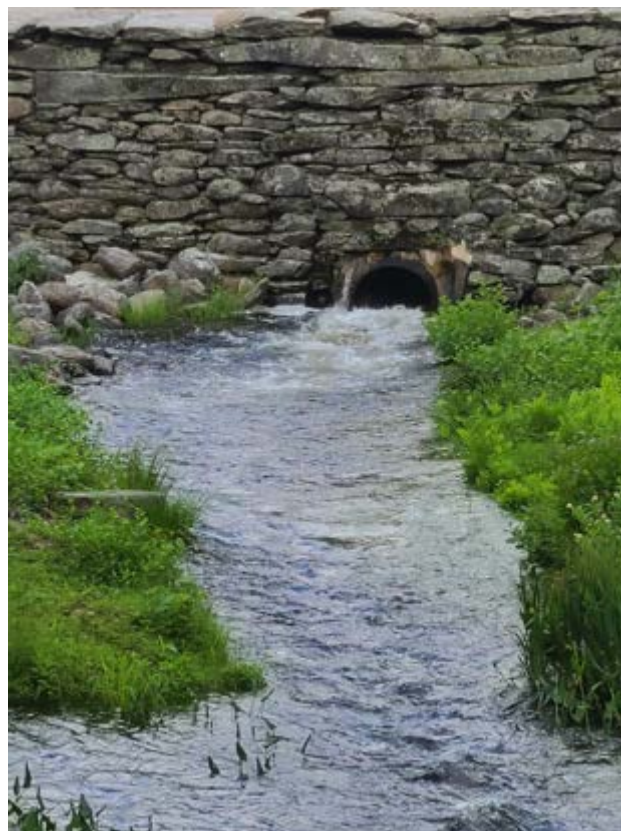
Friday, July 14, 2023

7/14/23: more than .5 cfs, gauge was +1 above neutral

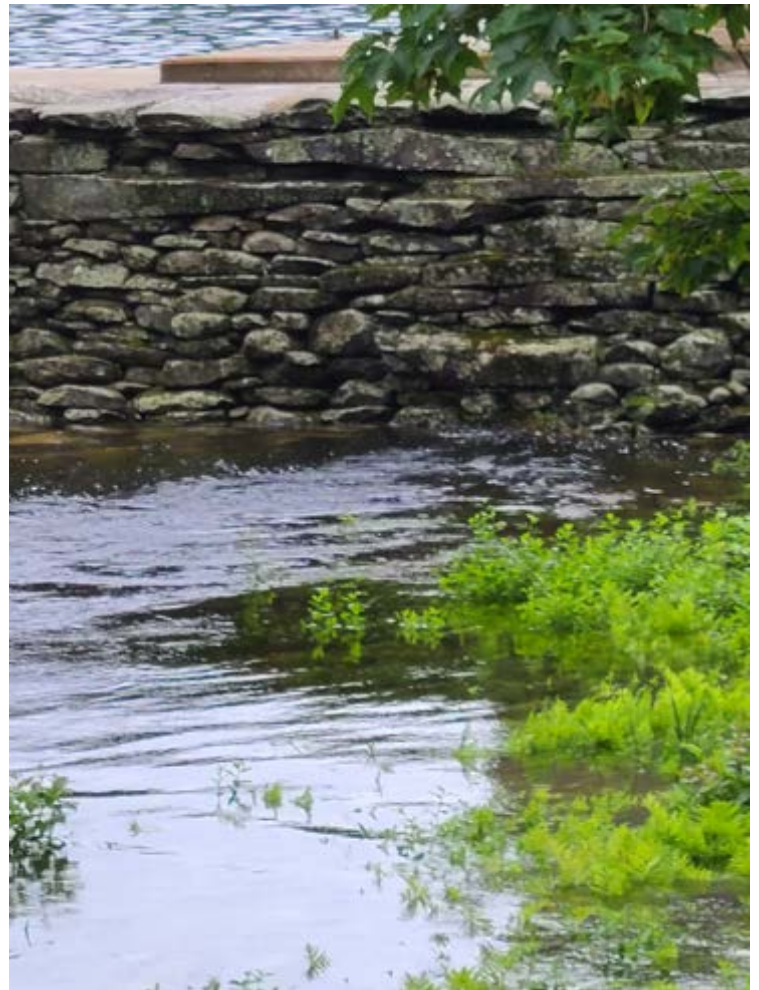
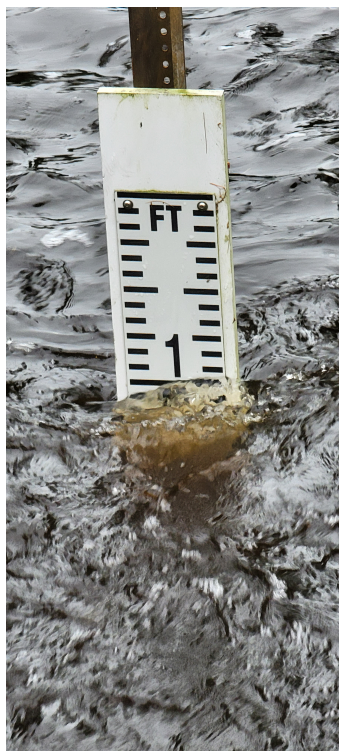
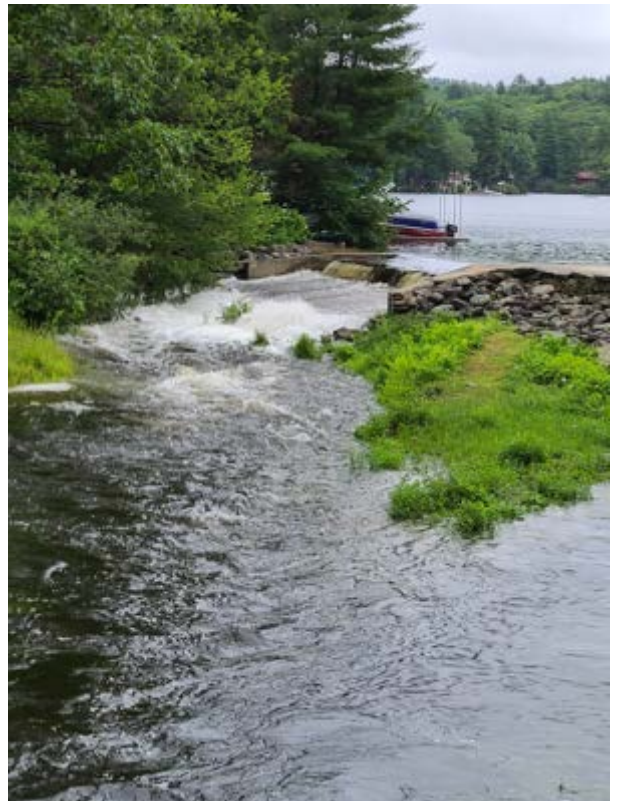
Sunday, July 16

7/16/23: more than .5 cfs; Dam Keeper reported that gate was fully open; gauge was +11 above neutral

Impromptu site visit at Lake Wyola Dam. Shutesbury Dam Keeper, Howard Kinder, and Mark Rivers were present. Dam Keeper informed the SCC Chair that, in response to recent storm events, he was releasing the maximum amount of water from the dam (i.e., he had opened the sluiceway gate to its fully open position) in order to lower the lake to a standard summer condition of 1-2 inches above the spillway neutral level.

Lakeview Culvert Gauge for Lake Wyola level indicated that the lake was 11 inches above the neutral position at the spillway.

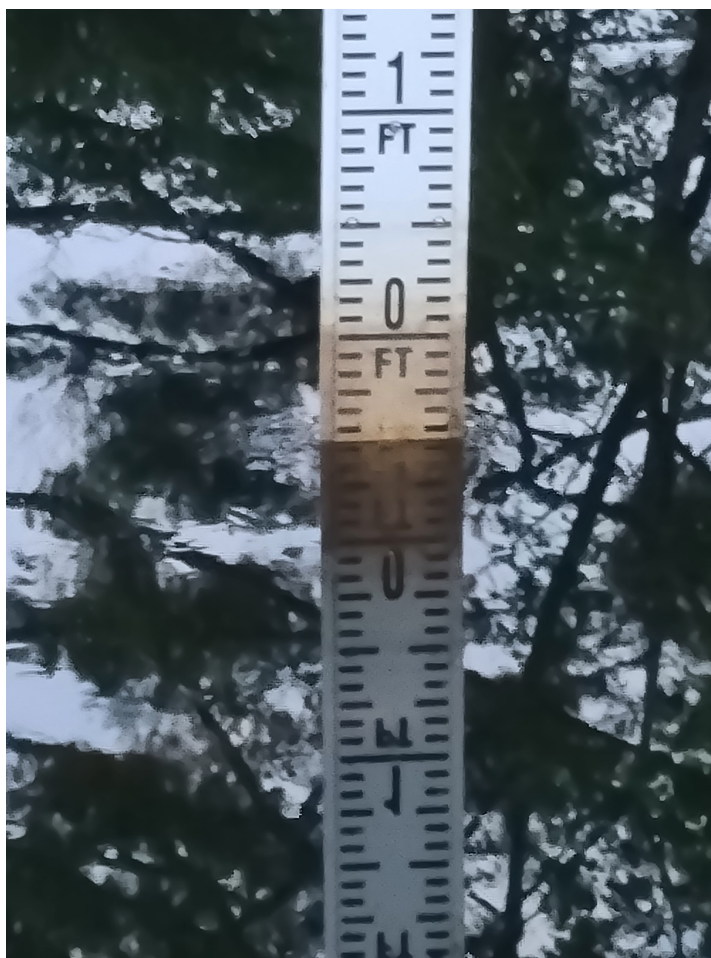
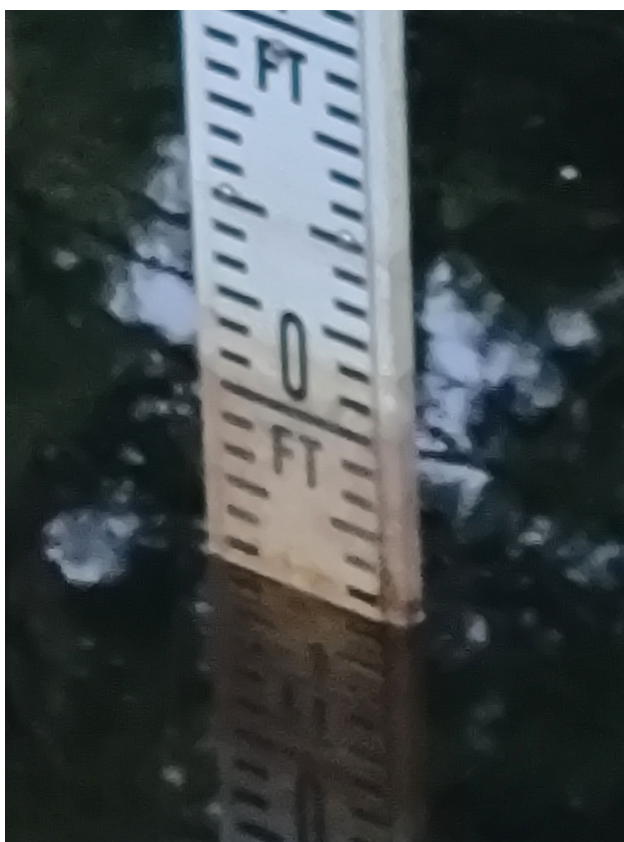
7/24/23

7/24/23: more than .5 cfs; gauge was -6 below neutral, no spillway release (note 10 inch drop in 48 hours)

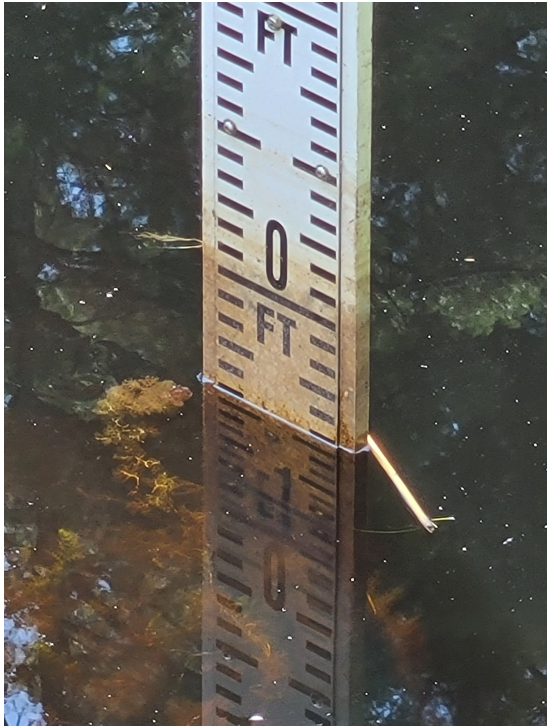
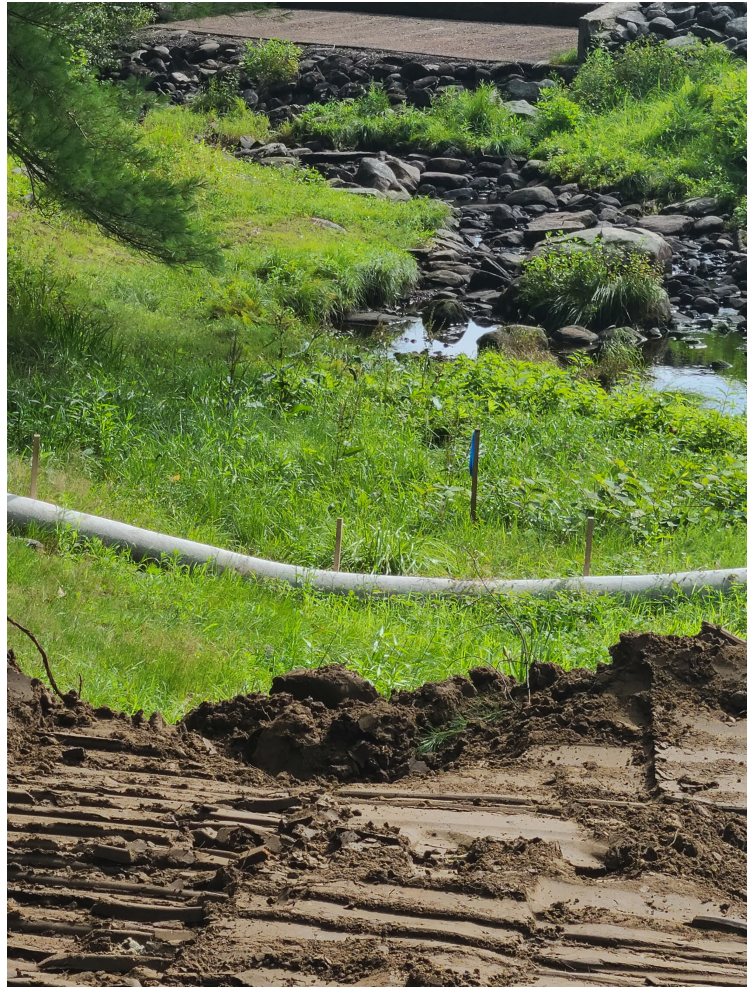
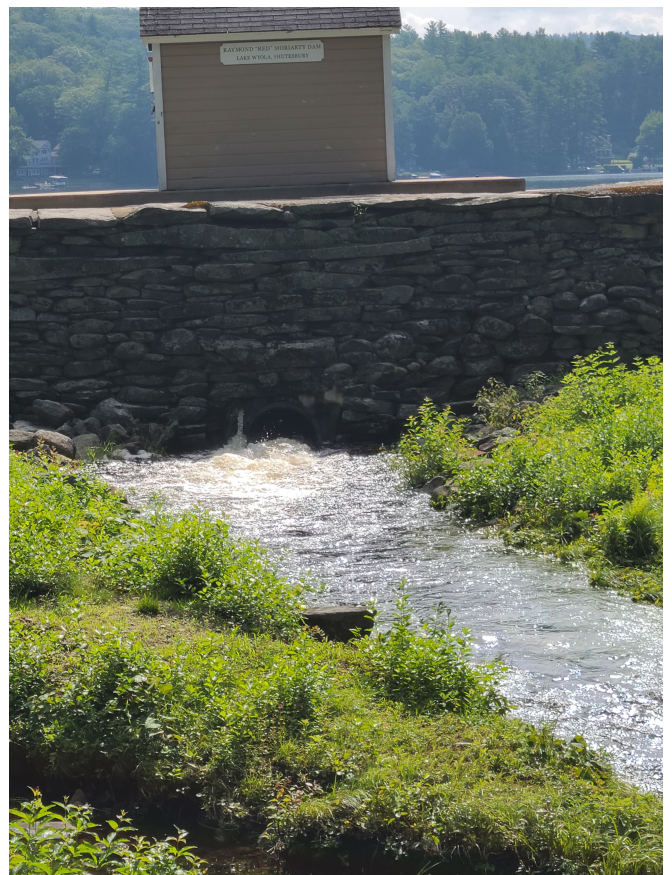
7/25/23

7/25/23: more than .5 cfs; gauge was -5 below neutral; no spillway release

Dam was observed appearing to be fully open and releasing maximum discharge. Water gauge showed that water levels at the Lakeview Road Culvert Gauge was -5" below neutral. Observation on 7/24/23 showed the level to be -6" below neutral.

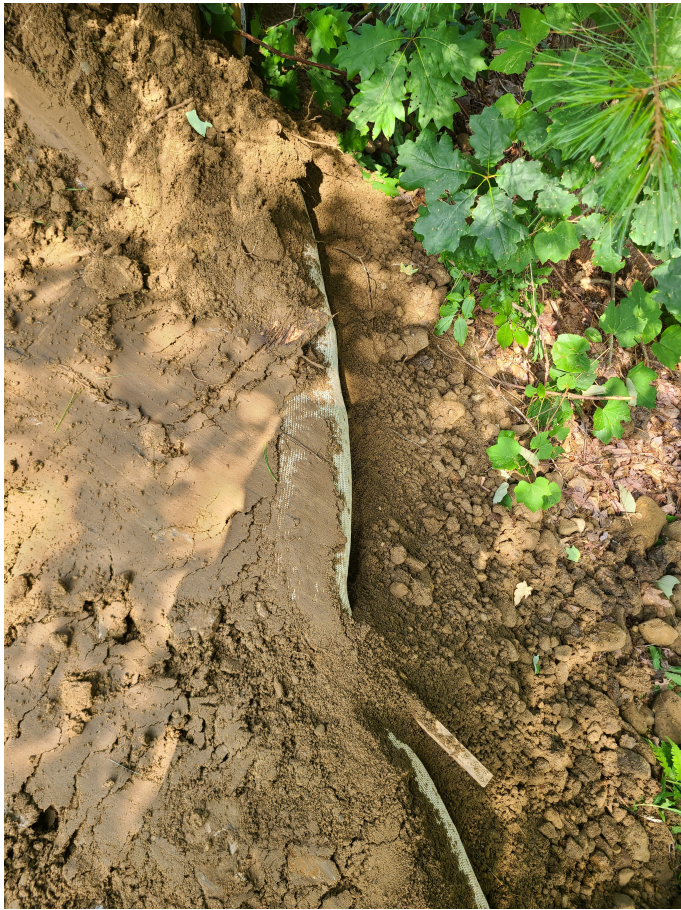
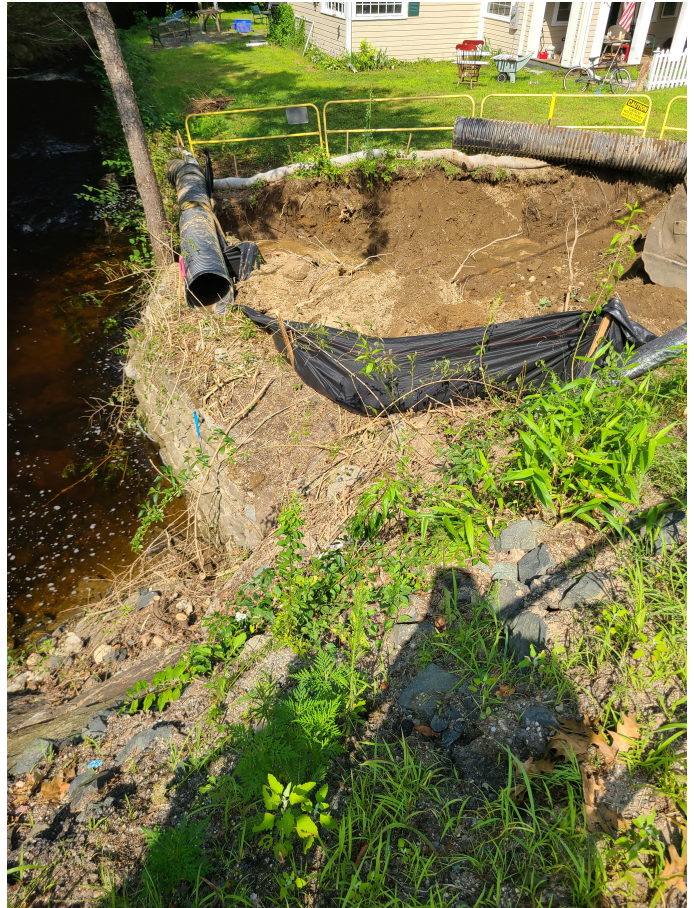
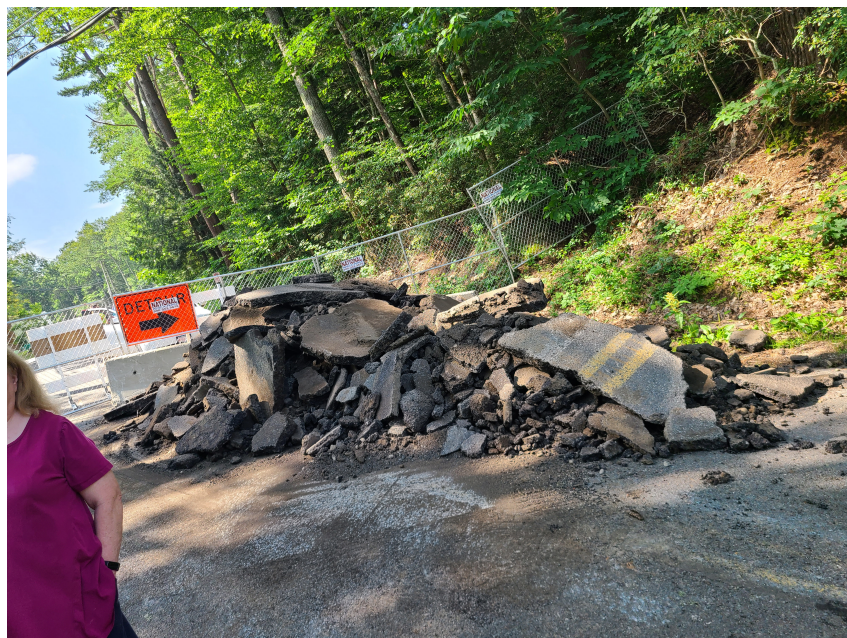
7/25/23 Erosion Controls

Silt socks were buried in several places.

Silt fences were falling down in several places.

Debris piles had no erosion controls.

Erosion controls were found to be damaged; unconsolidated piles of demolition debris had no tarp and was not protected by erosion controls (there was a downgradient pathway that circumvented the erosion controls).

know anything about the drawdown. Instructed Mr. Mercier that erosion controls must be repaired and inspected daily.
