WATERSHED-BASED PLAN

Lake Wyola

June, 2023

Franklin Regional Council of Governments
12 Olive Street
Greenfield, MA

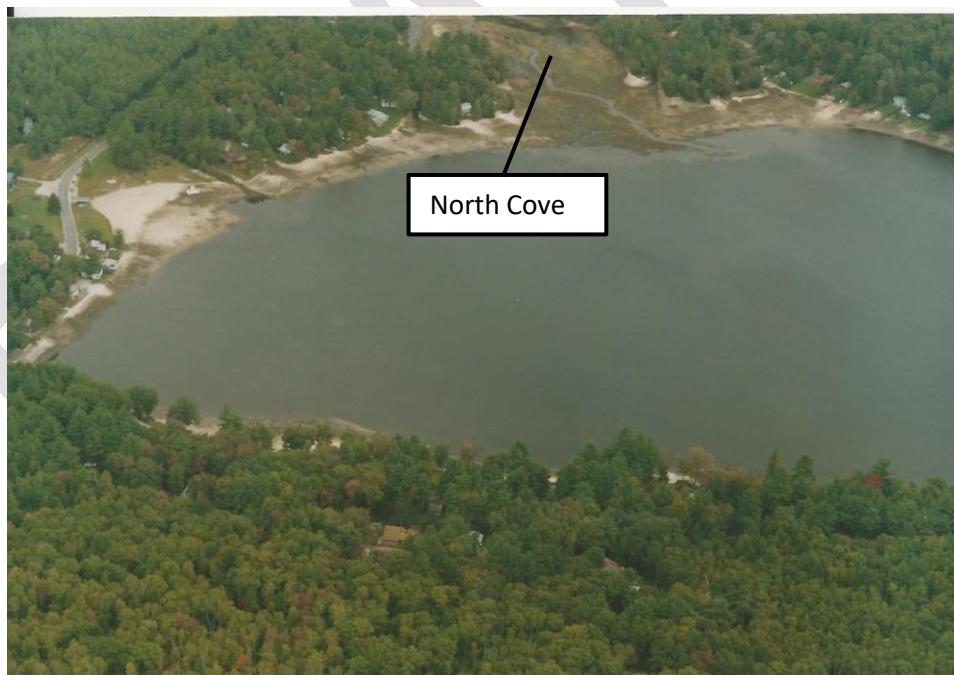
Figure A-5: Sediment in North Cove as seen from the southwest

Watershed residents are concerned about sedimentation in Lake Wyola, with the North Cove and the west side of the lake of particular concern. According to the NRCS 2005 *Lake Wyola Inventory and Evaluation*, one homeowner reported that around 1990 the lake depth near their house was over six feet and by 2005, it was less than two feet.²⁹ On the west side, photos and anecdotal evidence show the accumulation of sediment at stormwater outfalls. At North Cove, photos likely taken in 2008 when the lake level was lowered 8 feet to accommodate repair of the dam show the relative depth of North Cove to the rest of the lake during a draw down and the remaining channel (**Figure A-4** and **Figure A-5**). The area on the north side of the Lakeview Drive culvert where Fiske Brook meets North Cove has similarly filled in with silt and sediment, as shown in **Figure A-6**. The degree to which sediment accumulation in North Cove is anthropomorphic or part of natural processes is not fully understood, but can be studied by conducting hydraulic and hydrologic (H&H) and a fluvial geomorphic studies of the watershed.

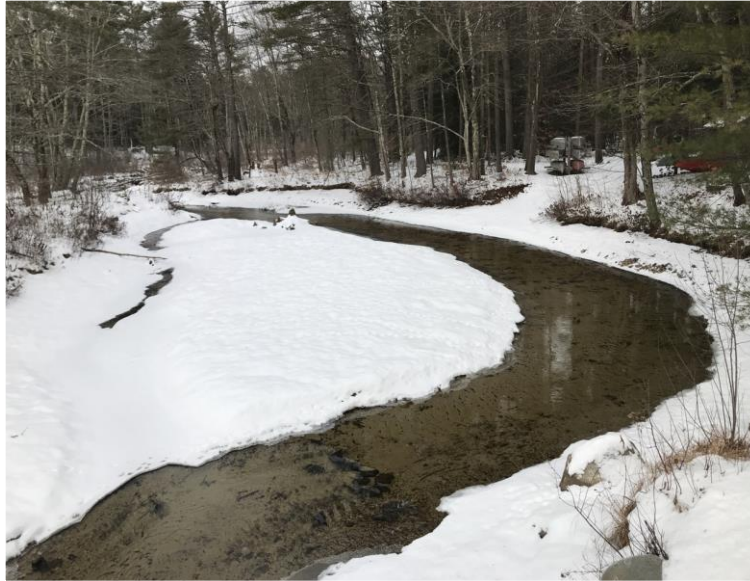
Figure A-6: Channel of Fiske Brook flowing through area North Cove north of Lakeview Drive, as seen from Lakeview Drive

Fiske Brook flows into North Cove at the northernmost point of the lake. There is a box culvert where Lakeview Road crosses the very top of the North Cove. The lake and the wetland at the mouth of Fiske Brook have both experienced significant siltation and sedimentation since the late 1990s (see Figures A-11d and A-11e). A 2005 NRCS evaluation⁴⁶ posited that the high level of sediment was caused by road sand around the lake area and erosion from banks and streambed of Fiske Brook accelerated by high-powered storms and by intermittent breaching of beaver dams or debris accumulated at the outlet spillway of Fiske Pond and likely other ponds in the watershed (McAvoy Pond, Tyler Pond, and smaller waterbodies). The sedimentation issue appears to be ongoing, though road sand is no longer considered a major source of sediment according to a representative of the LWA and the Shutesbury Highway Superintendent.

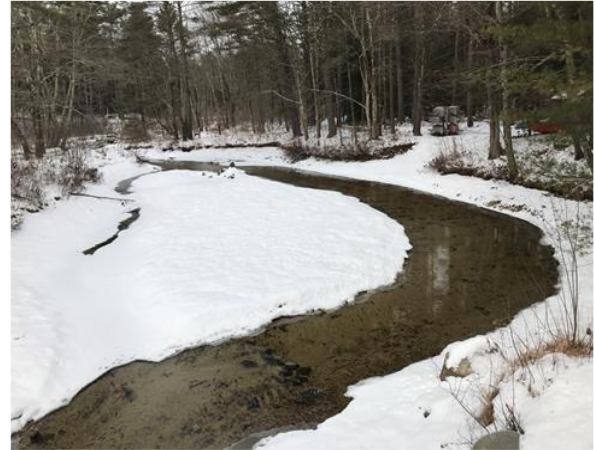
Figure A-11d: Fiske Brook/North Cove, north side of Lakeview Road culvert

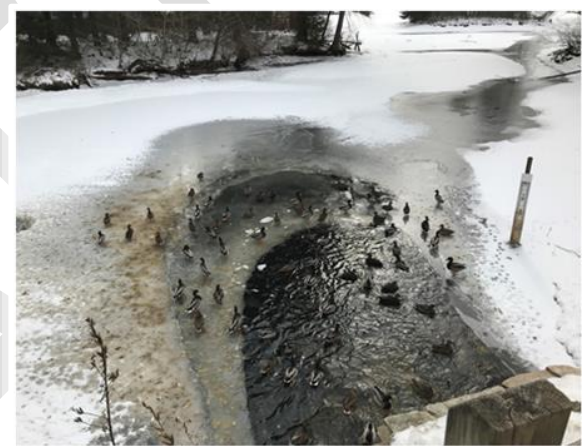
Figure A-11e: North Cove, south side of Lakeview Road culvert

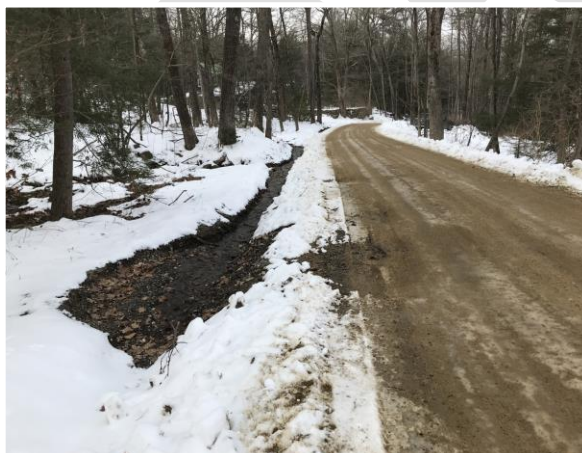
Figure A-11c: Wendell Road, roadside erosion

Wendell Road is on the lake's east side. Overall, the road material of this road appears to have a higher content of gravel than the roads along the east side and is much more compacted. According to the Highway Superintendent, there is a catch basin at the top of the road that drains very slowly because the planned outfall ran into ledge. In the field investigation, it was noted that there is a soft, wet spot (possibly caused by an underground spring) on the road and erosion in the ditch about 800 feet north of Freeman Road (A-11c). A major culvert over South Brook was replaced on the road several years ago that is working well.
