# ***ABBREVIATED NOTICE OF RESOURCE AREA DELINEATION***

## **Baker Road Project West Pelham Road (Parcel ID ZQ-6) Shutesbury, Massachusetts**

**RE: Baker Road Project – West Pelham Road (Parcel ID ZQ-6)  
Abbreviated Notice of Resource Area Delineation (ANRAD)  
Updated Plans & Other Requested Items**

**ATTACHMENT A**  
**Figure 1: Delineated Resources Map**  
**(February 2021)**

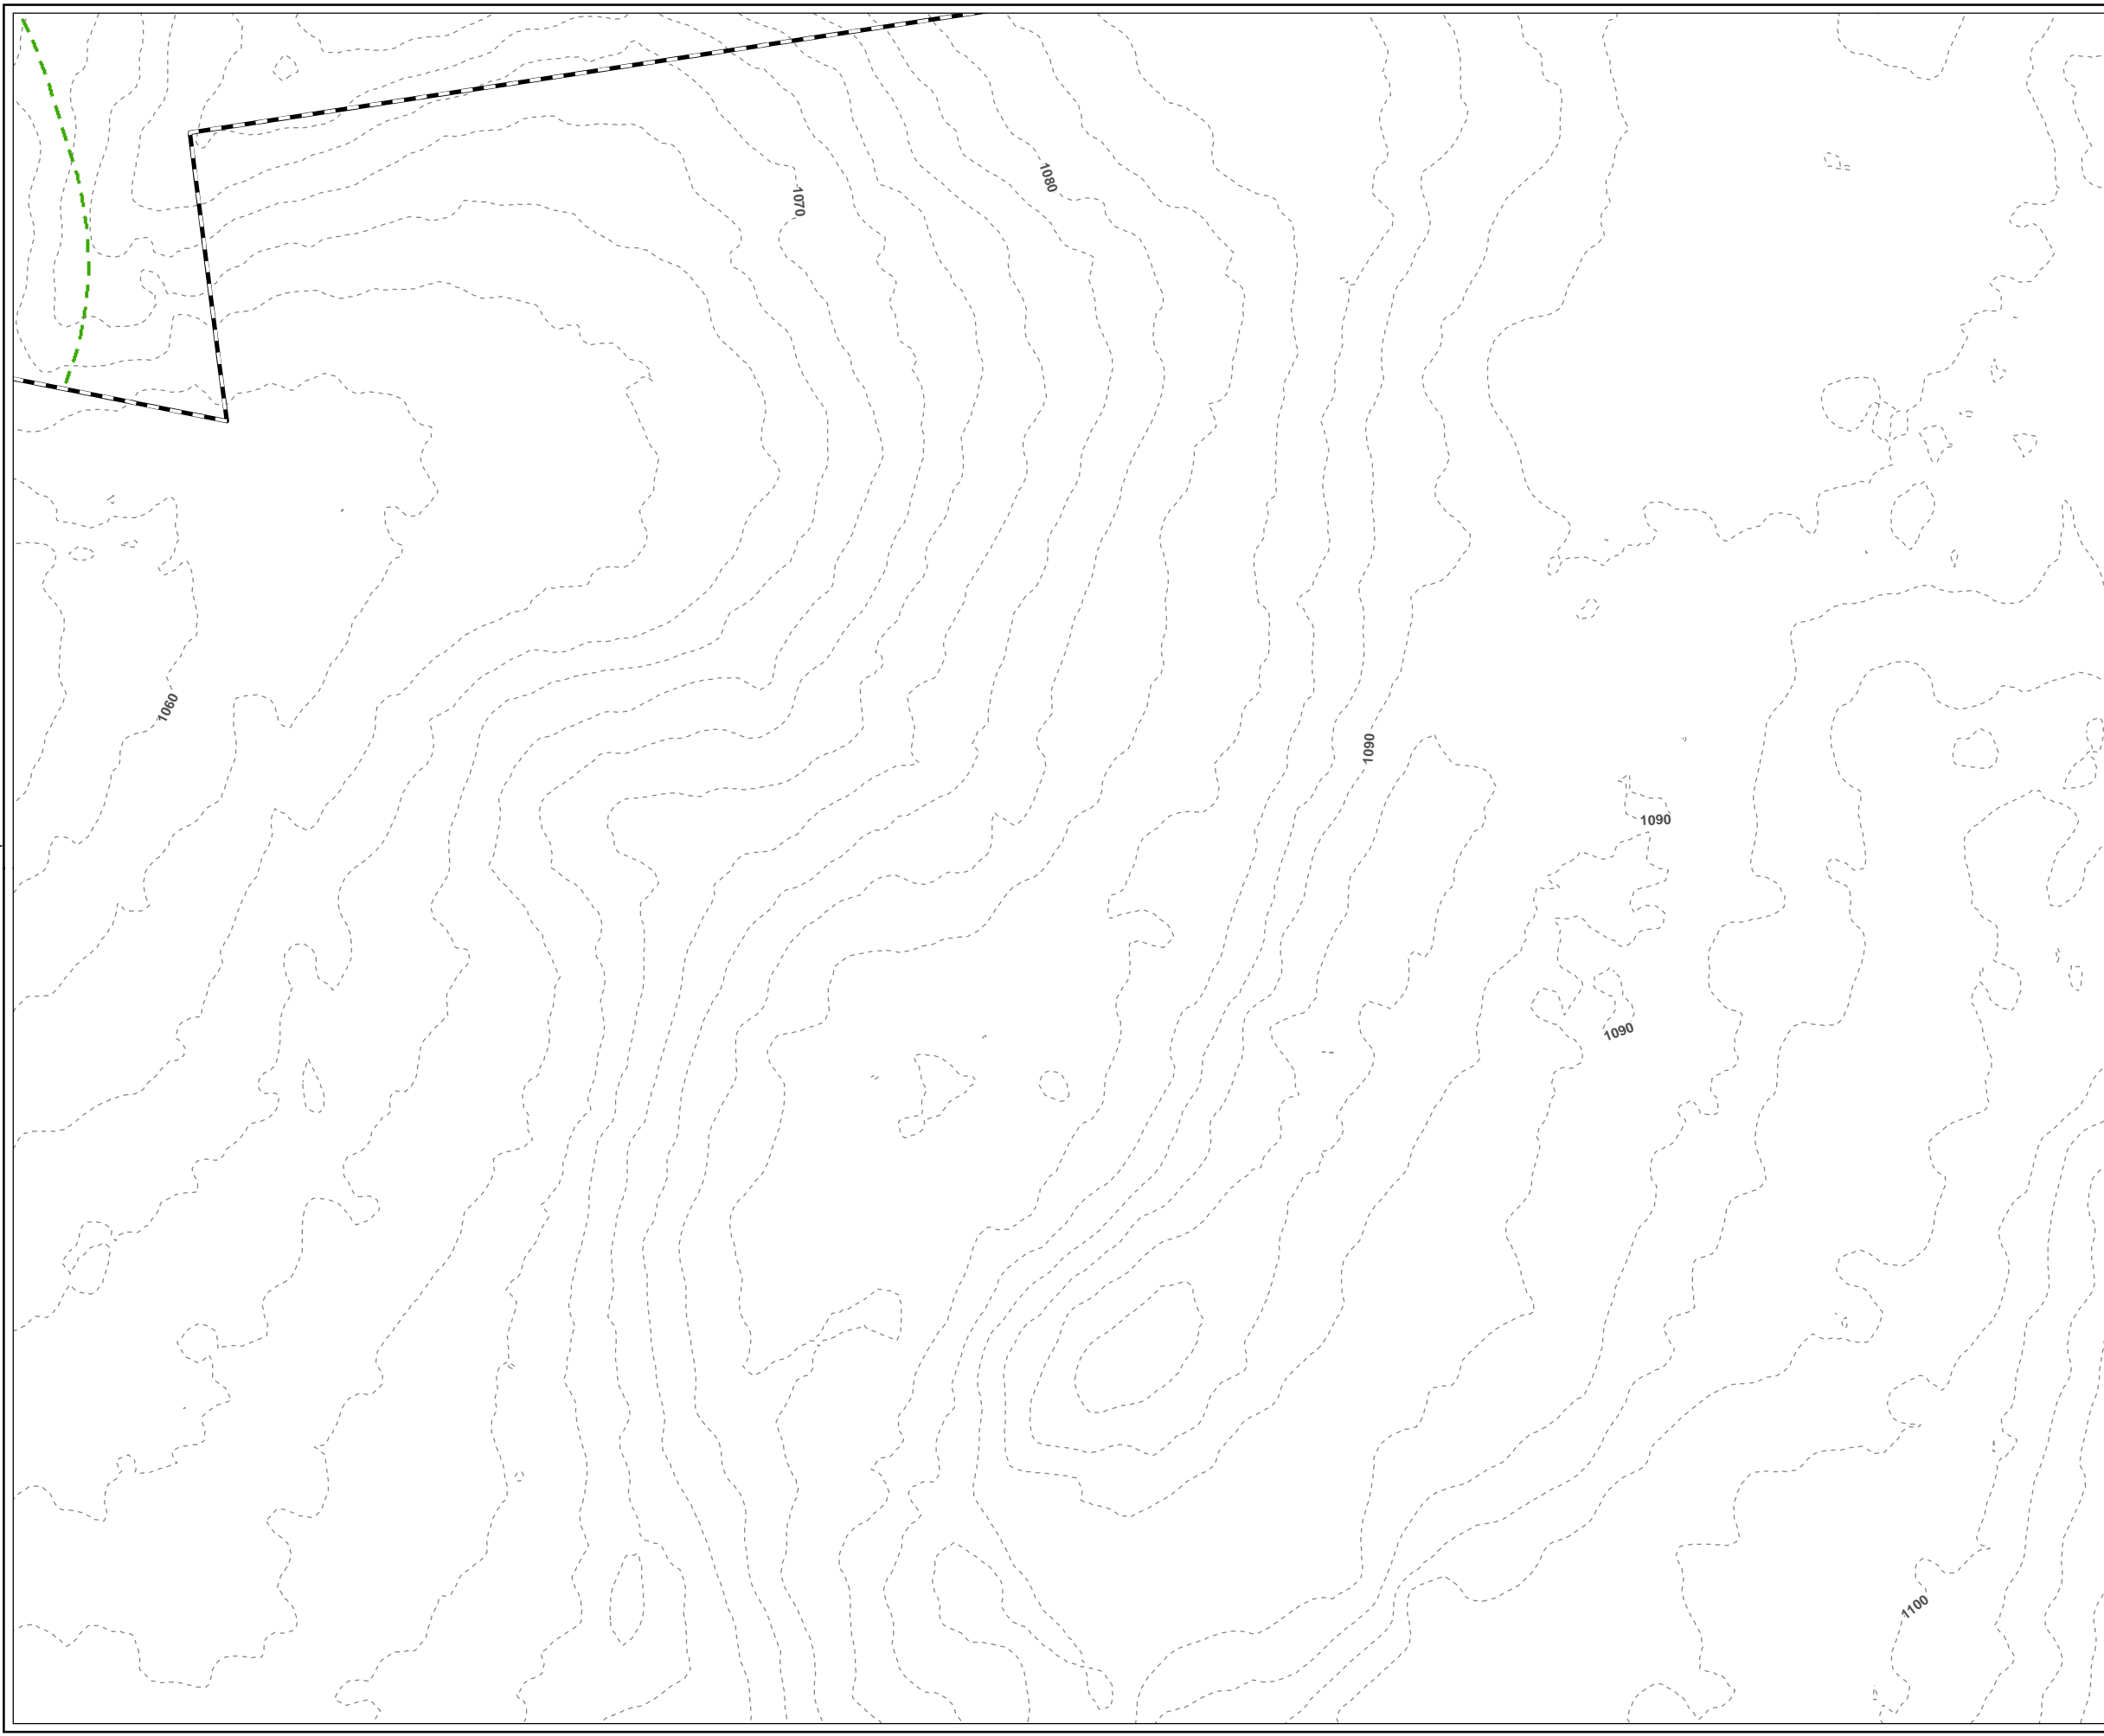
1. Attachment A – Figure 1: Delineated Resources Map (February 2021)
2. Attachment B – Wetland 8 & 9 Delineation Data Forms

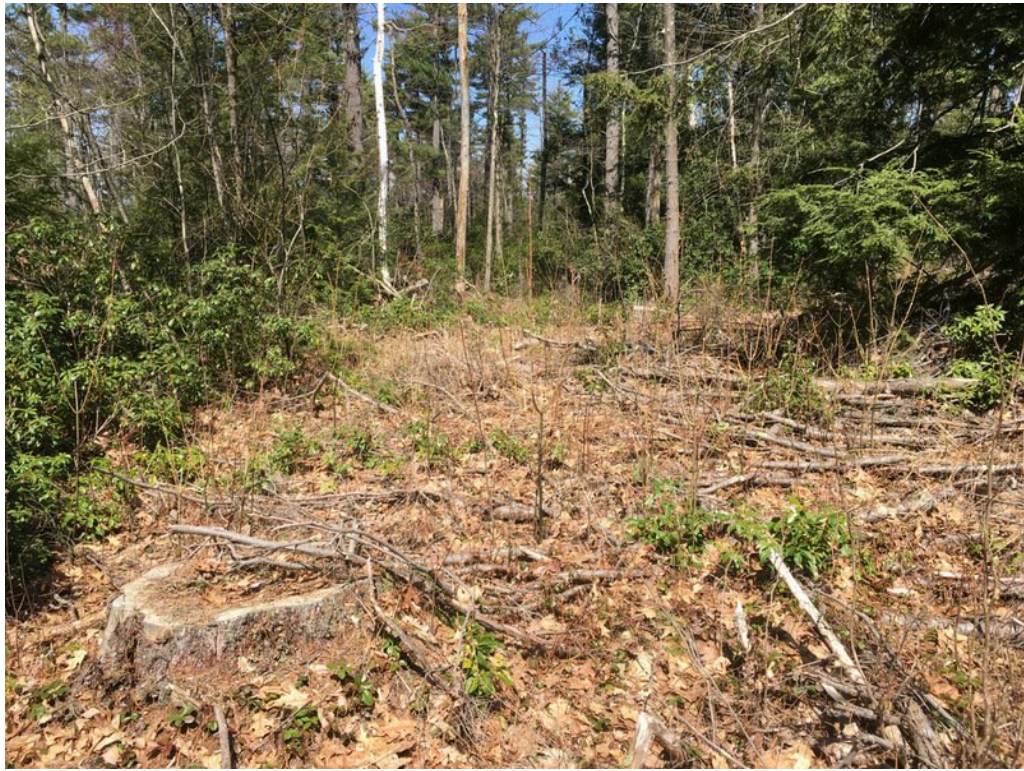
Photo of Sample Plot  
North

Project/Site: Baker City/County: Shutesbury, Franklin Sampling Date: 2020-April-15  
 Applicant/Owner: W.D. Cows State: MA Sampling Point: W-MJR-08\_UPL-1  
 Investigator(s): Matt Regan, Molly Lennon Section, Township, Range: \_\_\_\_\_  
 Landform(hillslope,terrace,etc.): Hillslope Local relief (concave, convex, none): Convex Slope (%): 1 to 3  
 Subregion (LRR or MLRA): LRR R Lat: 42.4224425247 Long: -72.4277730101 Datum: WGS84  
 Soil Map Unit Name: Chichester fine sandy loam, 8 to 15 percent slopes NWI classification: \_\_\_\_\_  
 Are climatic/hydrologic conditions on the site typical for this time of year? Yes  No  (If no, explain in Remarks.)  
 Are Vegetation  Soil  or Hydrology  significantly disturbed? Are "Normal Circumstances" present? Yes  No   
 Are Vegetation  Soil  or Hydrology  naturally problematic? (If needed, explain any answers in Remarks.)

Depth (inches)	Matrix		Redox Features				Texture	Remarks
	Color (moist)	%	Color (moist)	%	Type <sup>1</sup>	Loc <sup>2</sup>		
0 - 5	10YR 2/2	100					Silt Loam	
5 - 6	10YR 3/3	100					Silt Loam

<b>Restrictive Layer (if observed):</b>		<b>Hydric Soil Present?</b>	
Type:	Rock	Yes	No <input checked="" type="checkbox"/>
Depth (inches):	6

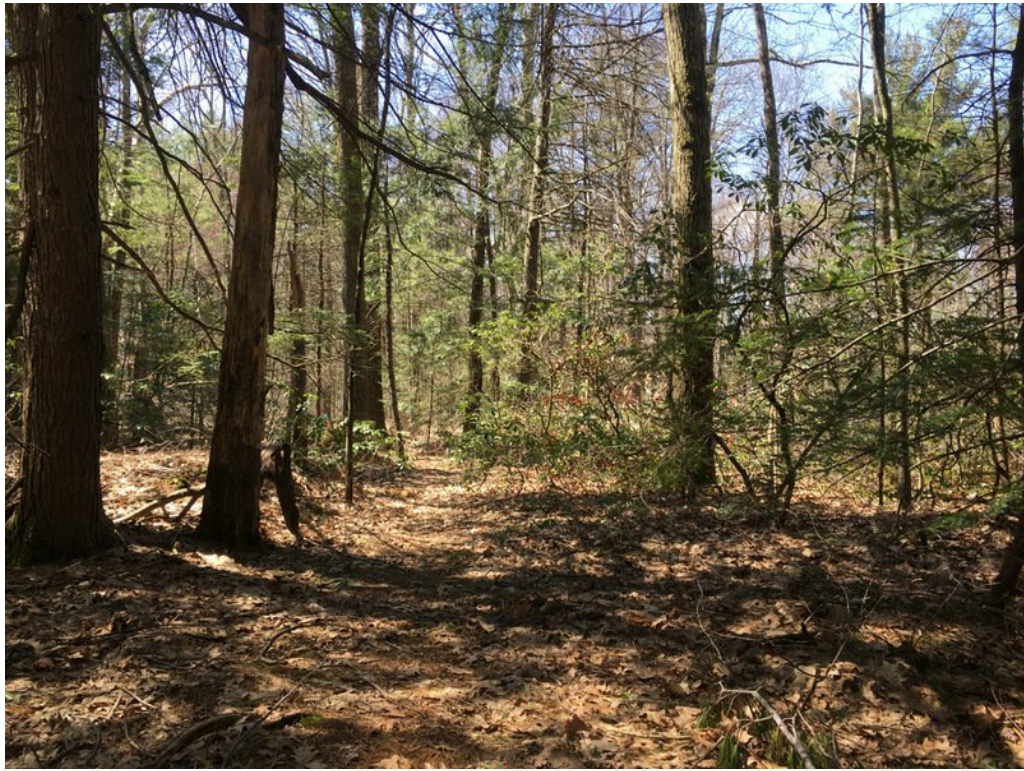
Photo of Sample Plot  
North

Project/Site: Baker City/County: Shutesbury, Franklin Sampling Date: 2020-April-15  
 Applicant/Owner: W.D. Cows State: MA Sampling Point: W-MJR-08\_UPL-2  
 Investigator(s): Matt Regan, Molly Lennon Section, Township, Range: \_\_\_\_\_  
 Landform(hillslope,terrace,etc.): Hillslope Local relief (concave, convex, none): Convex Slope (%): 0 to 1  
 Subregion (LRR or MLRA): LRR R Lat: 42.4219957693 Long: -72.4280566537 Datum: WGS84  
 Soil Map Unit Name: Chichester fine sandy loam, 8 to 15 percent slopes NWI classification: \_\_\_\_\_

Depth (inches)	Matrix		Redox Features				Texture	Remarks
	Color (moist)	%	Color (moist)	%	Type <sup>1</sup>	Loc <sup>2</sup>		
0 - 8	10YR 2/2	100					Sandy Loam	
8 - 18	10YR 4/6	100					Sandy Loam

<b>Restrictive Layer (if observed):</b>		<b>Hydric Soil Present?</b>	Yes ___ No <input checked="" type="checkbox"/>
Type:	None		
Depth (inches):

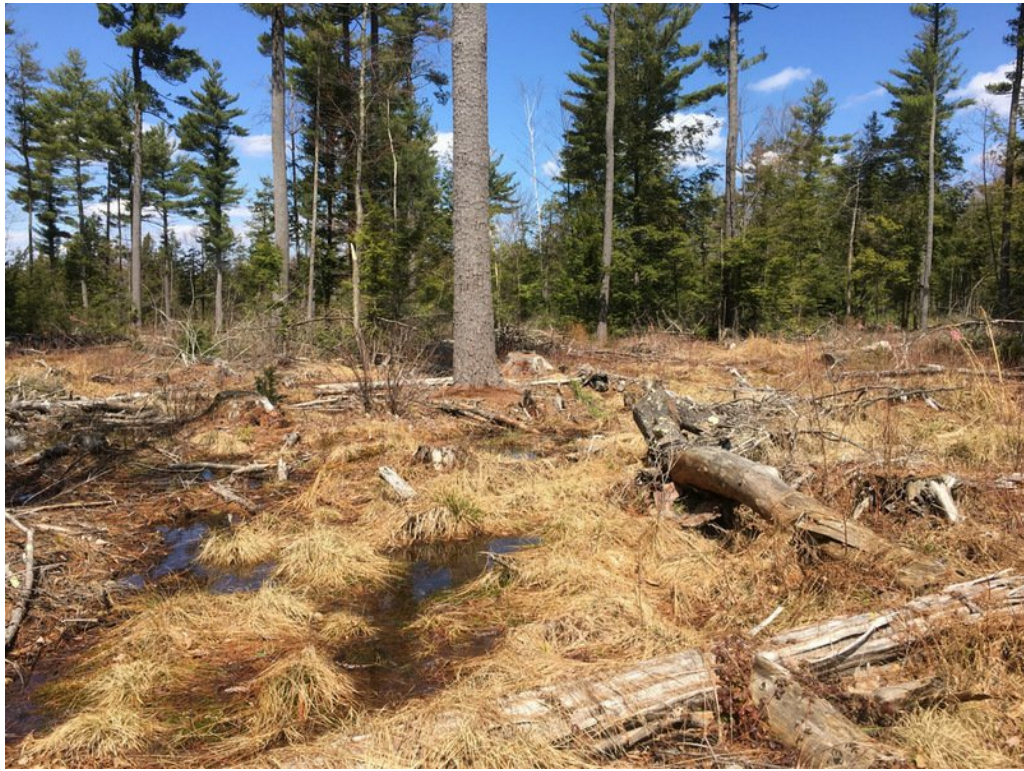
Photo of Sample Plot  
North

Project/Site: Baker City/County: Shutesbury, Franklin Sampling Date: 2020-April-15  
 Applicant/Owner: W.D. Cows State: MA Sampling Point: W-BAK-09\_PSS-1  
 Investigator(s): Matt Regan, Molly Lennon Section, Township, Range: \_\_\_\_\_  
 Landform(hillslope,terrace,etc.): Hillslope Local relief (concave, convex, none): Concave Slope (%): 0 to 1  
 Subregion(LRRorMLRA): LRR R Lat: 42.4236369878 Long: -72.4284350128 Datum: WGS84  
 Soil Map Unit Name: Pillsbury fine sandy loam, 0 to 8 percent slopes, very stony NWI classification: \_\_\_\_\_  
 Are climatic/hydrologic conditions on the site typical for this time of year? Yes  No  (If no, explain in Remarks.)  
 Are Vegetation  Soil  or Hydrology  significantly disturbed? Are "Normal Circumstances" present? Yes  No   
 Are Vegetation  Soil  or Hydrology  naturally problematic? (If needed, explain any answers in Remarks.)

<b>Wetland Hydrology Indicators:</b>	
<b>Primary Indicators (minimum of one is required; check all that apply)</b> <input type="checkbox"/> Surface Water (A1) <input checked="" type="checkbox"/> Water-Stained Leaves (B9) <input checked="" type="checkbox"/> High Water Table (A2) <input type="checkbox"/> Aquatic Fauna (B13) <input type="checkbox"/> Saturation (A3) <input type="checkbox"/> Marl Deposits (B15) <input type="checkbox"/> Water Marks (B1) <input type="checkbox"/> Hydrogen Sulfide Odor (C1) <input type="checkbox"/> Sediment Deposits (B2) <input type="checkbox"/> Oxidized Rhizospheres on Living Roots (C3) <input type="checkbox"/> Drift Deposits (B3) <input type="checkbox"/> Presence of Reduced Iron (C4) <input type="checkbox"/> Algal Mat or Crust (B4) <input type="checkbox"/> Recent Iron Reduction in Tilled Soils (C6) <input type="checkbox"/> Iron Deposits (B5) <input type="checkbox"/> Thin Muck Surface (C7) <input type="checkbox"/> Inundation Visible on Aerial Imagery (B7) <input type="checkbox"/> Other (Explain in Remarks) <input type="checkbox"/> Sparsely Vegetated Concave Surface (B8)	<b>Secondary Indicators (minimum of two required)</b> <input type="checkbox"/> Surface Soil Cracks (B6) <input type="checkbox"/> Drainage Patterns (B10) <input type="checkbox"/> Moss Trim Lines (B16) <input type="checkbox"/> Dry-Season Water Table (C2) <input type="checkbox"/> Crayfish Burrows (C8) <input type="checkbox"/> Saturation Visible on Aerial Imagery (C9) <input type="checkbox"/> Stunted or Stressed Plants (D1) <input checked="" type="checkbox"/> Geomorphic Position (D2) <input type="checkbox"/> Shallow Aquitard (D3) <input type="checkbox"/> Microtopographic Relief (D4) <input checked="" type="checkbox"/> FAC-Neutral Test (D5)

<b>Hydrophytic Vegetation Indicators:</b> <input type="checkbox"/> 1 - Rapid Test for Hydrophytic Vegetation <input checked="" type="checkbox"/> 2 - Dominance Test is >50% <input checked="" type="checkbox"/> 3 - Prevalence Index is ≤ 3.0 <sup>1</sup> <input type="checkbox"/> 4 - Morphological Adaptations <sup>1</sup> (Provide supporting data in Remarks or on a separate sheet) <input type="checkbox"/> Problematic Hydrophytic Vegetation <sup>1</sup> (Explain) <sup>1</sup> Indicators of hydric soil and wetland hydrology must be present, unless disturbed or problematic  <b>Definitions of Vegetation Strata:</b> <b>Tree</b> – Woody plants 3 in. (7.6 cm) or more in diameter at breast height (DBH), regardless of height. <b>Sapling/shrub</b> – Woody plants less than 3 in. DBH and greater than or equal to 3.28 ft (1 m) tall. <b>Herb</b> – All herbaceous (non-woody) plants, regardless of size, and woody plants less than 3.28 ft tall. <b>Woody vines</b> – All woody vines greater than 3.28 ft in height.  Hydrophytic Vegetation Present? Yes <input checked="" type="checkbox"/> No <input type="checkbox"/>		Total % Cover of:	Multiply By:	OBL species	90	x 1 = 90	FACW species	10	x 2 = 20	FAC species	35	x 3 = 105	FACU species	20	x 4 = 80	UPL species	0	x 5 = 0	Column Totals	155	(A) 295 (B)	Prevalence Index = B/A =		<u>1.9</u>
	Total % Cover of:	Multiply By:																										
OBL species	90	x 1 = 90																										
FACW species	10	x 2 = 20																										
FAC species	35	x 3 = 105																										
FACU species	20	x 4 = 80																										
UPL species	0	x 5 = 0																										
Column Totals	155	(A) 295 (B)																										
Prevalence Index = B/A =		<u>1.9</u>																										
1. <i>Pinus strobus</i>	10	Yes	FACU																									
2. _____	_____	_____	_____																									
3. _____	_____	_____	_____																									
4. _____	_____	_____	_____																									
5. _____	_____	_____	_____																									
6. _____	_____	_____	_____																									
7. _____	_____	_____	_____																									
10 = Total Cover																												
<b>Sapling/Shrub Stratum (Plot size: 15 ft )</b>																												
1. <i>Acer rubrum</i>	35	Yes	FAC																									
2. <i>Kalmia latifolia</i>	10	Yes	FACU																									
3. _____	_____	_____	_____																									
4. _____	_____	_____	_____																									
5. _____	_____	_____	_____																									
6. _____	_____	_____	_____																									
7. _____	_____	_____	_____																									
45 = Total Cover																												
<b>Herb Stratum (Plot size: 5 ft )</b>																												
1. <i>Juncus effusus</i>	70	Yes	OBL																									
2. <i>Schoenoplectus tabernaemontani</i>	20	Yes	OBL																									
3. <i>Coptis trifolia</i>	10	No	FACW																									
4. _____	_____	_____	_____																									
5. _____	_____	_____	_____																									
6. _____	_____	_____	_____																									
7. _____	_____	_____	_____																									
8. _____	_____	_____	_____																									
9. _____	_____	_____	_____																									
10. _____	_____	_____	_____																									
11. _____	_____	_____	_____																									
12. _____	_____	_____	_____																									
100 = Total Cover																												
<b>Woody Vine Stratum (Plot size: 30 ft )</b>																												
1. _____	_____	_____	_____																									
2. _____	_____	_____	_____																									
3. _____	_____	_____	_____																									
4. _____	_____	_____	_____																									
0 = Total Cover																												
Remarks: (Include photo numbers here or on a separate sheet.)
