ABBREVIATED NOTICE OF RESOURCE AREA DELINEATION

Montague Road Project Carver Road West (Parcel ID ZD-37) Shutesbury, Massachusetts

**RE: Montague Road Project
Carver Road West (Parcel ID ZD-37)
Abbreviated Notice of Resource Area Delineation (ANRAD)**

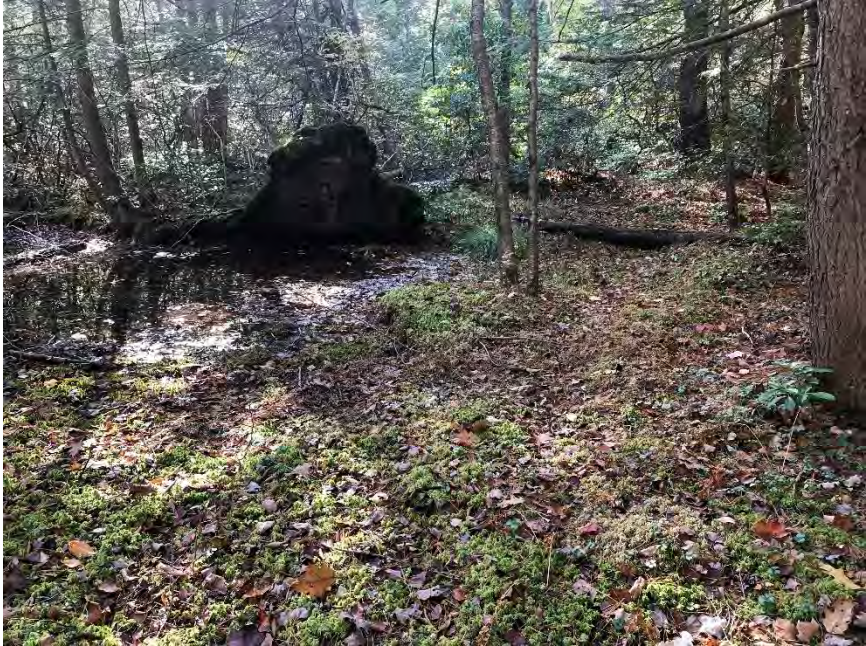
MONTAGUE ROAD PROJECT CARVER ROAD WEST, SHUTESBURY, MASSACHUSETTS	
Photograph: 1 Date: 10/24/2019 Direction: North Description: Typical conditions observed within forested wetland W1.

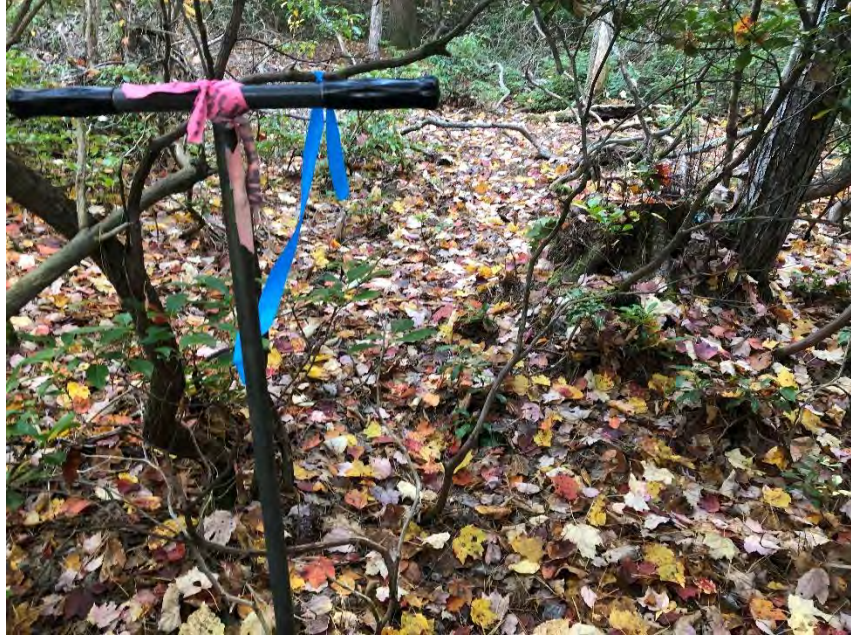
Photograph: 4

Upland data point for W-GR-1-PFO.

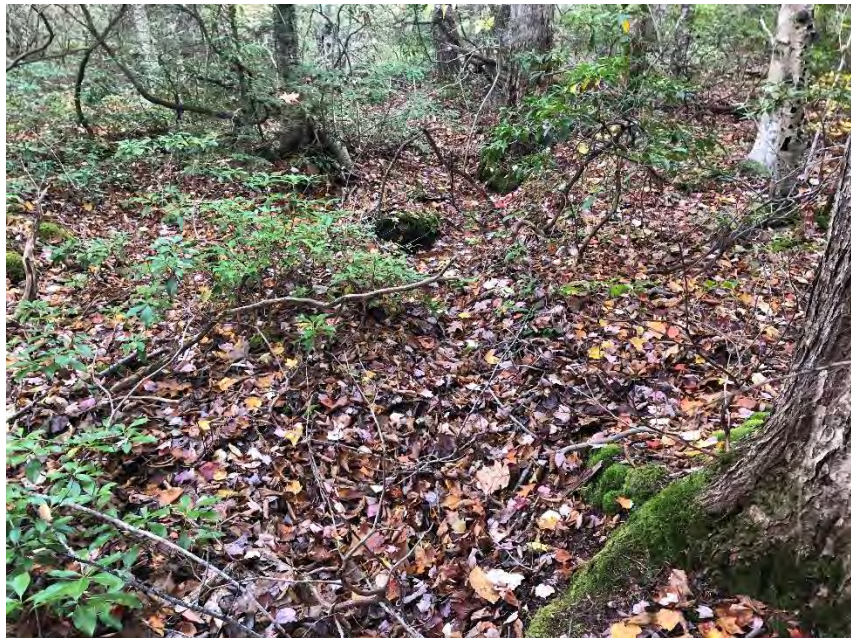
Downstream view of S-GR-1.

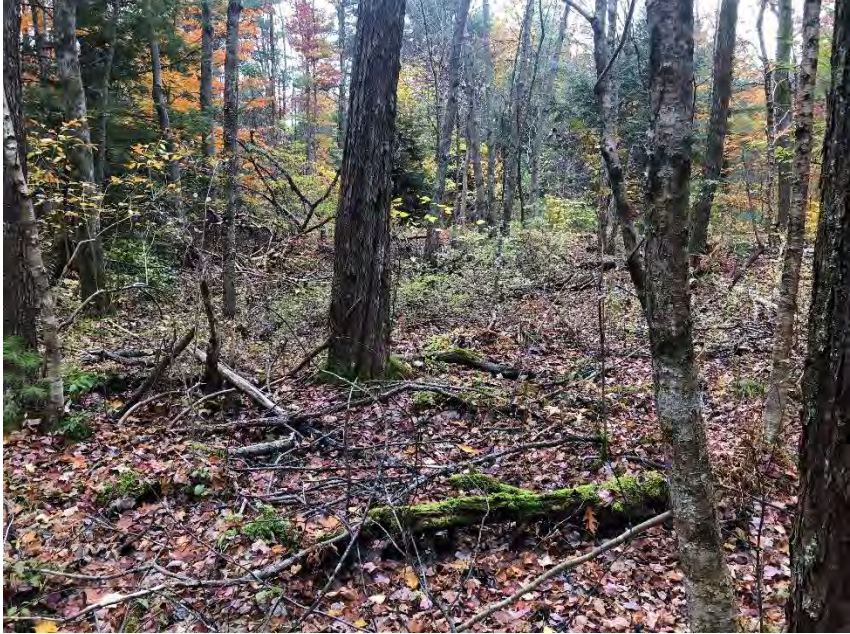
MONTAGUE ROAD PROJECT CARVER ROAD WEST, SHUTESBURY, MASSACHUSETTS	
Photograph: 5 Date: 10/25/2019 Direction: North Description: Typical conditions observed within scrub- shrub wetland W2.

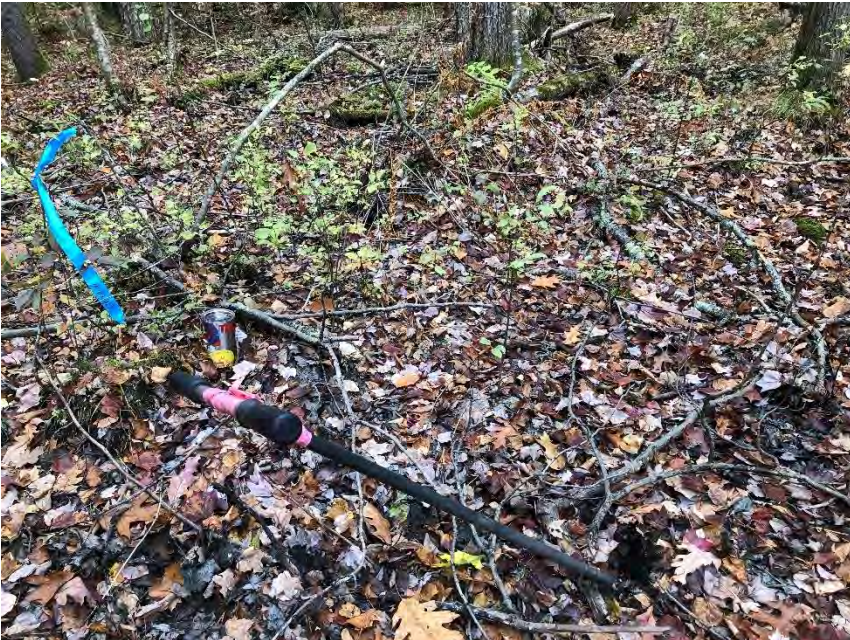
Photograph: 6 Date: 10/25/2019 Direction: North Description: W-GR-2-PSS Data Point.

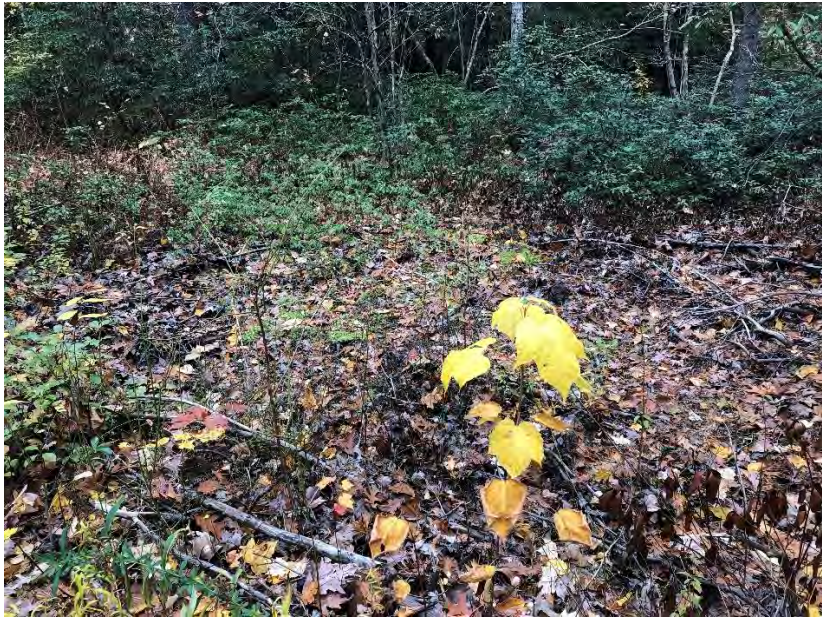
Photograph: 10 Date: 10/25/2019 Direction: Northwest Description: Potential vernal pool adjacent to Carver Road on south border of the Site.

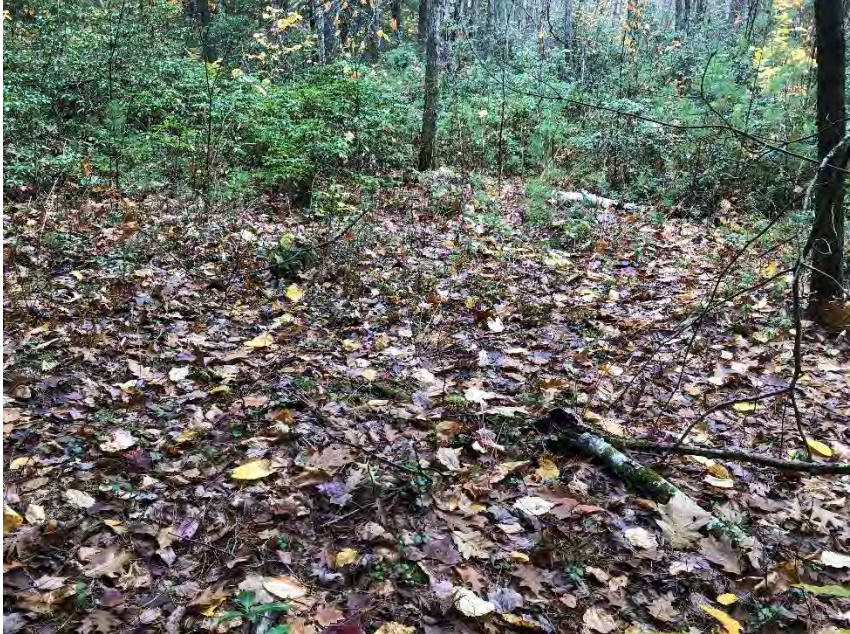
MONTAGUE ROAD PROJECT CARVER ROAD WEST, SHUTESBURY, MASSACHUSETTS	
Photograph: 11 Date: 10/25/2019 Direction: Southwest Description: Typical conditions observed within palustrine scrub-shrub wetland W3.

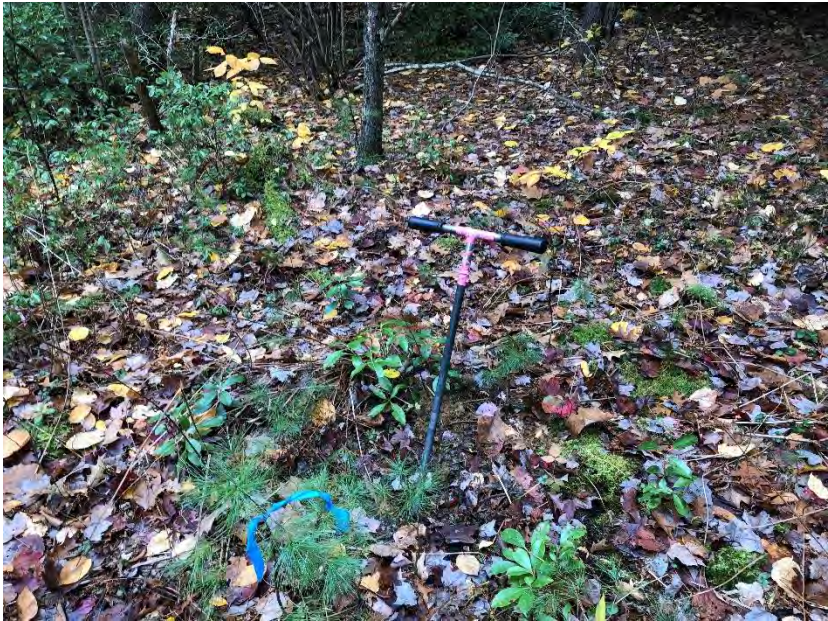
Photograph: 12 Date: 10/25/2019 Direction: Southeast Description: W-GR-3-PSS Data Point.

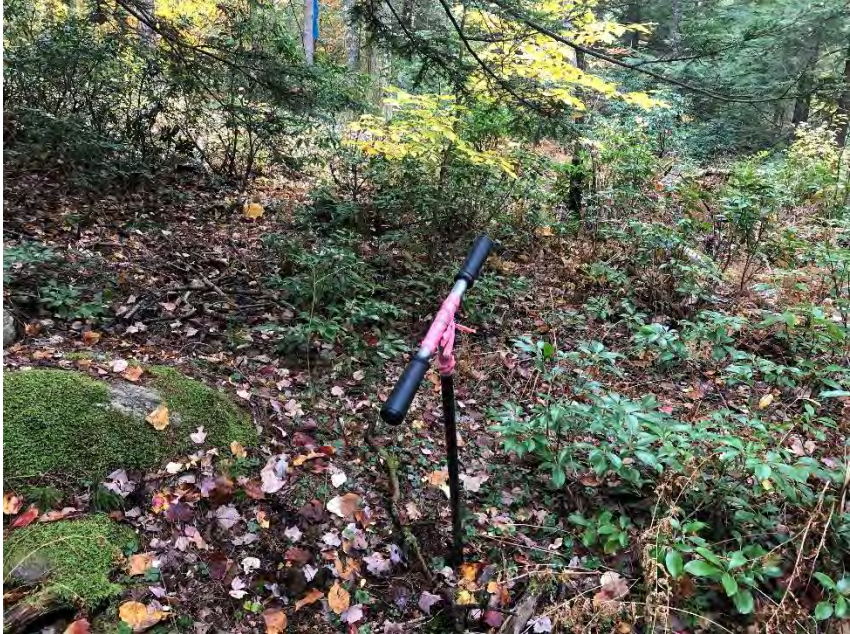
MONTAGUE ROAD PROJECT CARVER ROAD WEST, SHUTESBURY, MASSACHUSETTS	
Photograph: 15 Date: 10/25/2019 Direction: South Description: Upland data point for W-GR-4-PEM.

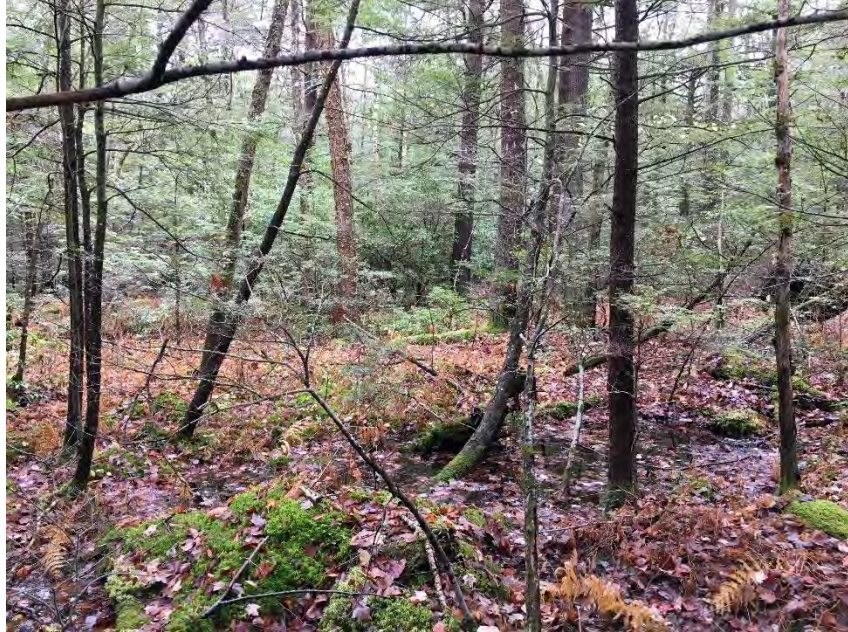
Typical conditions
observed within PFO
wetland W-MJR-7

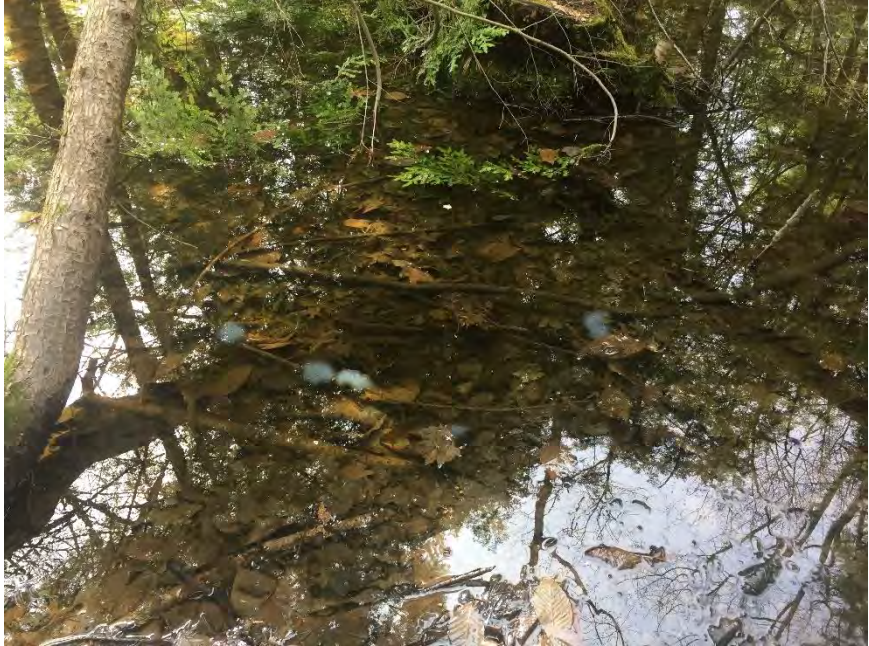
MONTAGUE ROAD PROJECT CARVER ROAD WEST, SHUTESBURY, MASSACHUSETTS	
<p>Photograph: 1</p> <p>Date: 4/29/2020</p> <p>Direction: South</p> <p>Description:</p> <p>Typical conditions observed in vernal pool VP1. Several egg masses can be seen in this photo. Approximately eight egg masses were in the vernal pool, and they were all likely wood frog eggs.</p>

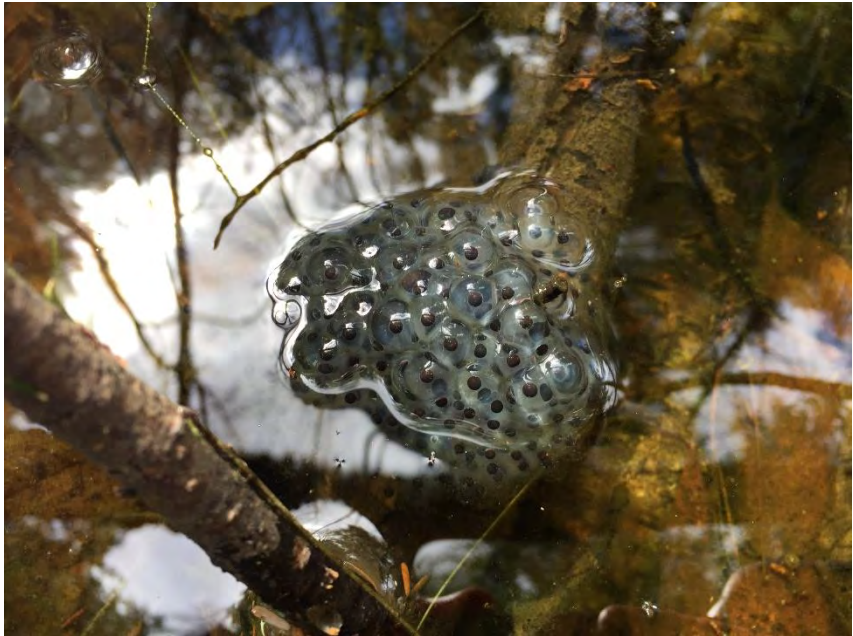
<p>Photograph: 2</p> <p>Date: 4/17/2020</p> <p>Direction: N/A</p> <p>Description:</p> <p>Wood frog egg mass in vernal pool VP1.</p>

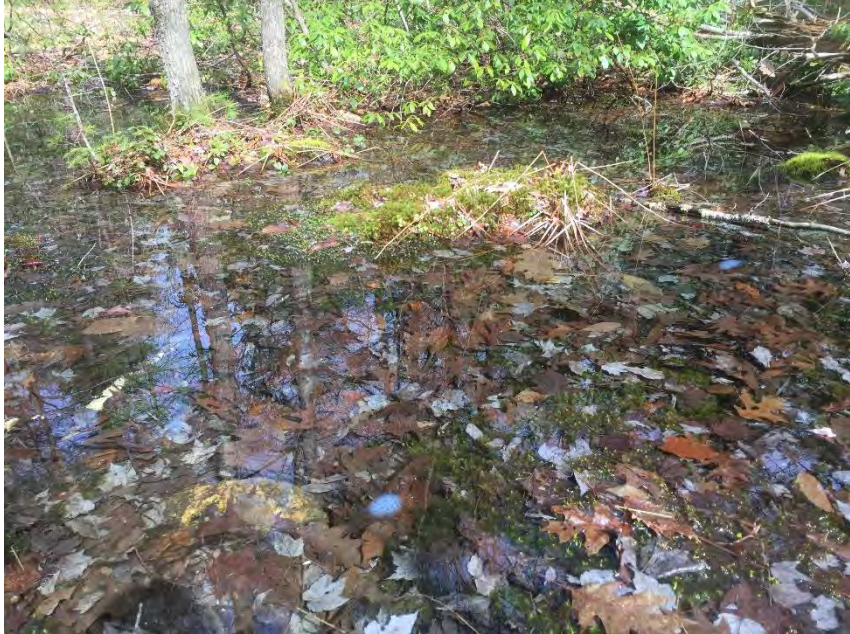
MONTAGUE ROAD PROJECT CARVER ROAD WEST, SHUTESBURY, MASSACHUSETTS	
<p>Photograph: 3</p> <p>Date: 4/29/2020</p> <p>Direction: North</p> <p>Description:</p> <p>Typical conditions observed in vernal pool VP2. A couple egg masses can be seen in this photo. There were approximately five egg masses that were likely all spotted salamander.</p>

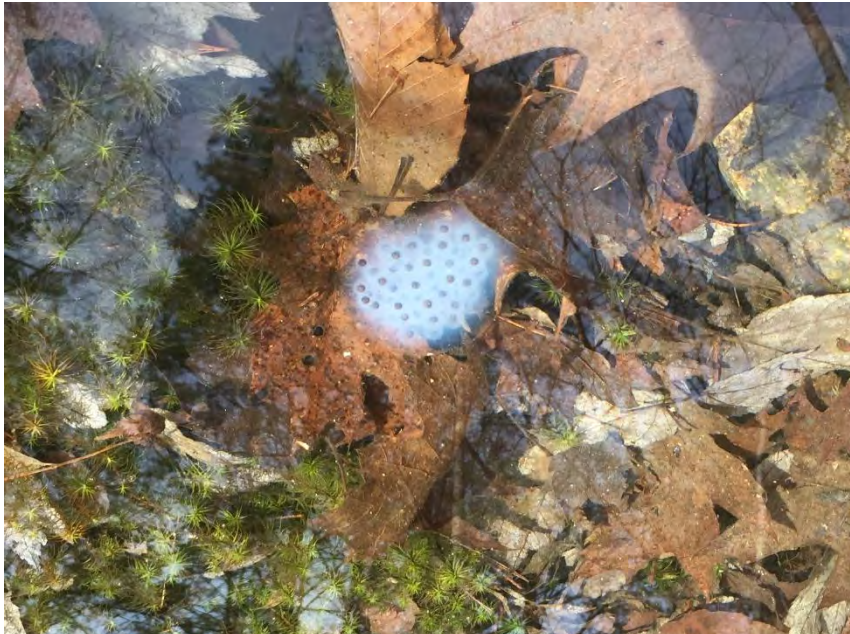
<p>Photograph: 4</p> <p>Date: 4/29/2020</p> <p>Direction: North</p> <p>Description:</p> <p>Egg mass in vernal pool VP2. The egg mass is likely a spotted salamander mass.</p>

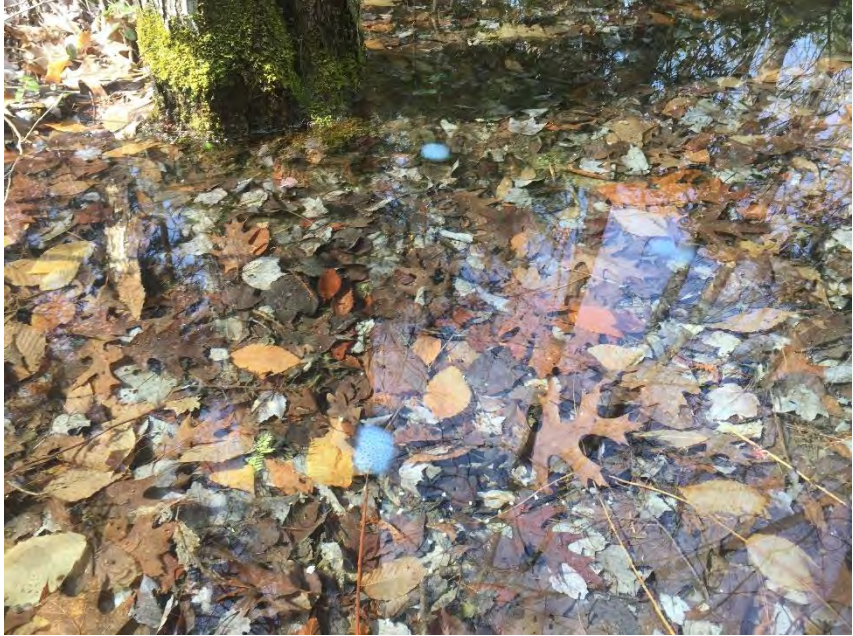
MONTAGUE ROAD PROJECT CARVER ROAD WEST, SHUTESBURY, MASSACHUSETTS	
<p>Photograph: 5</p> <p>Date: 4/29/2020</p> <p>Direction: North</p> <p>Description:</p> <p>Typical conditions observed in vernal pool VP3. Several egg masses can be seen in this photo. Approximately four egg masses were found in vernal pool VP3 and were likely all spotted salamander.</p>

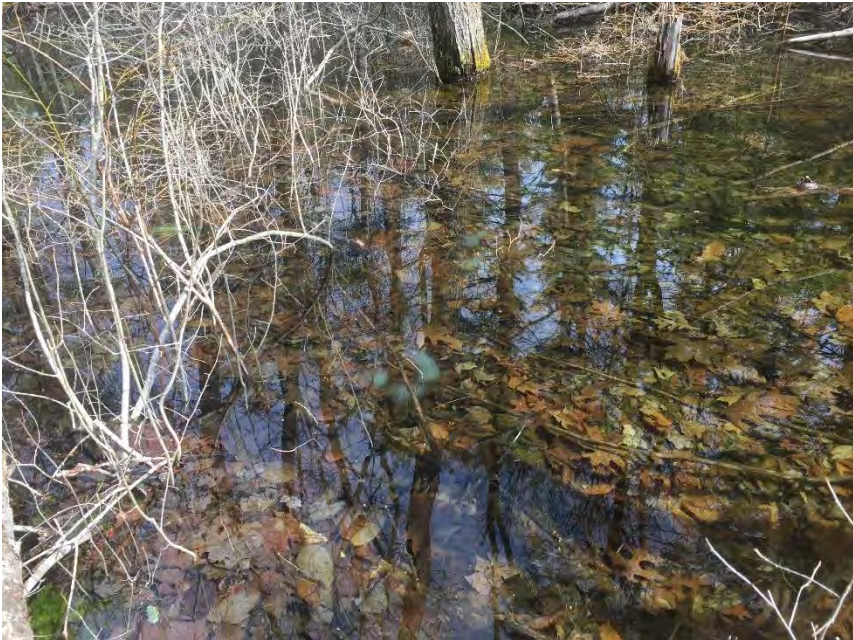
<p>Photograph: 6</p> <p>Date: 4/29/2020</p> <p>Direction: East</p> <p>Description:</p> <p>Typical conditions observed in vernal pool VP4. Multiple egg masses can be seen in this photo. Approximately 55 egg masses were found in vernal pool VP4 consisting primarily of spotted salamander egg masses and several wood frog egg masses.</p>

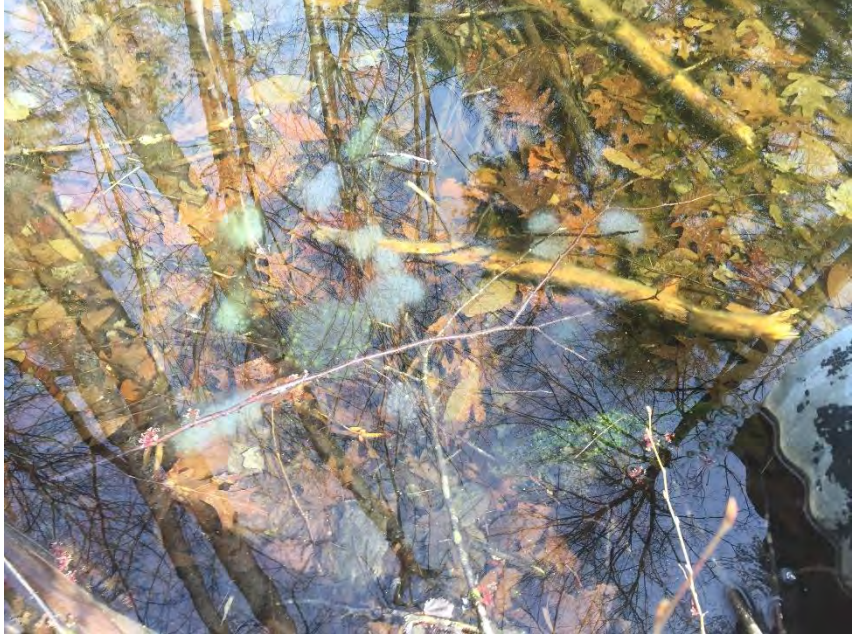
MONTAGUE ROAD PROJECT CARVER ROAD WEST, SHUTESBURY, MASSACHUSETTS	
<p>Photograph: 7</p> <p>Date: 4/29/2020</p> <p>Direction: North</p> <p>Description:</p> <p>A clump of multiple spotted salamander egg masses in vernal pool VP4 can be seen in this photo.</p>

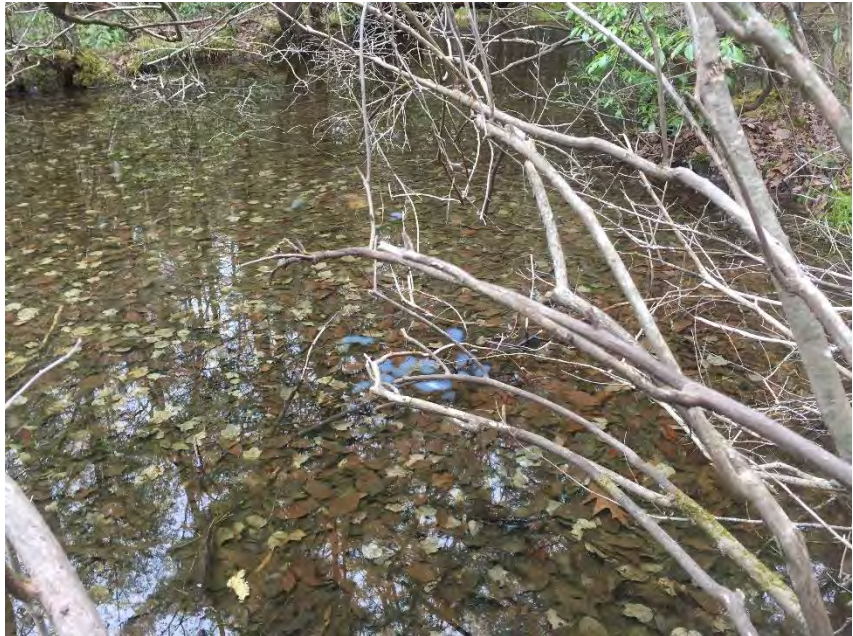
<p>Photograph: 8</p> <p>Date: 4/29/2020</p> <p>Direction: North</p> <p>Description:</p> <p>Typical conditions observed in vernal pool VP5. A clump of multiple egg masses can be seen in this photo. Approximately 28 egg masses were found in vernal pool VP5 mostly consisting of spotted salamander egg masses and several wood frog egg masses.</p>
