NOTICE OF INTENT - AMES POND TRAIL MAINTENANCE

PREPARED BY
SWCA Environmental Consultants

**Re: Notice of Intent - Ames Pond Beach Maintenance
Near 711 Wendell Road, Shutesbury, MA
SWCA Project No. 69584**

WPA Form 3 - Notice of Intent

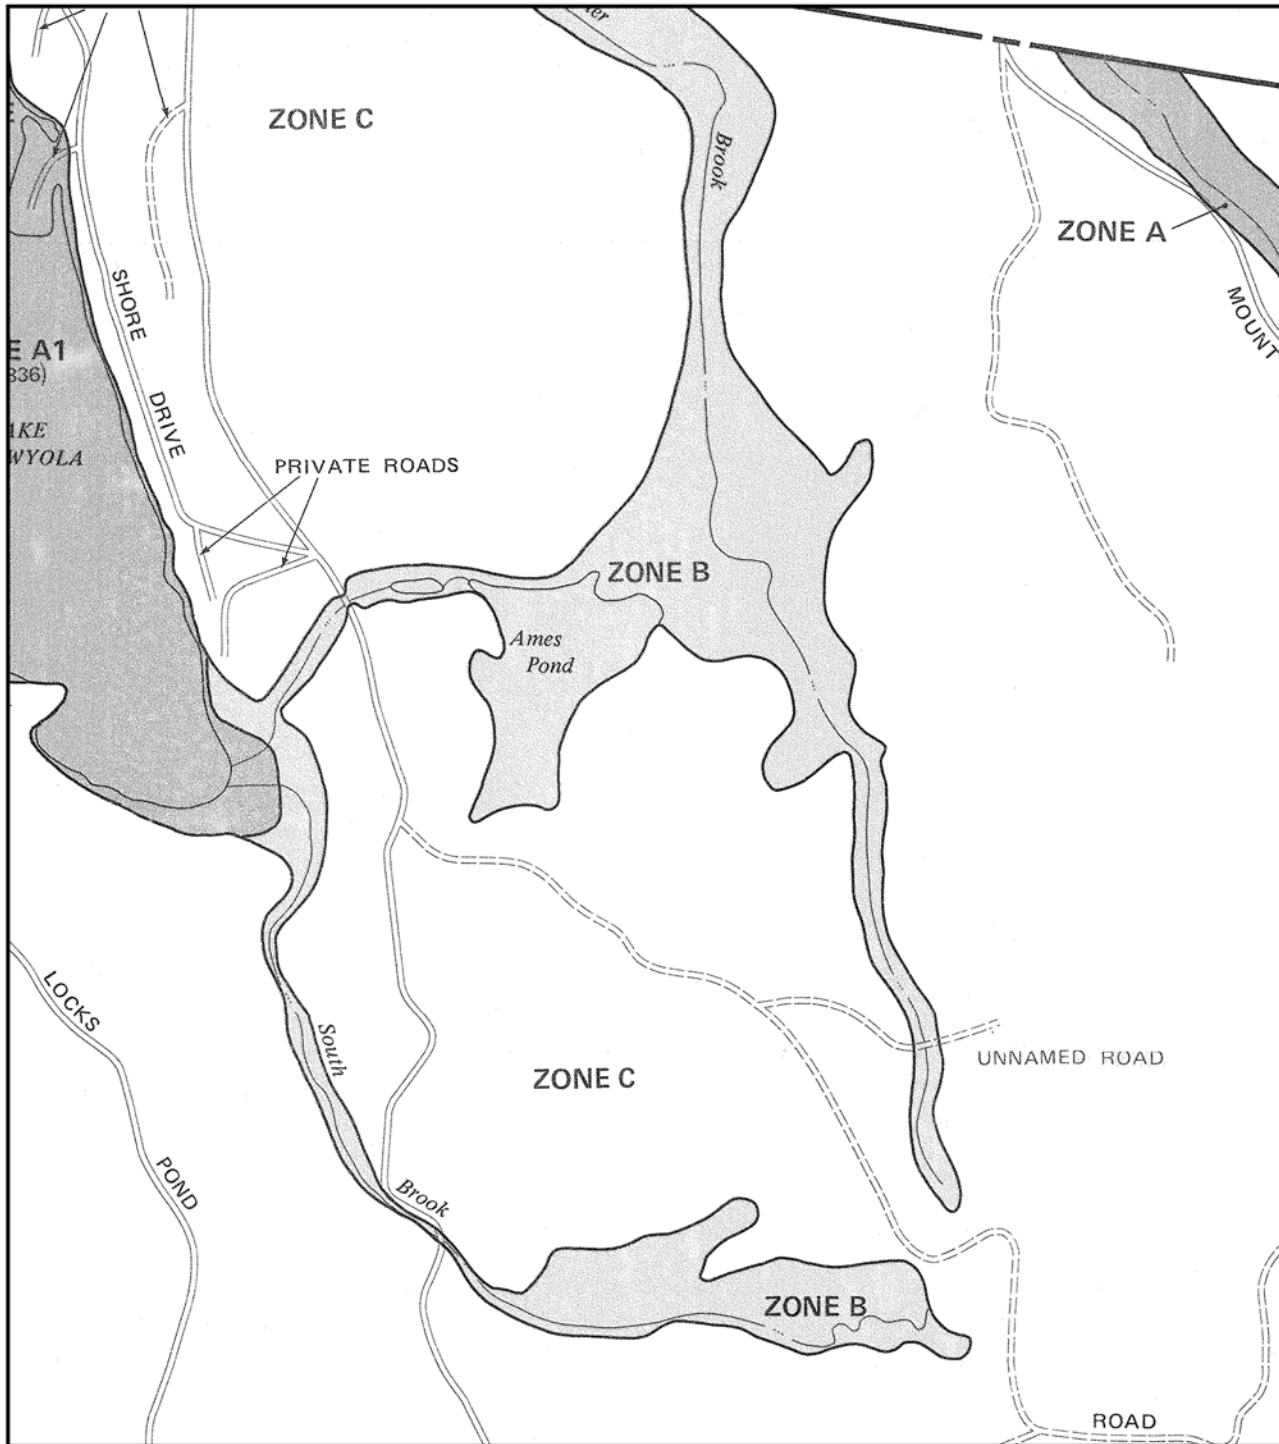
This is an official FIRMette showing a portion of the above-referenced flood map created from the MSC FIRMette Web tool. This map does not reflect changes or amendments which may have been made subsequent to the date on the title block. For additional information about how to make sure the map is current, please see the Flood Hazard Mapping Updates Overview Fact Sheet available on the FEMA Flood Map Service Center home page at <https://msc.fema.gov>.

Bordering Land Subject to Flooding (BLSF) coincides with the 100-year flood zone (see 310 CMR 10.57(2)(a)3). Bordering Land Subject to Flooding coincides with a 1% chance for annual flood or the 100-year flood zone. As part of evaluating resource areas at the site, SWCA reviewed the Flood Insurance Rate Map Community Panel Number 250128 for the Town of Shutesbury and found that no portions of the project area coincides with 100-year Floodplain (FEMA 1992; see Figure 6).

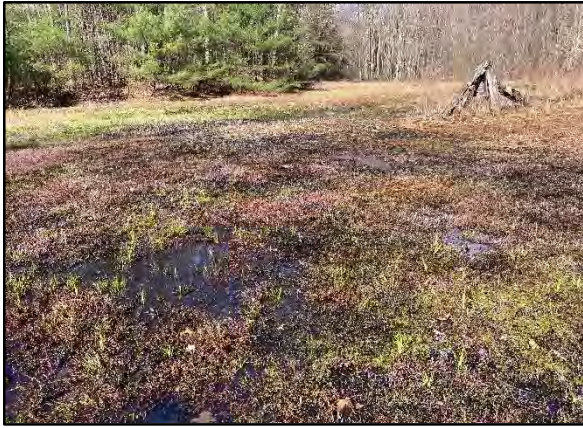
Photo 1. View facing north showing the A-wetland. Note the seasonally high water throughout this portion of the existing trail, which leads to trail 'braiding' by hikers. *Photo taken April 20, 2022.*

Under existing conditions, impacts associated with recreational trail use at the A-wetland include trail braiding (where hikers avoid wetter areas along the trail), soil compaction, and erosion within the BVW. A portion of this trail is proposed to be relocated to the buffer zone, reducing foot traffic through the wetland. A small portion of the trail cannot be relocated but will be upgraded with raised puncheon to discourage off-trail use (and the resulting trail braiding), soil compaction, and erosion. Table 3 illustrates the existing and proposed foot traffic-related impacts through the A-wetland below.

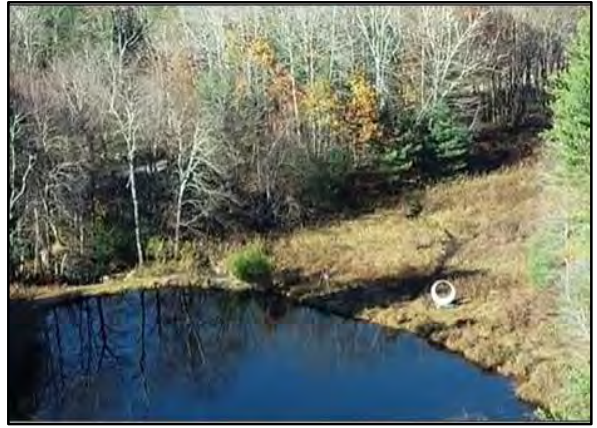
Photo 2. View facing west (from a drone) showing the existing trail through the A-wetland. The improved trail is proposed to be placed along the edge of the wetland to discourage trail 'braiding' and soil compaction within the wetland.

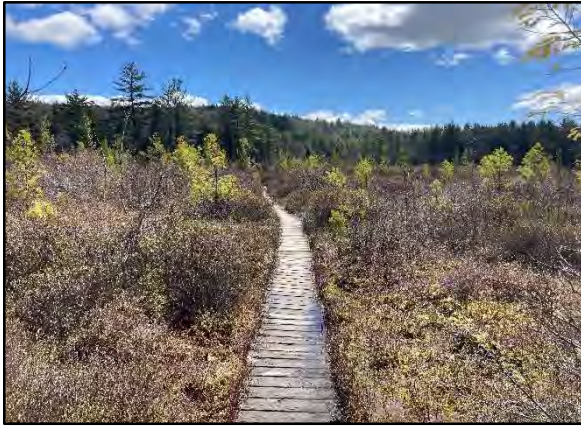
Photo 7. View of Bog and existing boardwalk facing southeast from the northwestern end of the boardwalk. *Photo taken April 20, 2022.*

Since significant flooding has rendered the existing bog boardwalk impassable in past years and extreme storm events and flooding are likely to continue, Kestrel proposes to replace this boardwalk with a more stable structure that will last longer than the existing structure has. Photos 7 through 10 (Appendix C)

illustrate the condition of the existing boardwalk at the bog trail. For both immediate and future flooding prevention, the replacement boardwalk will be installed 6 inches higher than the existing boardwalk. Under the current conditions, approximately 75% of the boardwalk experiences flooding for portions of the year. Raising the boardwalk 6 inches will mitigate any future flooding caused by future climate changes and beaver activity. The boardwalk is additionally proposed to be widened from 18-inches to 36-inches to allow for users to pass each other without requiring one to step into the sensitive bog area. Widening will also allow for wheelchair accessibility. Additional turnaround areas will be spaced a maximum of 200-feet apart throughout the existing boardwalk for wheelchair accessibility. This will require retaining and upgrading an existing turnaround area with a bench (see Photo 8, Appendix C), and the installation of two additional turnaround areas. The total length of boardwalk replacement within the bog is estimated to be 787 linear feet, with an expansion of 1,210.5 square feet added to the current boardwalk area to accommodate boardwalk widening.

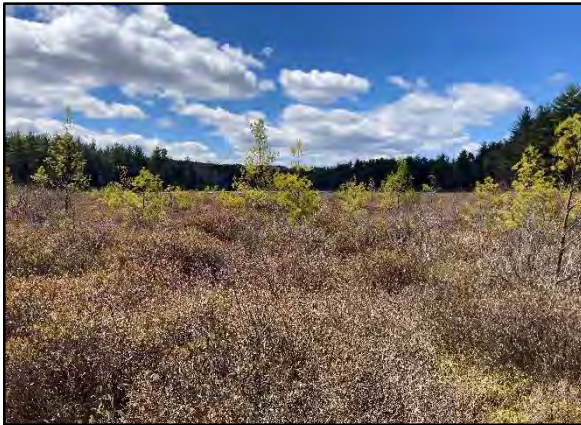
Photo 9. View of the bog facing south from the middle of the boardwalk. *Photo taken April 20, 2022.*

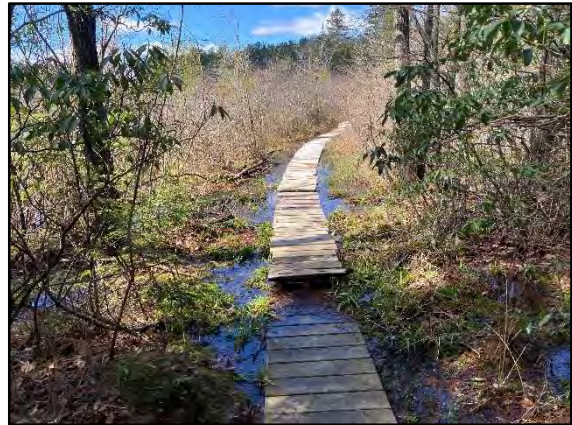
Photo 10. View facing northwest from the southeastern end of the existing boardwalk. *Photo taken April 20, 2022.*

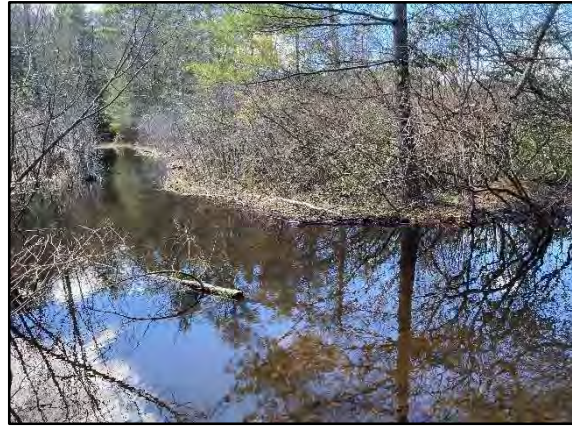
Photo 14. Beaver dam located between the H and J-wetland lines. *Photo taken April 20, 2022.*

Wetlands H and J borders an intermittent stream impounded by a beaver dam (see photo 14, Appendix C) and consist of palustrine forested wetlands with red maple and eastern hemlock in the overstory, sheep laurel in the understory, and dense *Sphagnum* moss covering the forest floor. Evidence of beaver activity, including beaver chews, lodges, and a dam, can be seen in these wetlands. Evidence of trail use over the beaver dam was observed and evidence of a historic trail can be seen underwater between the H and J wetland lines.

New boardwalk is proposed to be located at a recently flooded section of existing trail (between the H and J wetland lines) due to beaver activity. A beaver dam located at this area has been utilized by trail users as trail crossing. New boardwalk installed at this location will improve the existing conditions as it will discourage recreation through resource areas, disturbing surface water, and wildlife habitat features. No temporal loss of BVW is proposed.

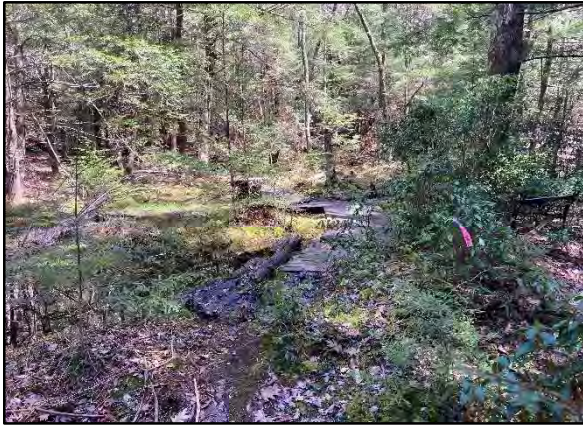
Photo 19. View of L-wetland showing the existing puncheon in poor repair. *Photo taken April 20, 2022.*

Wetlands K and L consist of palustrine forested wetlands bordering an intermittent stream. Red maple and eastern hemlock dominate in the overstory with sheep laurel common in the understory (see Photo 19, Appendix C). *Sphagnum* moss covers the wetlands as well as sparse cinnamon fern (*Osmundastrum cinnamomeum*). Evidence of hydrology, including pit-and-mound micro-topography with *Sphagnum* moss covering the pits, high water table, geomorphic position, and water staining were observed. Braided intermittent stream channels were observed within the boundary of the K and L-wetlands, which drain further south. Soils exhibited dark chroma colors consistent with hydric soils, with evidence of redoximorphic features (depletions and concentrations) below 3 inches in the soil profile.

In addition to the bog boardwalk replacement and installation of new boardwalk at the beaver dam, Kestrel proposes to upgrade and replace a section of puncheon which passes through a forested wetland (the L-wetland; see photo 19, Appendix C). This section of trail (the "Wetland Loop") includes an old carriage road, a section of upland forested trail, and a trail through low wetland areas that are consistently flooded. Approximately 35 linear feet of puncheon was previously installed at the L-wetland. As part of this section of trail upgrade, Kestrel is proposing to repair the existing puncheon, while retaining as much of the existing structure as possible and extend the puncheon an additional 12 feet to the edge of the wetland area. This section would include new 12-foot wooden stringers to provide stability. The improved section of 47-foot (total length) puncheon will allow hikers to cross the wetland without going off the path to avoid standing water and mud. This will help to protect the resource areas in the long-term by decreasing continuous impacts by trail users.

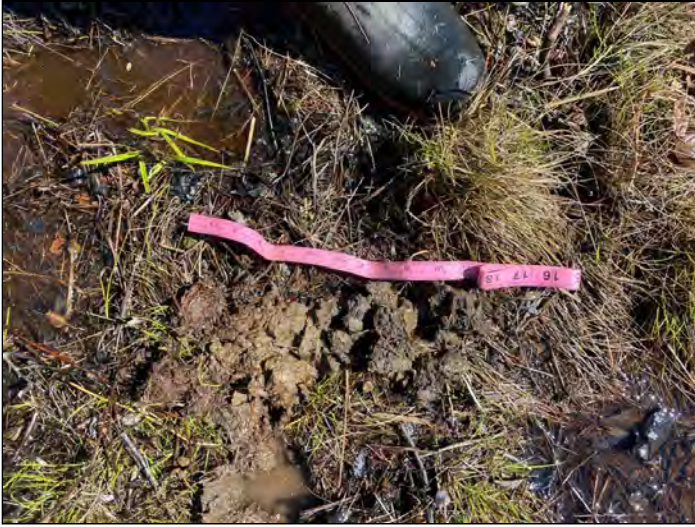
Photo Direction: Soil Test Pit
Photo Date: 04/20/2022
Caption: Soil profile at A-3 WET

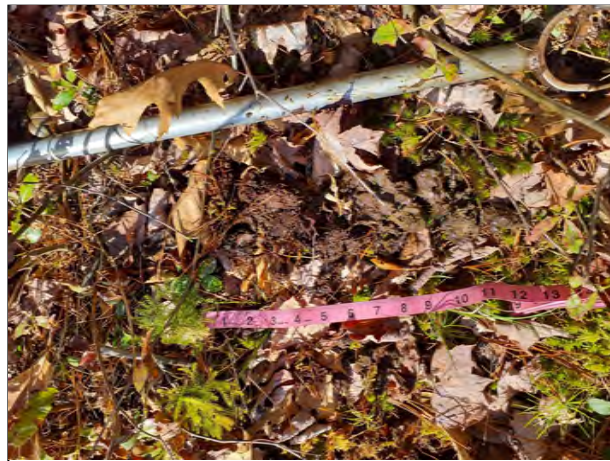
Photo Direction: Soil Test Pit
Photo Date: 04/21/2022
Caption: Soil profile at B-3 WET plot.

Remarks: Refusal observed at 12". Evidence of hydric soil was observed at the B-3 WET plot.

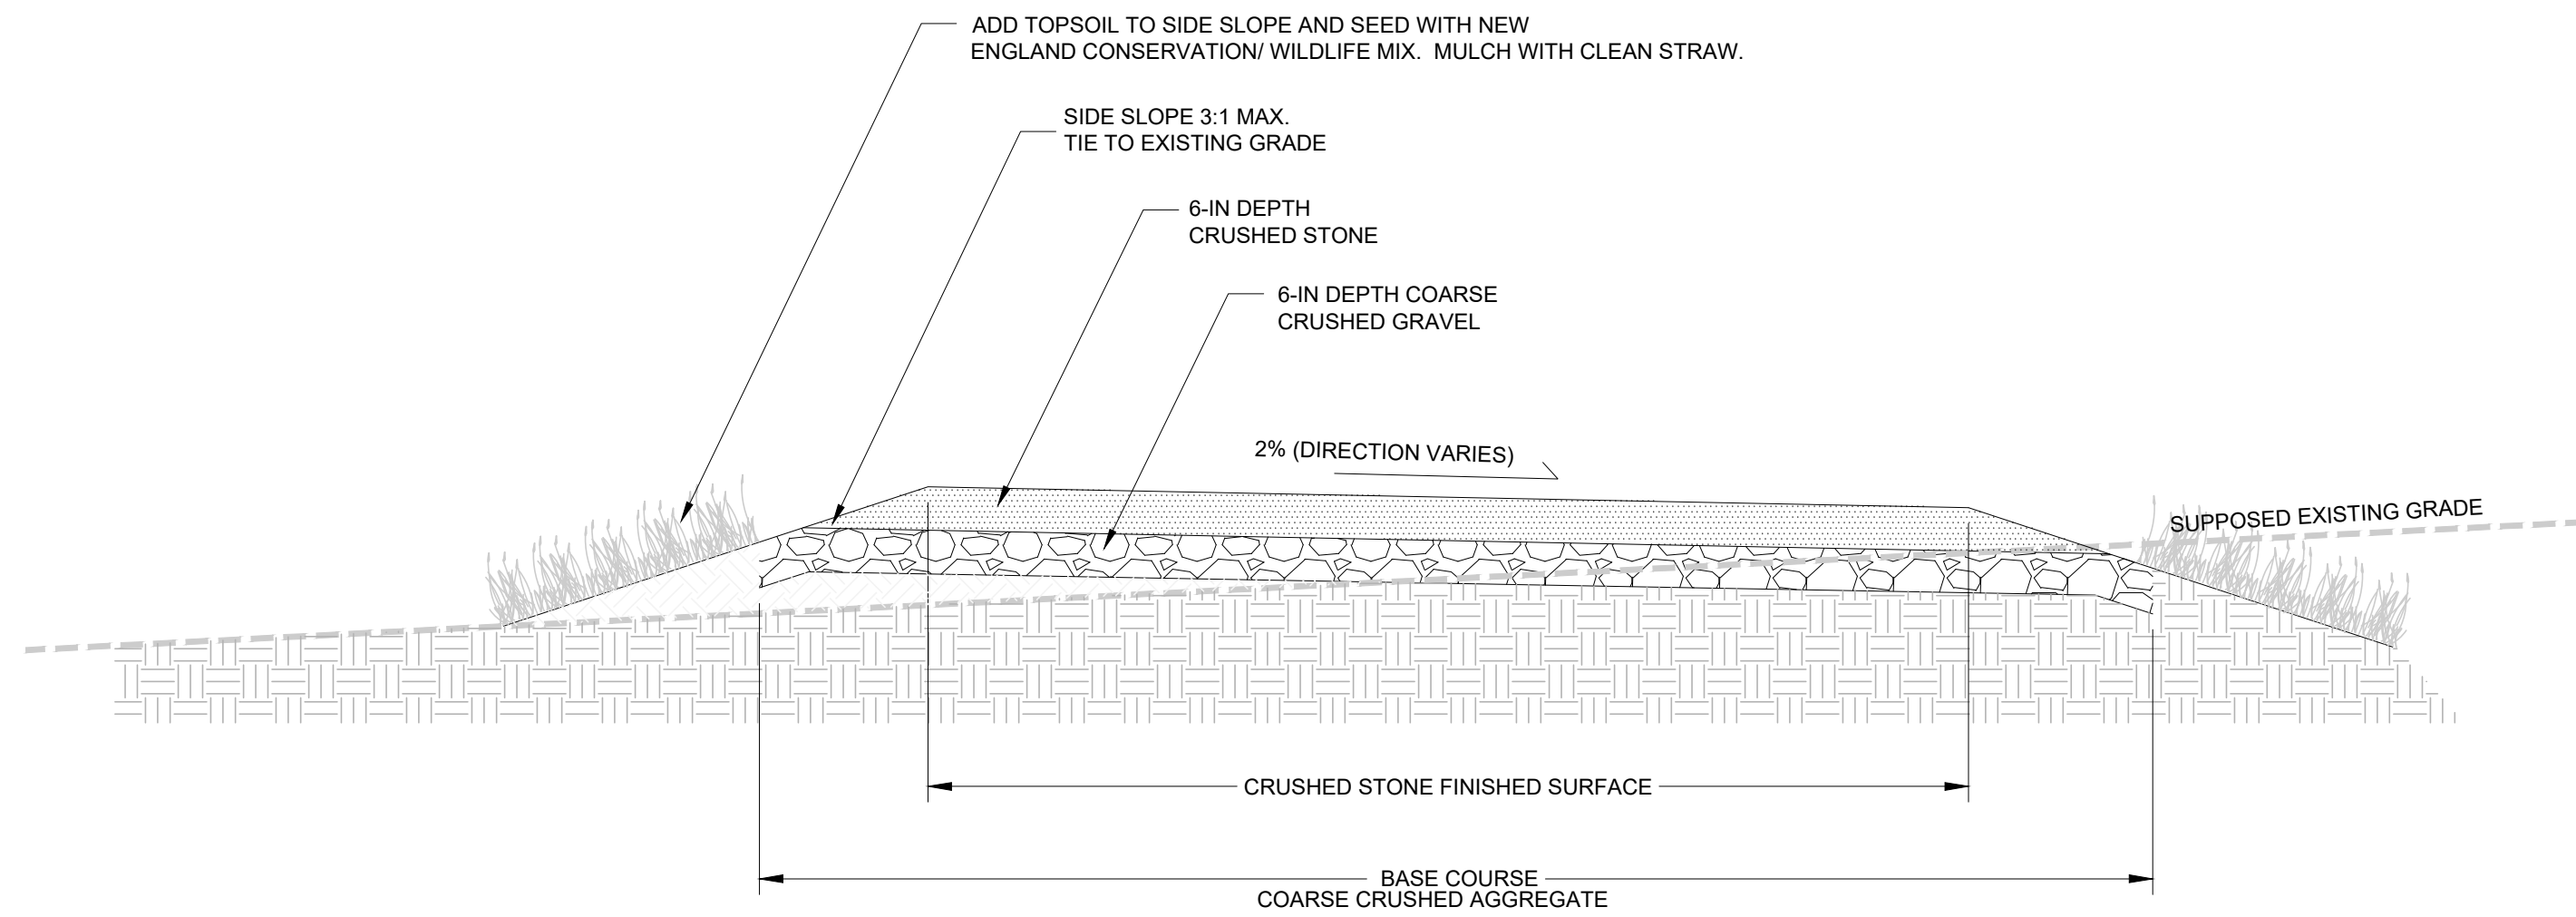
1 CRUSHED STONE PARKING AND ACCESS DRIVE
NOT TO SCALE

- NOTES:
1. ACCESS ROAD/PARKING PITCH IN A DIRECTION TO DIRECT WATER AWAY FROM WETLAND.

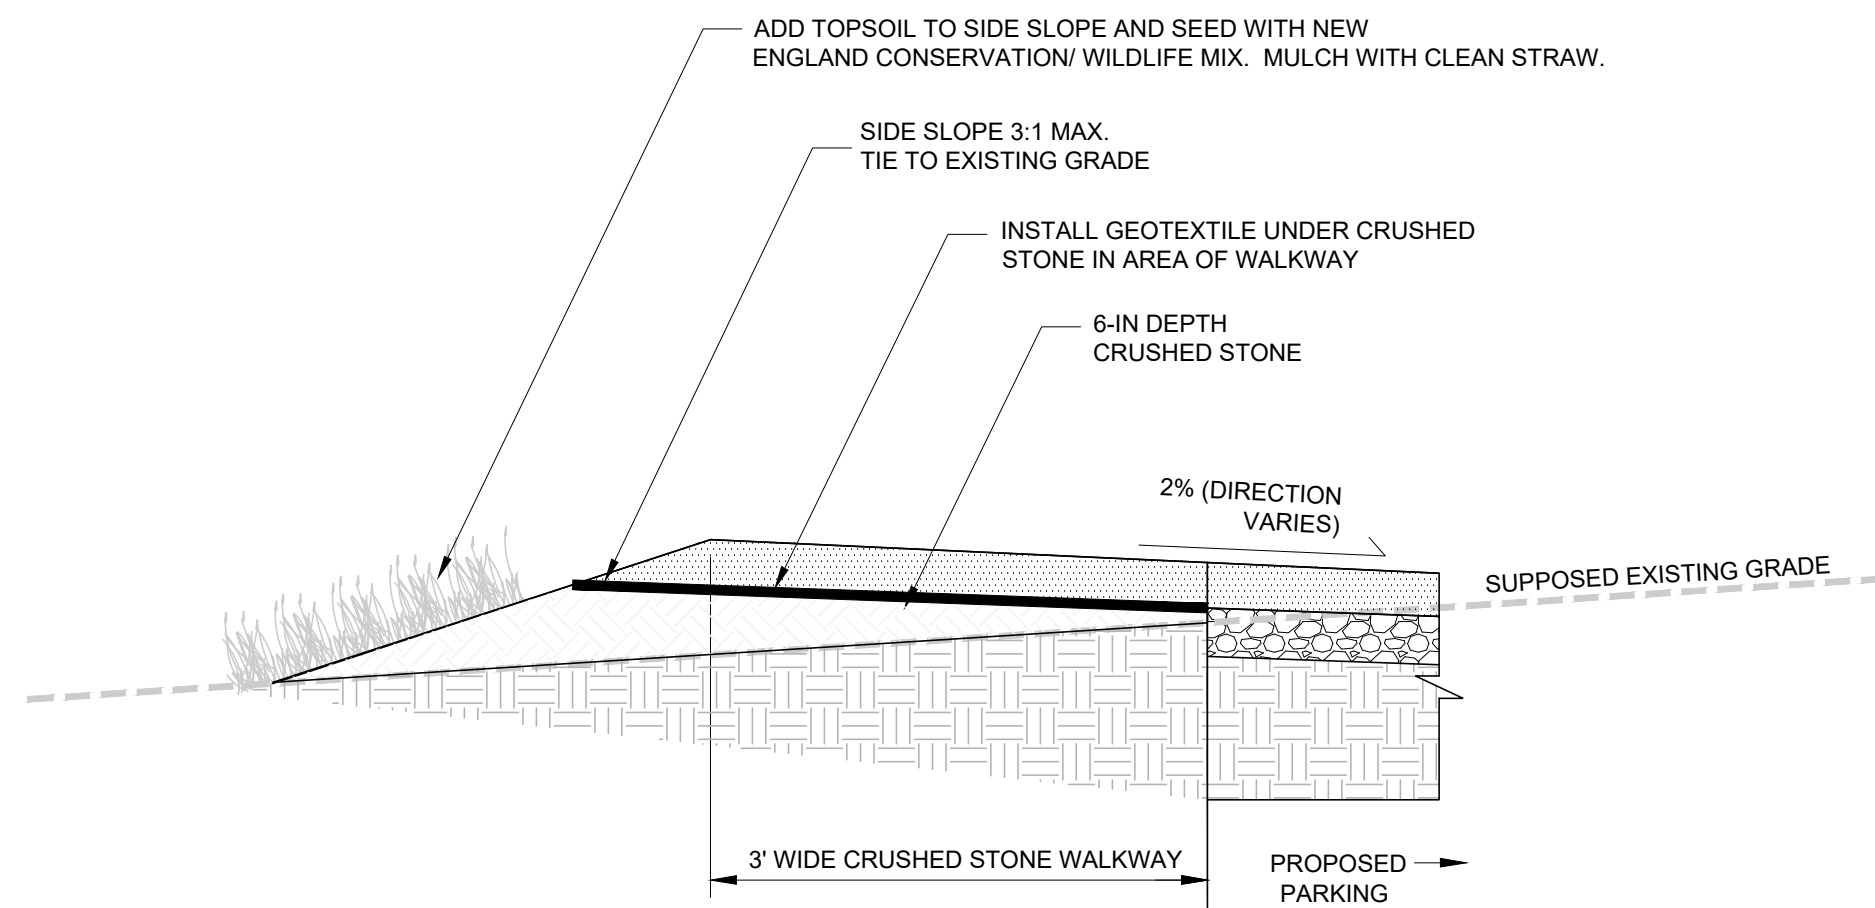
2 CRUSHED STONE WALKWAY
NOT TO SCALE

- NOTES:
1. PITCH WALKWAY IN A DIRECTION TO DIRECT WATER AWAY FROM WETLAND.
