FUSS & O'NEILL

RE: Applicant Response to Wetland Consultant Peer Review (WE 286-0297)  
66 Leverett Road, Shutesbury, MA 01072  
Fuss & O'Neill Reference No. 20091032.A22

November 11, 2022 Wetland Site Investigation Memo (WE 286-0297)

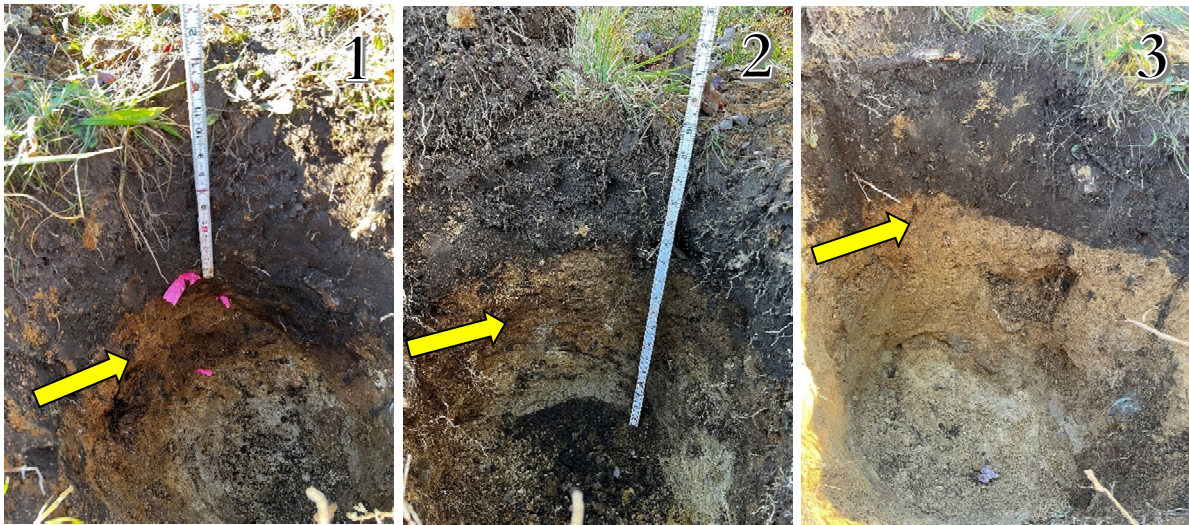
2. The A horizon in Test Pits #1 through #3 ranged from 9-10 inches with a clear boundary.
3. Based on the historic aerials, depth of the A horizon, and clear boundary observed in all three test pits in BVW 1, the A horizon is likely an Ap horizon (i.e., plowed A horizon). Refer to the photographs 1 through 3 below for reference.

4. Redoximorphic concentrations were observed within the Ap horizon at all three soil test pits. Percentages of concentrations ranged from 3% - 7%. These concentrations are believed to be the result of historic tilling, not fluctuations of groundwater fluctuations.

9. The August 5, 2022 wetland delineation found hydric soil indicator Redox Dark Surface (F6). Test Pits #1 and #2, dug during the November 10, 2022 investigation, met the criteria of redox dark surface but based on the F6 user notes, this is considered a false positive because of the absence of wetland hydrology. The horizon directly beneath the Ap horizon in Test Pits #1 and #2 were 10YR 4/4. Test Pit #3 did not meet the criteria of Redox Dark Surface.

**Photographs 1-3** View of BVW 1 test pits from left to right: Test Pit #1, Test Pit #2, Test Pit #3. View of dark yellowish brown colors (yellow arrows) indicative of upland soils directly beneath the Ap horizon. BVW 1 was re-delineated to exclude this area, which did not exhibit evidence of wetland hydrology based on observations from test pits.

10. Buried soils were not observed within these three test pits.
11. Based on this investigation, the boundary of BVW was refined to remove the area generally between flags 1A-118 and 1A-129 which lacked hydric soils and evidence of hydrology. The updated BVW 1 boundary is provided in Figures 2 and 3.

12. Original flags 1A-100 to 1A-118 remained. Original flags 1A-119 to 1A-127 were removed. Original Flags 1A-128 through 1A-133 remained, but were renamed to 1A-121 through 1A-126.

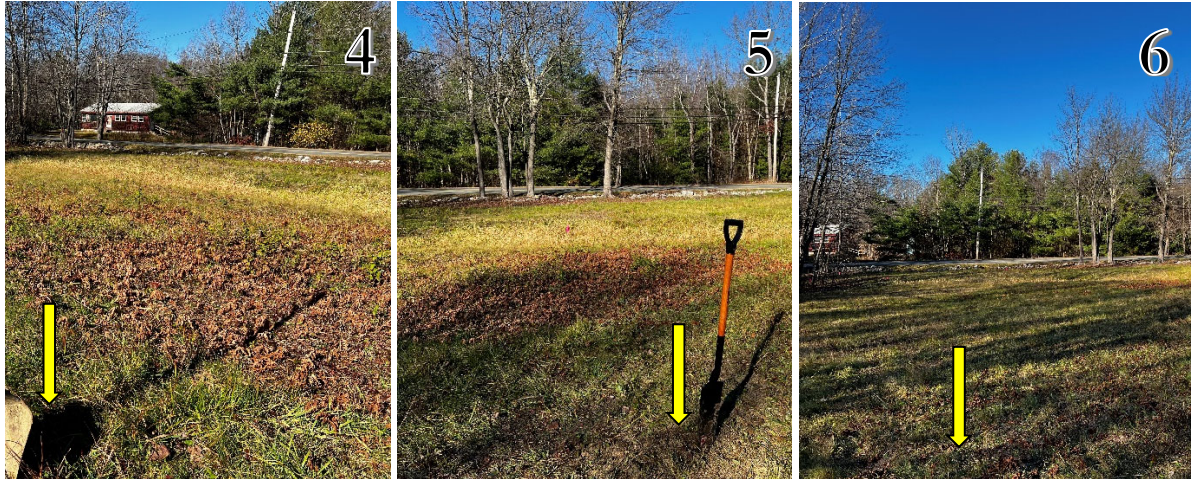
**Photographs 4-6** View of BVW 1 test pit locations (yellow arrow) from left to right: Test Pit #1, Test Pit #2, Test Pit #3. BVW 1 was re-delineated to exclude this area, which did not exhibit hydric soils or evidence of wetland hydrology based on observations from test pits.

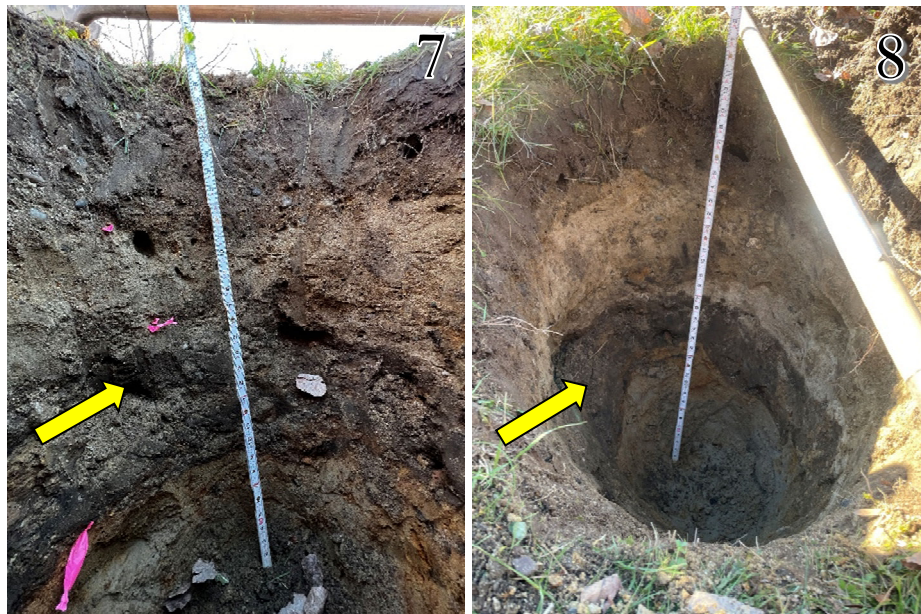
15. Within Test Pit #4, a darker horizon was observed between 16 inches and 26 inches. Based on known past disturbance, this horizon is likely a buried A horizon.

16. A buried hydric soil (Problem Hydric Soils, Three Chroma Sands NE-S1) was observed within the Test Pit #4 (see yellow arrow in Photograph 7 below). Although the review of the 1962 aerial shows disturbance within the vicinity of the BVW 2 was prior to pertinent regulations, the location of Test Pit #4 was conservatively included in the updated BVW 2 delineation.

*Photographs 7-8* View of BVW 2, Test Pit #4. Buried A horizon indicated by the yellow arrow.

17. As recommended by Ms. Stockman, the mounded fill pile originally excluded from the BVW 2 delineation is included in the updated BVW 2 delineation. It is assumed the pile was placed after 1965 and in the absence of the pile, a wetland would be present.

18. The updated BVW 2 delineation generally follows the toe of access road slope. Original flag 2A-100 remained. Original flags 2A-101 through 2A-103 were generally moved to the west to increase the wetland size. Original flags 2A-104 and 2A-105 remained and were renamed to 2A-105 and 2A-106, respectively.

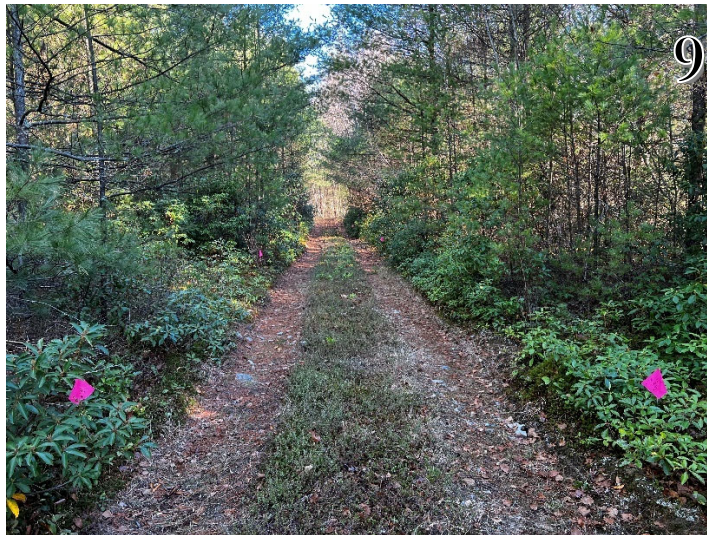
As noted by Ms. Stockman in comment #7, the overall IVW area encapsulates areas of internal, isolated uplands. During the November 2022 investigation, IVW 4 was re-delineated to exclude these isolated uplands. The re-delineation resulted in IVW being split into two separate IVWs (i.e., IVW 4 and IVW 5). IVW 4 is 820 sf and IVW 5 is 174 sf. Because these wetlands are less than 1,000 square feet, they are not considered jurisdictional under the Town of Shutesbury General Wetlands Protection Bylaw (Shutesbury Wetlands Bylaw). IVW's 4 and 5 are shown on Figures 2 and 3 for reference. Because IVW's 4 and 5 are not jurisdictional under the Shutesbury Wetlands Bylaw and Massachusetts Wetlands Protection Act (MAWPA), no buffer zone is associated with these IVW's.

*Photograph 9* View of IVW 4 after re-delineation on November 10, 2022.

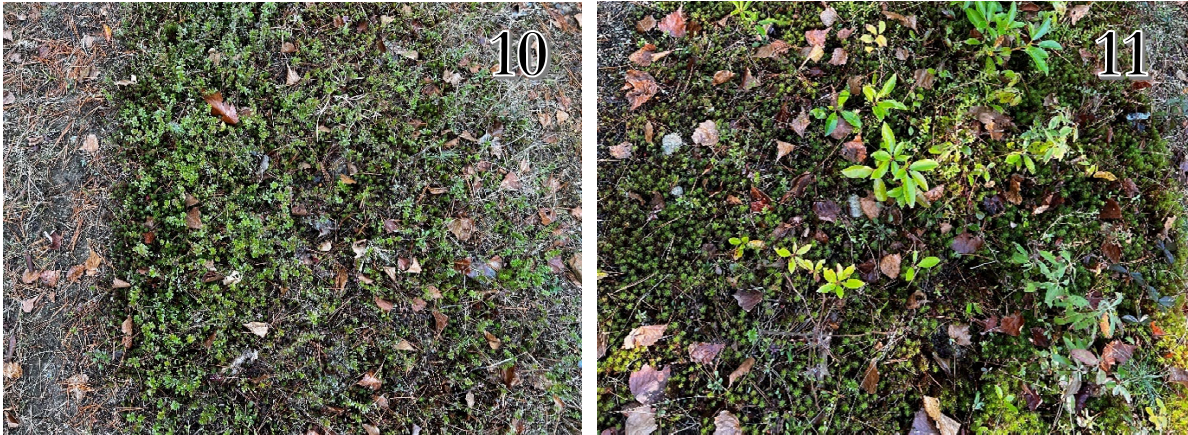
**Photographs 10 and 11** View of IVW 5 vegetation dominated by cranberries (left) compared to upland area (right) dominated by hairy cap moss and some mountain laurel. This upland area, originally included in IVW 4, now separates IVW 4 and IVW 5.

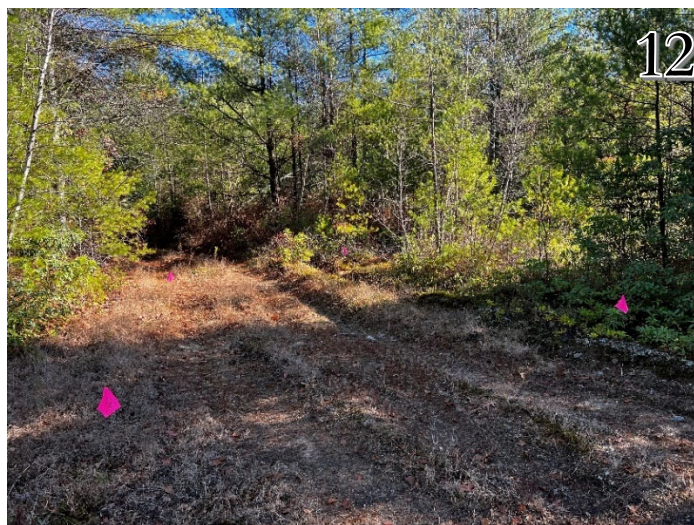
IVW 6 is a new isolated wetland delineated south of IVW's 4 and 5. Hydric soil indicator Depleted Matrix (F3) was observed at the base of the ruts. Vegetation included cranberry (*Vaccinium oxycoccus*; OBL), sedges (*Rhynchospora* spp.), and sheep laurel (*Kalmia angustifolia*; FAC). BVW 6 is 233 sf, and is therefore not considered jurisdictional under the Shutesbury Wetlands Bylaw. IVW 6 is shown on Figures 2 and 3 for reference. Because IVW 6 is not jurisdictional under the Shutesbury Wetlands Bylaw and MAWPA, no buffer zone is associated with it.

**Photograph 12** View northeast of IVW 6 within the access route delineated on November 10, 2022

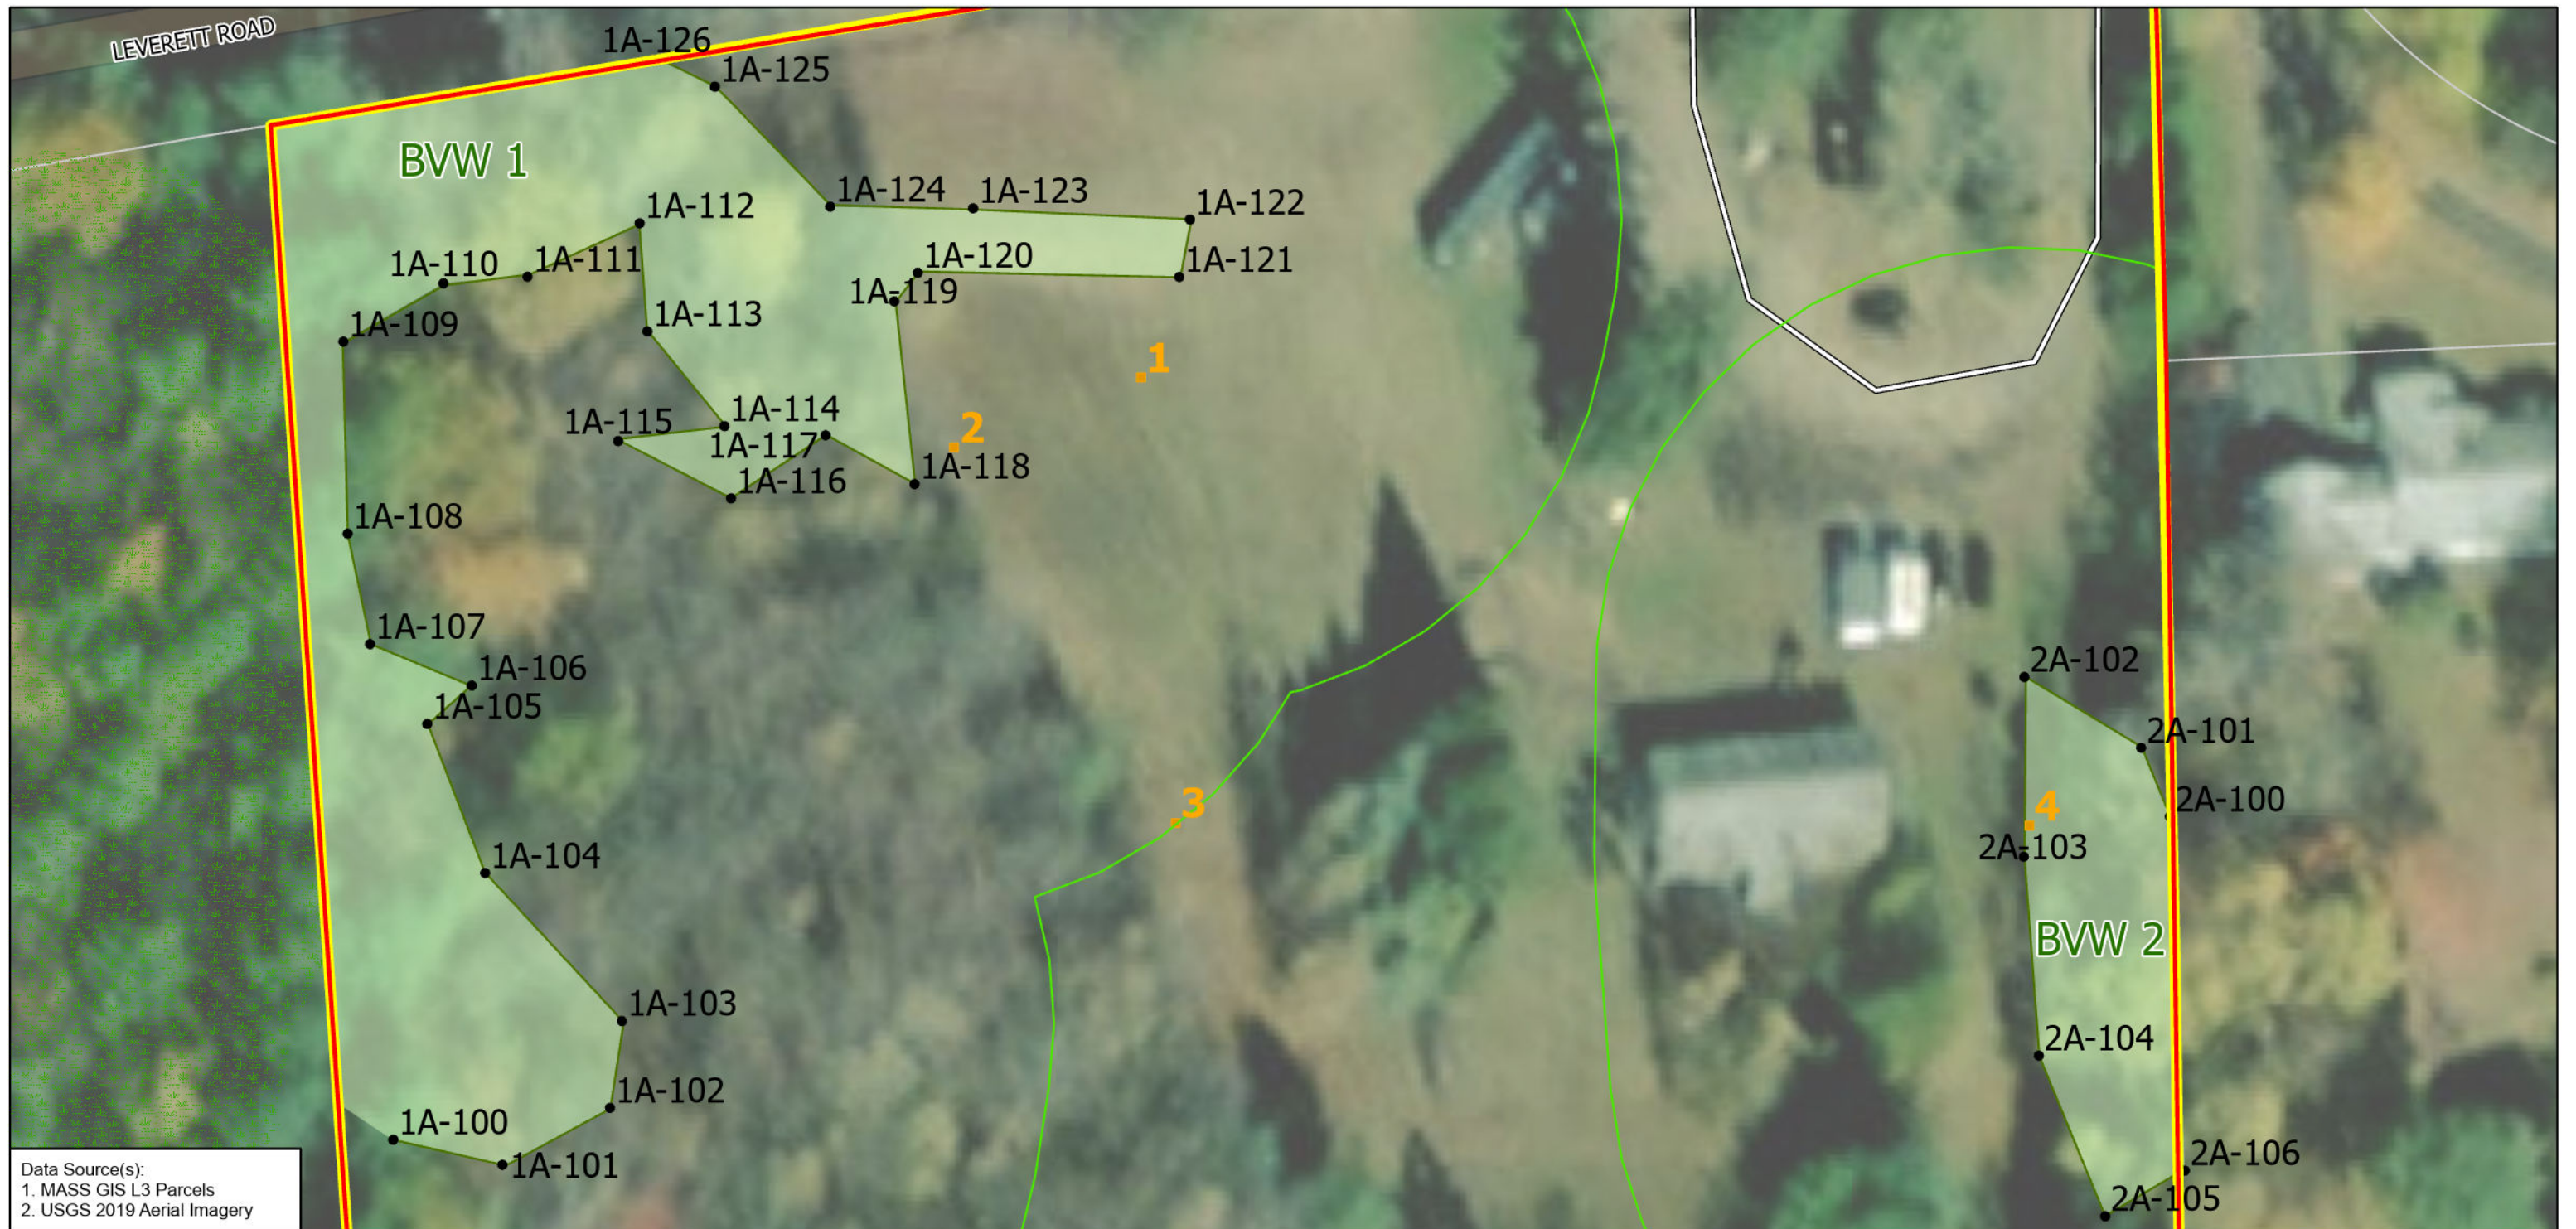
**Figure 2**

13. The 100-foot Buffer Zone to BVW was added to Figure 2 and 3.

19. The 100-foot Buffer Zone to BVW 2 was added to Figures 2 and 3.
