WILDLIFE HABITAT EVALUATION REPORT SHUTESBURY, MA

Lake Wyola
Shutesbury, MA

Lake Wyola Advisory
Committee
PO Box 276
1 Cooleyville Road
Shutesbury, MA 01072

June 2019

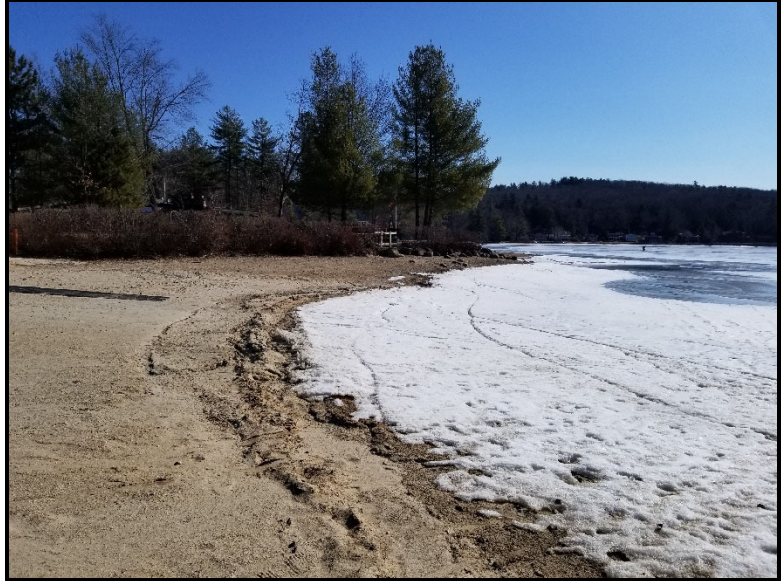
Photo #2.

Northern Portion. Exposed bank. Example of rocks above and below the water surface (note stain lines) and crevices. Example of sand and coarse substrate common throughout the outer littoral zone.

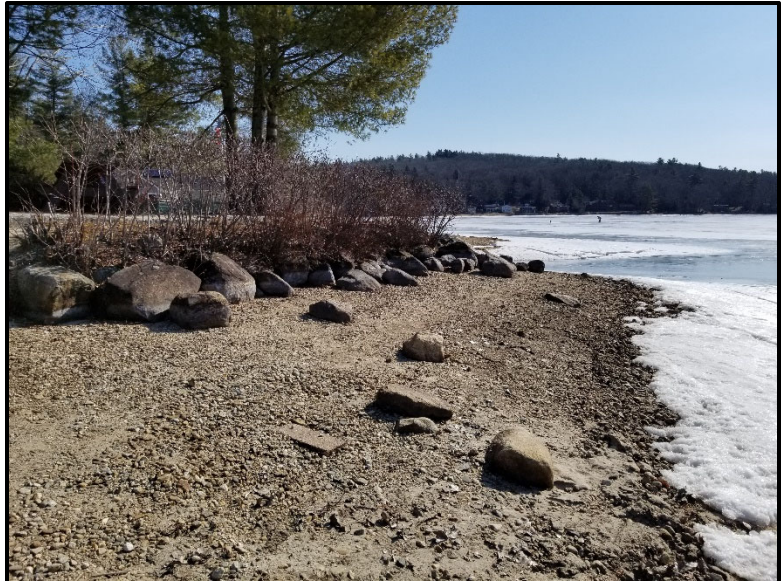
Photo #3.

Northern Portion. Earthen dam and spillway. Another example of rocks above and below the water surface (note stain lines) and crevices.

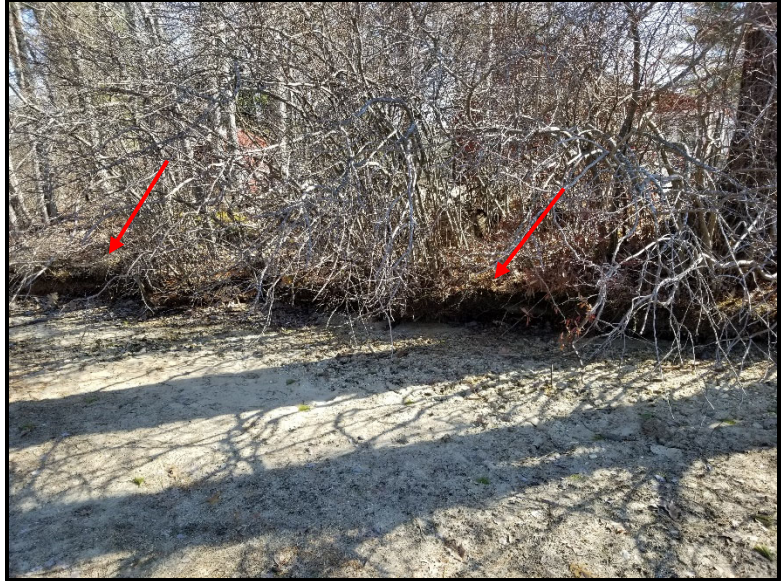
Photo #5.

Northern Portion. Exposed Bank and LUW. Another example of sand and coarse substrate common throughout the outer littoral zone.

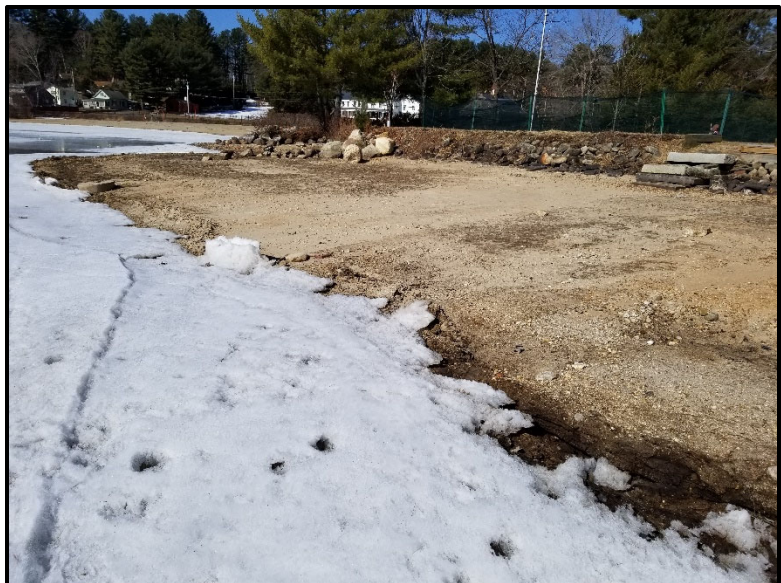
Photo #6.

Northern Portion Exposed Bank and LUW. Contrasting substrate. Increased fines, and organics within backwater coves and inlets. Mudflats are exposed during drawdown conditions.

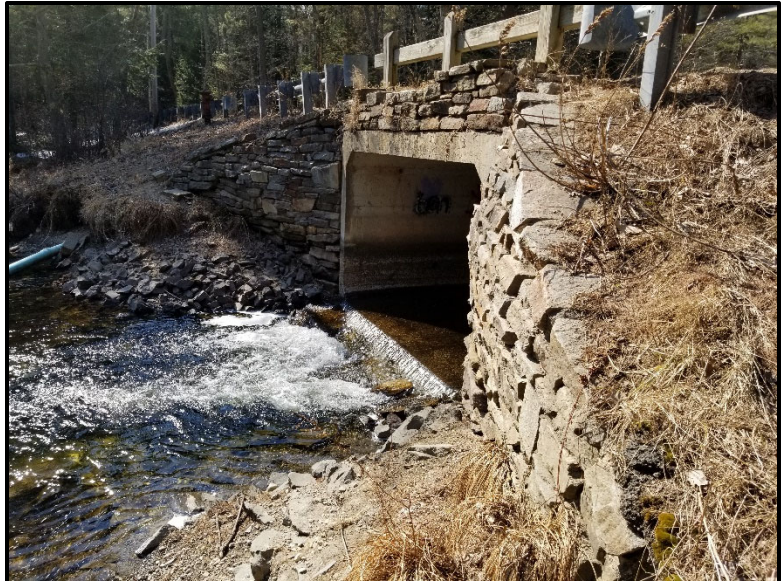
Photo #12.

Several culverts discharge into the lake resulting in sedimentation presumably associated with turbid stormwater. In the case of the Fiske Brook culvert, a large plunge pool was observed at the outlet area.

Northern Portion. Plunge pool associated within Lakeview Road box culvert outlet (Fiske Brook).

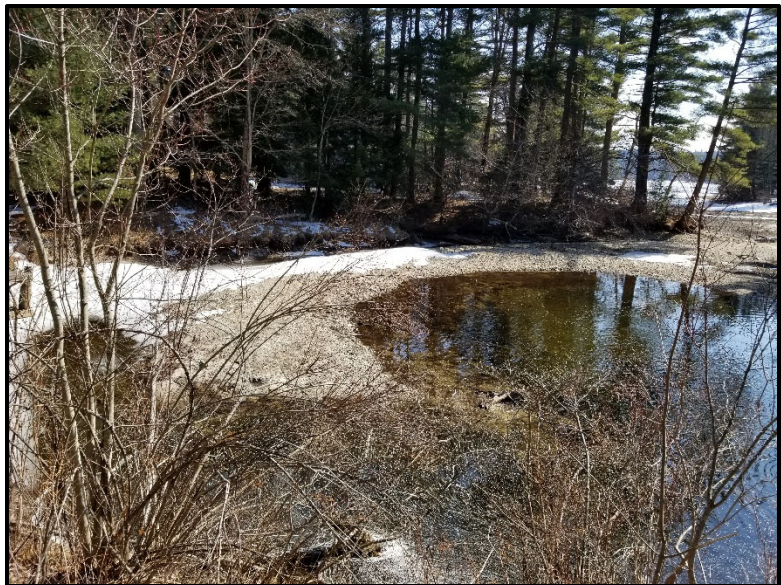
Photo #13.

Northern Portion. Elevated culvert outlet during drawdown. Sedimentation.

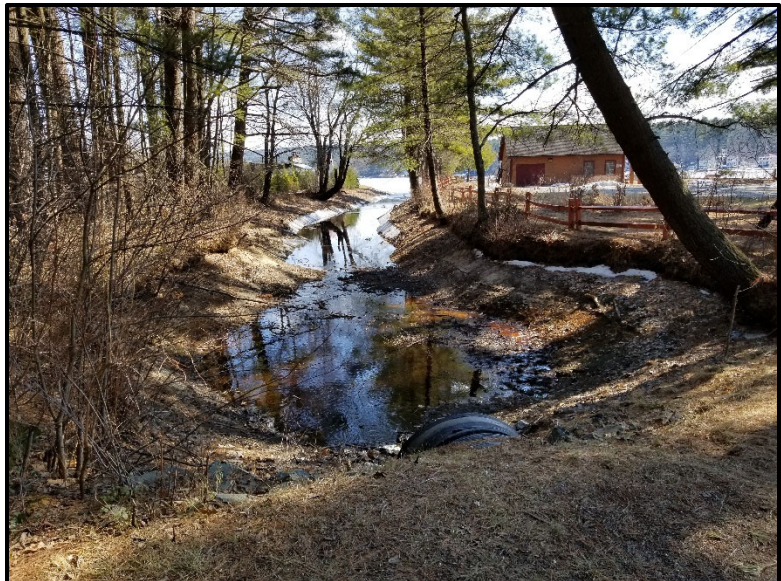
Photo #15.

There were several seeps observed along both the westerly and easterly Bank. Seeps can improve the level of dissolved oxygen within the lake, which is already typically low during the winter month and can decrease further under drawdown conditions.

Central Portion. Exposed Bank and LUW. Several seeps were observed along both the west and east central lake shore.

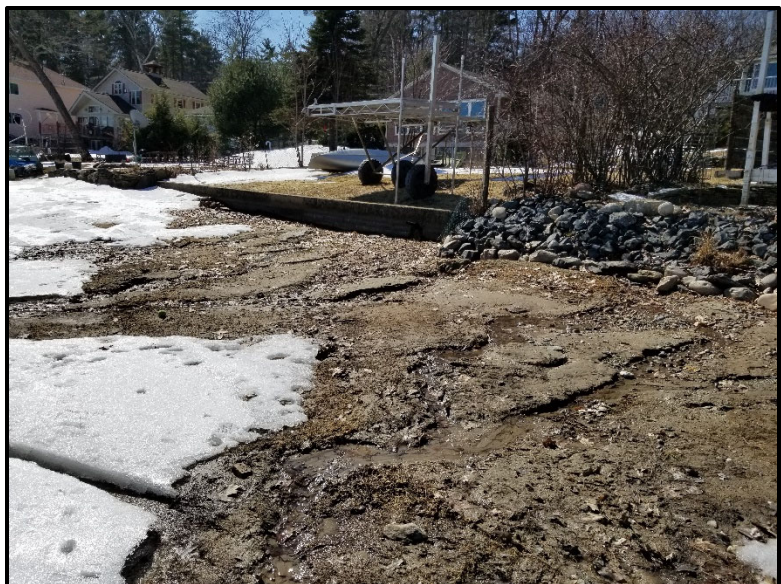
Photo #16.

Central Portion. Exposed Bank and LUW. Example of undercuts and rocks at and below the water surface during full pool.

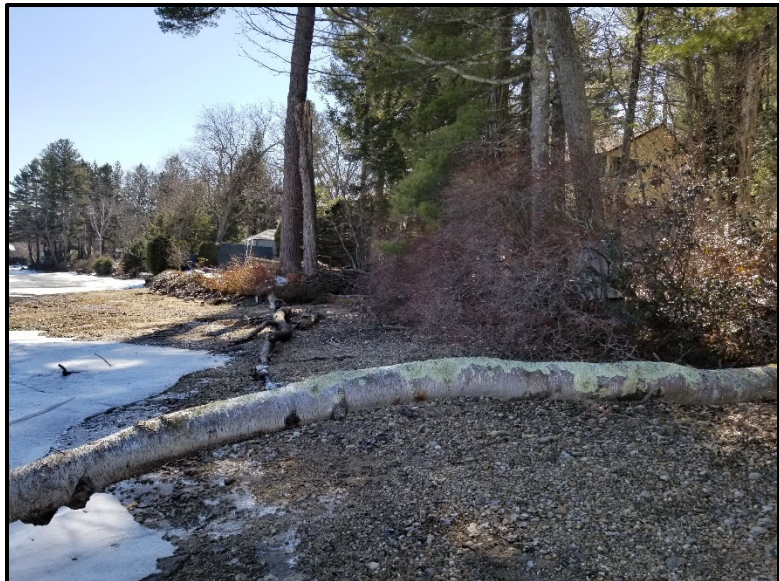
Photo #18.

Several culverts discharge into the lake resulting in sedimentation presumable associated with turbos stormwater. A sedimentation delta was observed along the westerly Bank where a culvert from Lake Drive discharges stormwater. Additional culverts were observed along the easterly Bank, presumable discharging stormwater associated with North Laurel Drive.

Central Portion. Small cove area with inflow from culvert at Lake Drive. Note sedimentation attributed to turbid stormwater from nearby Lake Drive, which is a gravel/dirt road. Also note the fine sediments and organics which were typically observed within the coves and small inlet areas around the lake.

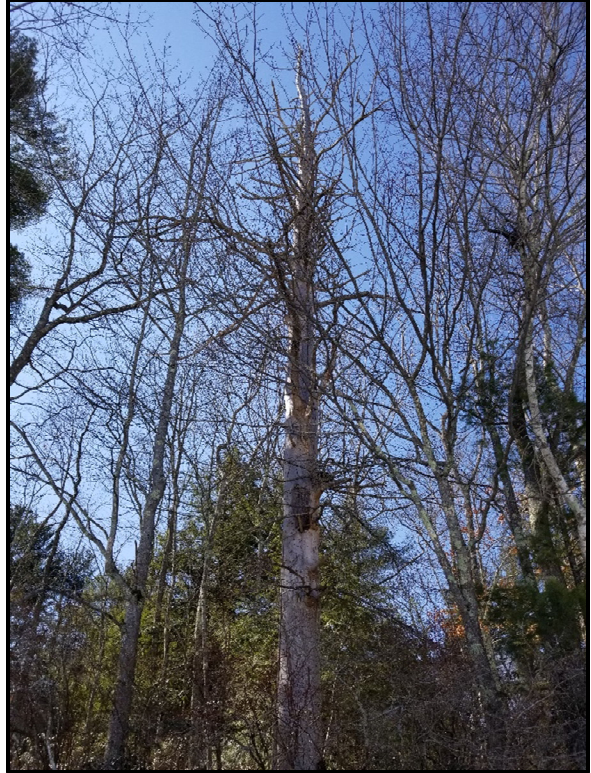
Photo #23.

Central Portion. Easterly shore. Example of sands and coarser substrate along the outer littoral zone. Also note discharge presumable associated with a culvert at North Laurel Drive.

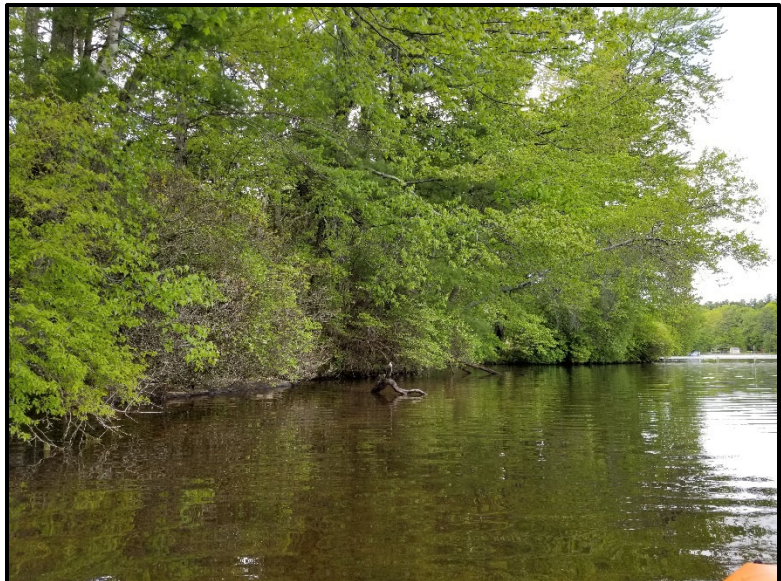
Photo #68.

Central Portion. Less developed backwater area where the culvert from Lake Drive discharges.
