Appendix C

Post-Restoration and Mitigation Information

RE: Lot O-32 Wetland Restoration Project (MassDEP File #: 286-0298)
Wetland Restoration Initial Report

Re: DEP file # 286-298, Wetland Restoration Inspection, 66 Leverett Road

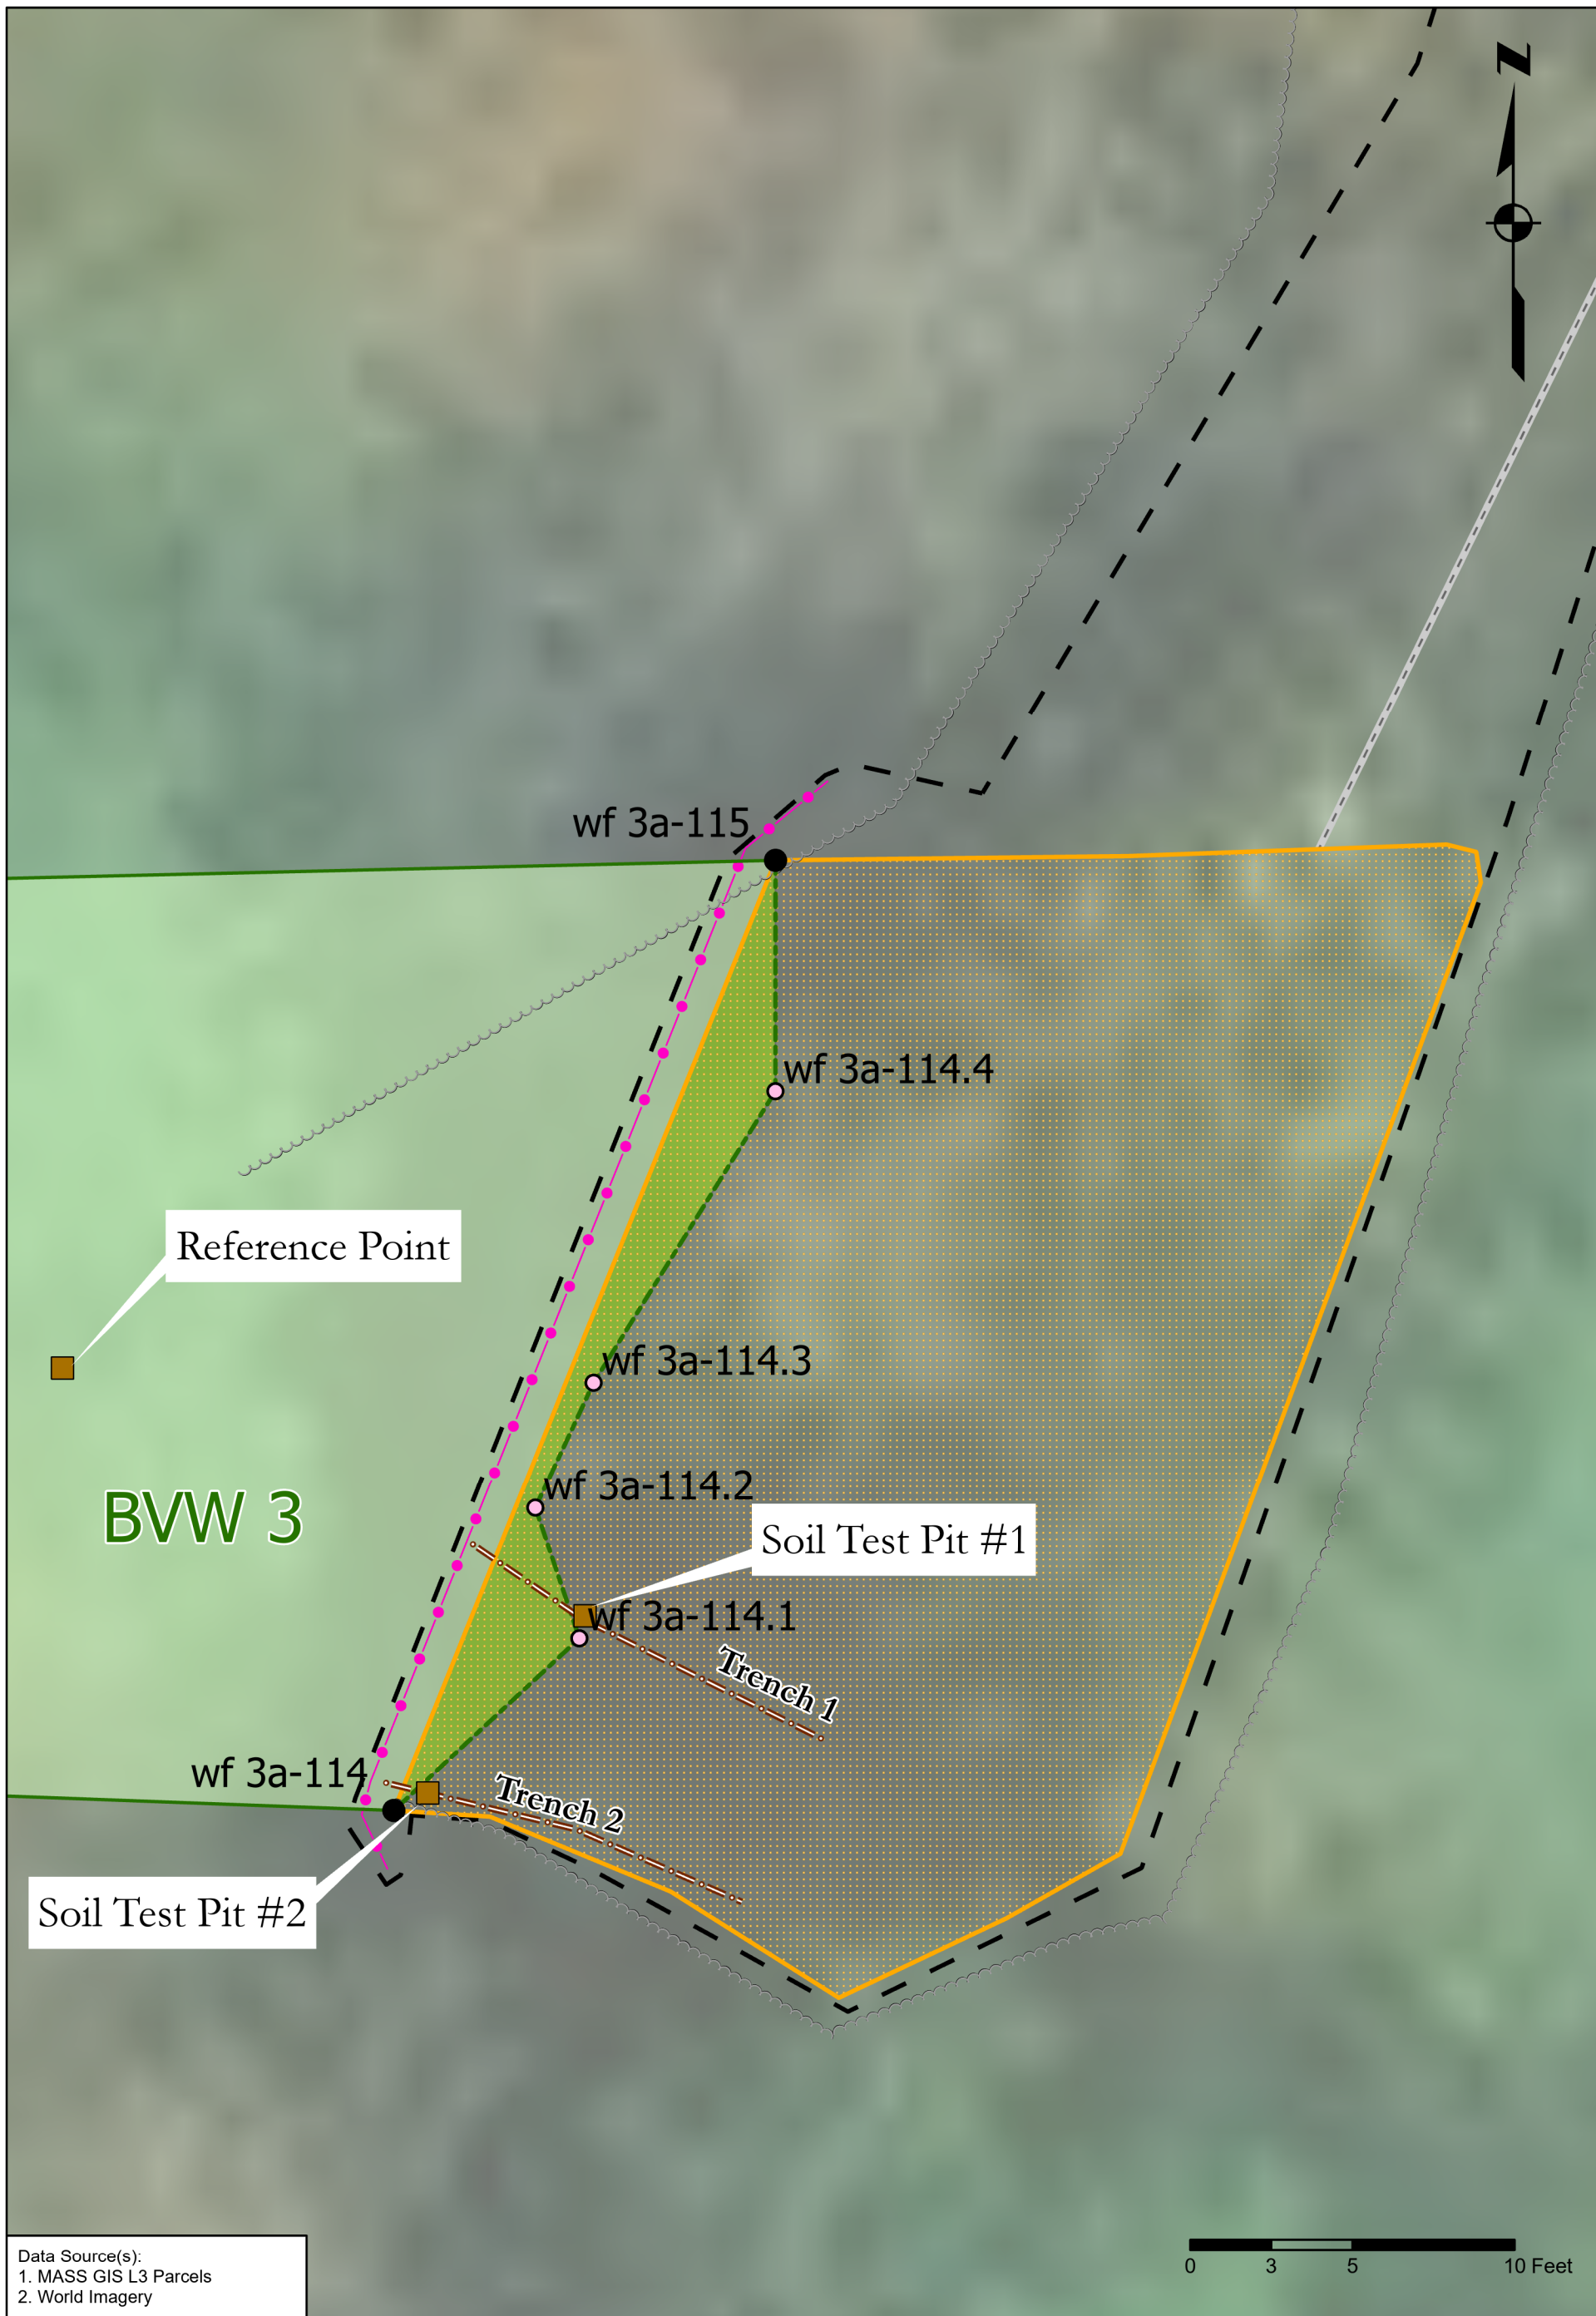
A soil auger hole was advanced within BVW 3 (42.4499527, -72.4166316) to serve as a reference point to determine if the excavation area soil conditions matched hydric soil conditions within the reference point. The soil profile in the reference point meets the criteria of hydric soil indicators Depleted Matrix (F3) and Sandy Redox (S5). The soil profile description of this reference point is described in *Table 1* below. Refer to Figure 5 for the location of the BVW 3 Reference Point.

Soil Test Pit #2 was observed on the south face of Trench 2 (42.4499349, -72.4166383). Trench 2 was dug from the west to east, directly adjacent to the southern treeline in the Potential Restoration Area, adjacent to flag wf 3a-114. Trench 2 was dug south of Trench 1 to investigate the extent of fill that was observed on the south side of Trench 1. The location of the soil description was selected because of observations of buried trash at this location that were noted during a peer review process in support of the previously submitted ANRAD. No buried horizon was observed in Soil Text Pit #2 or within Trench 2. Observations from Soil Test Pit #2 are detailed in *Table 3* below. Refer to Figure 5 for the location of Trench 2 and Soil Test Pit #2.
